Historic Cultural Properties Inventory (HCPI) Base Form (FORM 1)

NAME OF PROPERTY: **Bent St 134 - Trujillo House**

LOCAL REFERENCE NUMBER: **2005011**

2005 CLG Survey

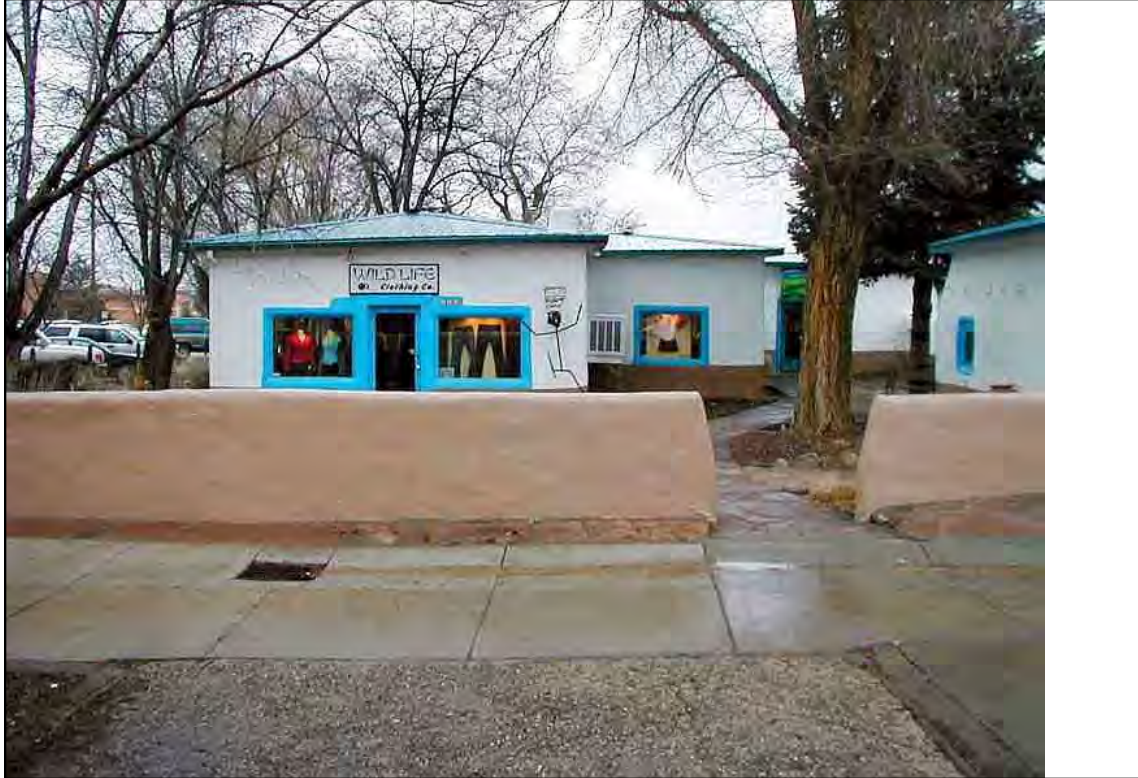
PHOTOGRAPH VIEW: **2005 Survey Photo 1**

132-134 Bent Street is a single story painted stucco on adobe former residential building with a low cross-hip roofline covered with blue propanel. Its paint scheme includes white on the upper areas of the wall and brown at the lower areas in an undulating pattern. The walls are pattered and curve inwards at the gable roof eaves. Windows are fixed undivided plate glass units with metal grilles. Doors are single leaf glass and wood units providing access to the various commercial spaces inside. The building sits at the street edge on the north and adjacent to a large parking lot on the south. A centrally-located painted stucco yard wall runs along the north property line east and connects this building with #130 Bent to the east. It too shares the paint scheme of the building. A flagstone patio exists in the open area between the structures. An additional low stuccoed yard wall encloses the property on the east.

NOTES ON CONDITION: **Good**
