Historic Cultural Properties Inventory (HCPI) Base Form (FORM 1)

NAME OF PROPERTY: **Paseo del Pueblo Norte 220 - First Baptist Church** LOCAL REFERENCE NUMBER: **2005021**
LOCATION OF PROPERTY: **220 PASEO DEL PUEBLO NORTE** UTM ZONE:
CITY OR TOWN: **Taos** UTM EASTING:
COUNTY: **Taos** UTM NORTHING:

NAME OF PROJECT:
2005 CLG Survey

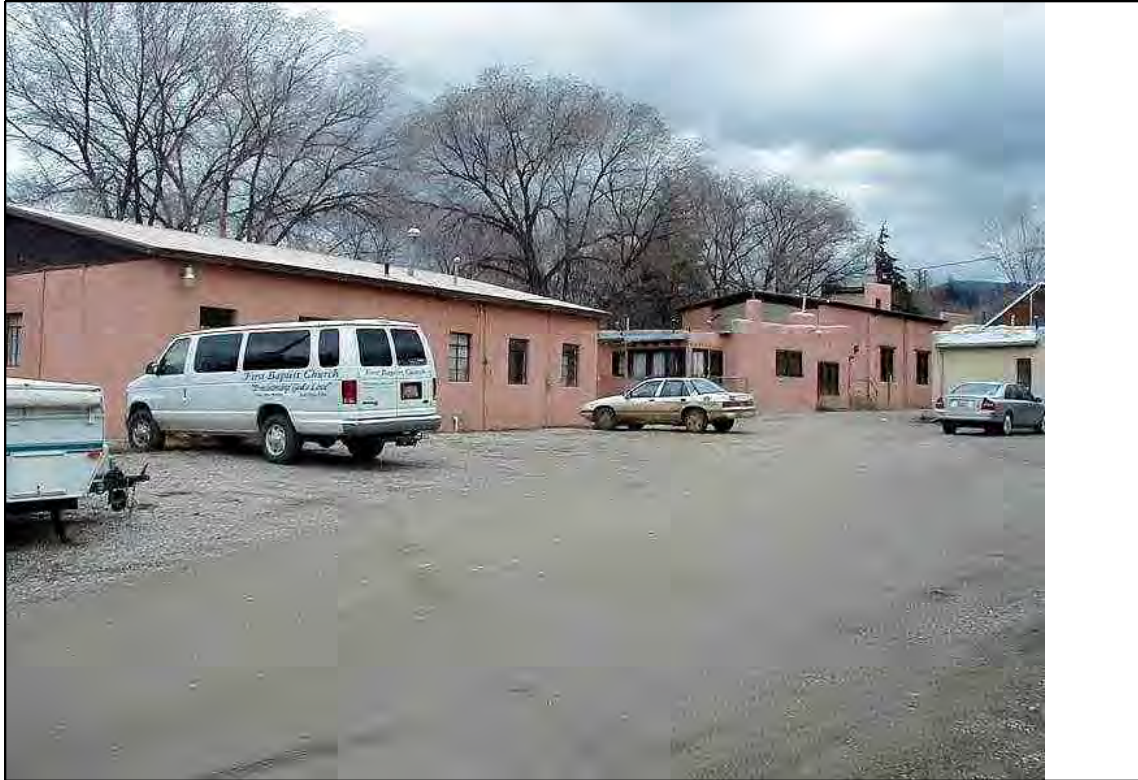
PROPERTY TYPE: **Primary** PHOTOGRAPH VIEW: **south elevation from west showing post-1957 roofline of rear building**

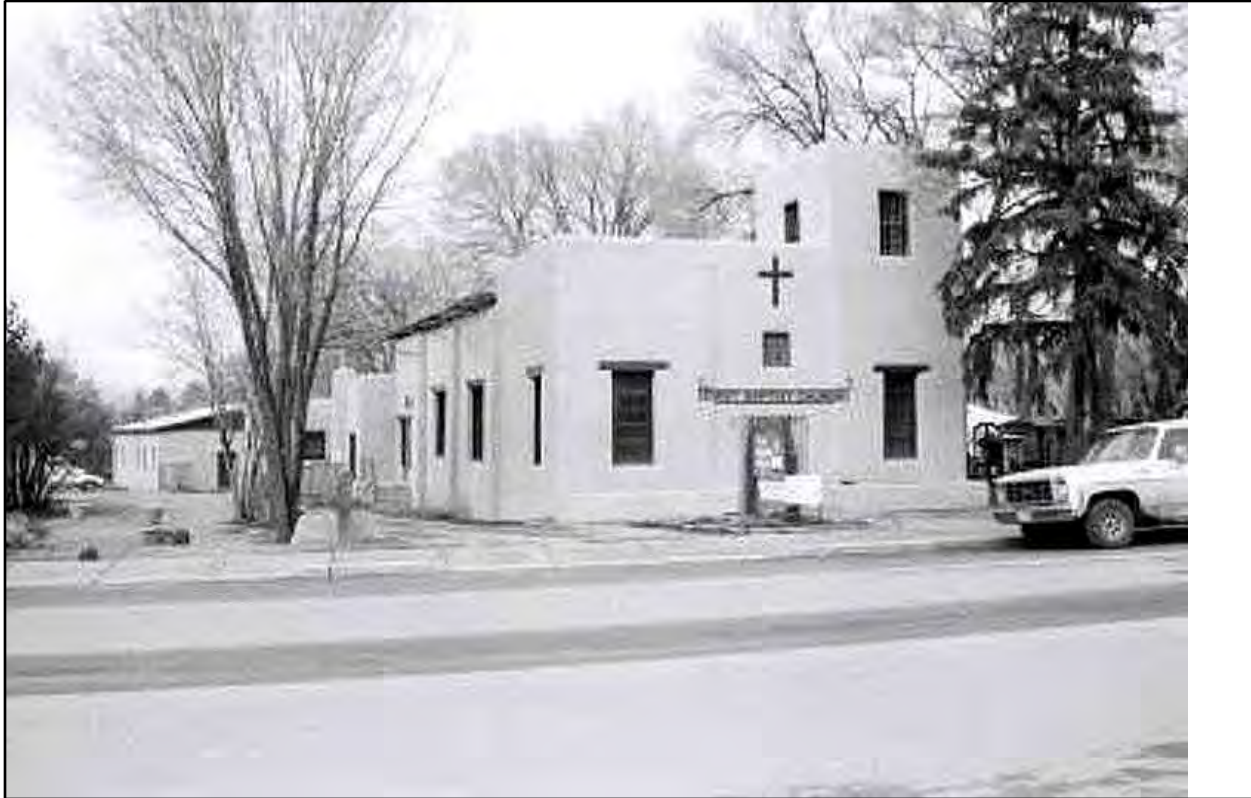
NOTES ON ADDITIONAL PERSPECTIVE: east and south elevations
(If photo, include photo info, as in #10)
