Historic Cultural Properties Inventory (HCPI) Base Form (FORM 1)

NAME OF PROPERTY: **Don Fernando St 305 A - Enos Garcia Elementary School**

LOCAL REFERENCE NUMBER: **2005059**

2005 CLG Survey

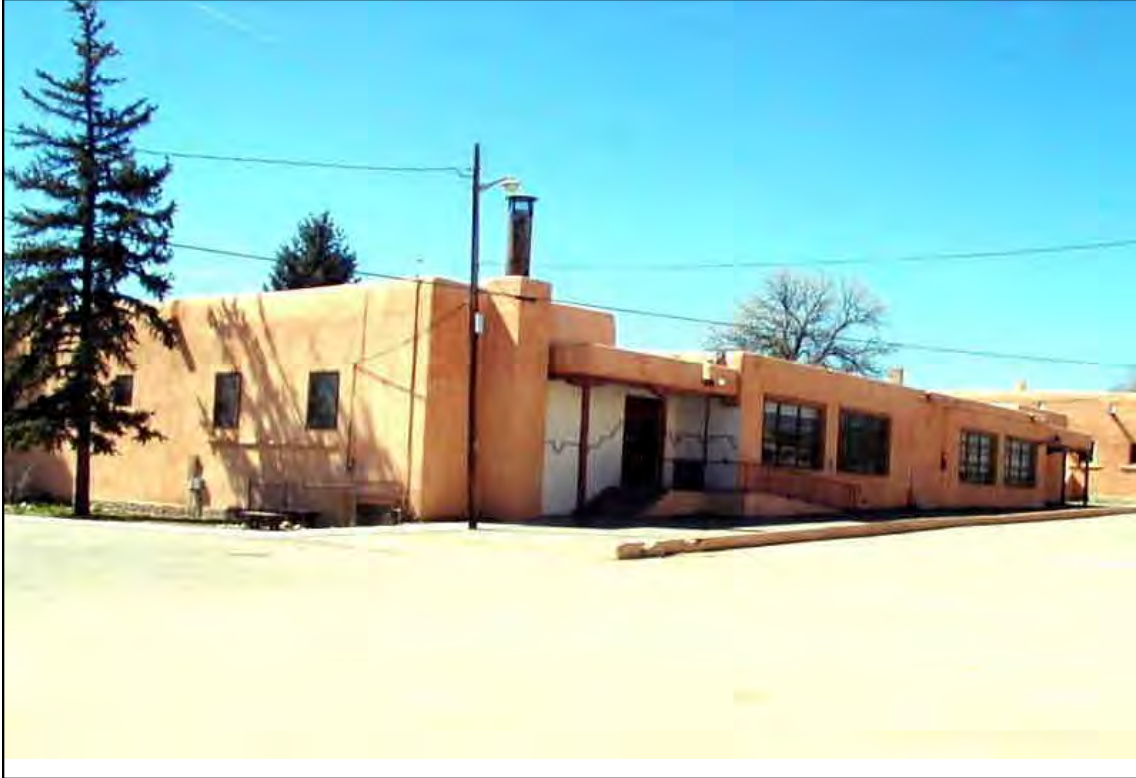
PHOTOGRAPH VIEW: **north elevation**

Public school building, WPA era. Deteriorated lintels on north portal

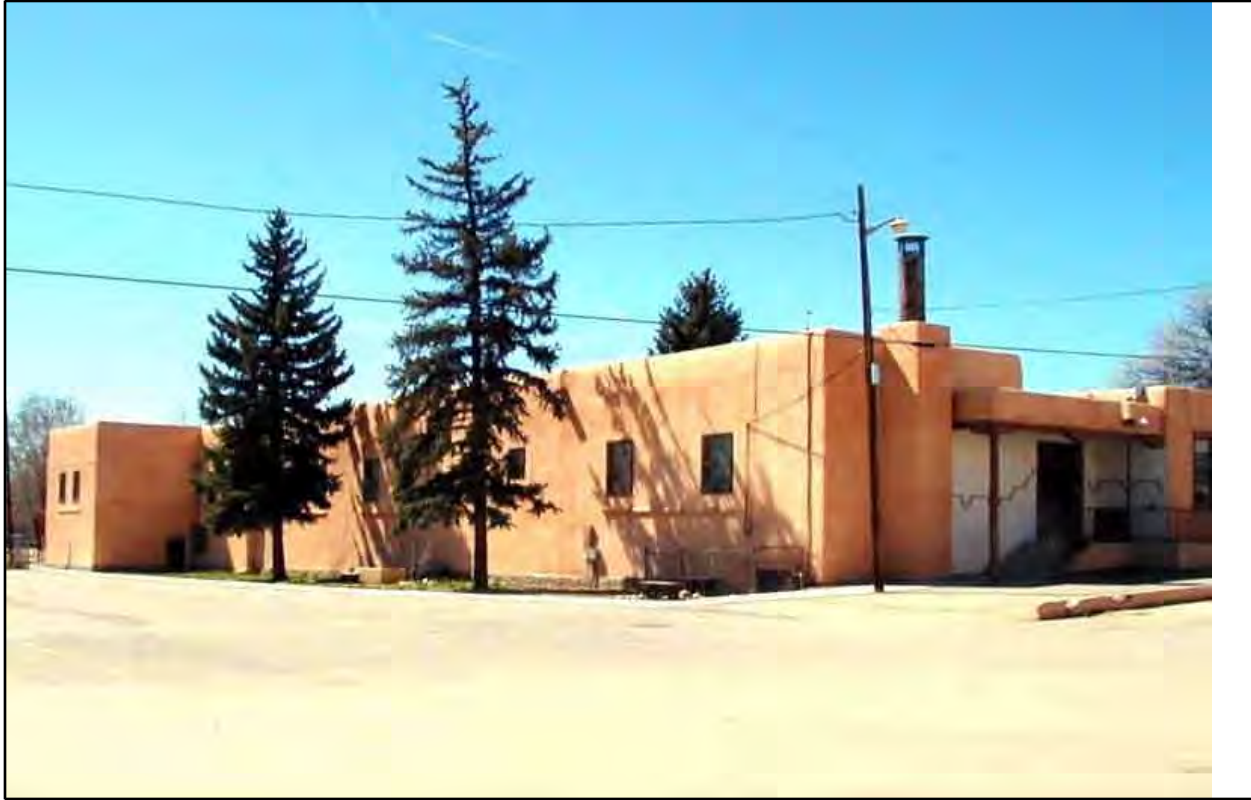
NOTES ON ADDITIONAL PERSPECTIVE: east elevation
(If photo, include photo info, as in #10)
