Historic Cultural Properties Inventory (HCPI) Base Form (FORM 1)

NAME OF PROPERTY: **Don Fernando St 205 C - Loretto Academy School and Convent** LOCAL REFERENCE NUMBER: **2005061**
LOCATION OF PROPERTY: **205 DON FERNANDO** UTM ZONE:
CITY OR TOWN: **Taos** UTM EASTING:
COUNTY: **Taos** UTM NORTHING:

2005 CLG Survey

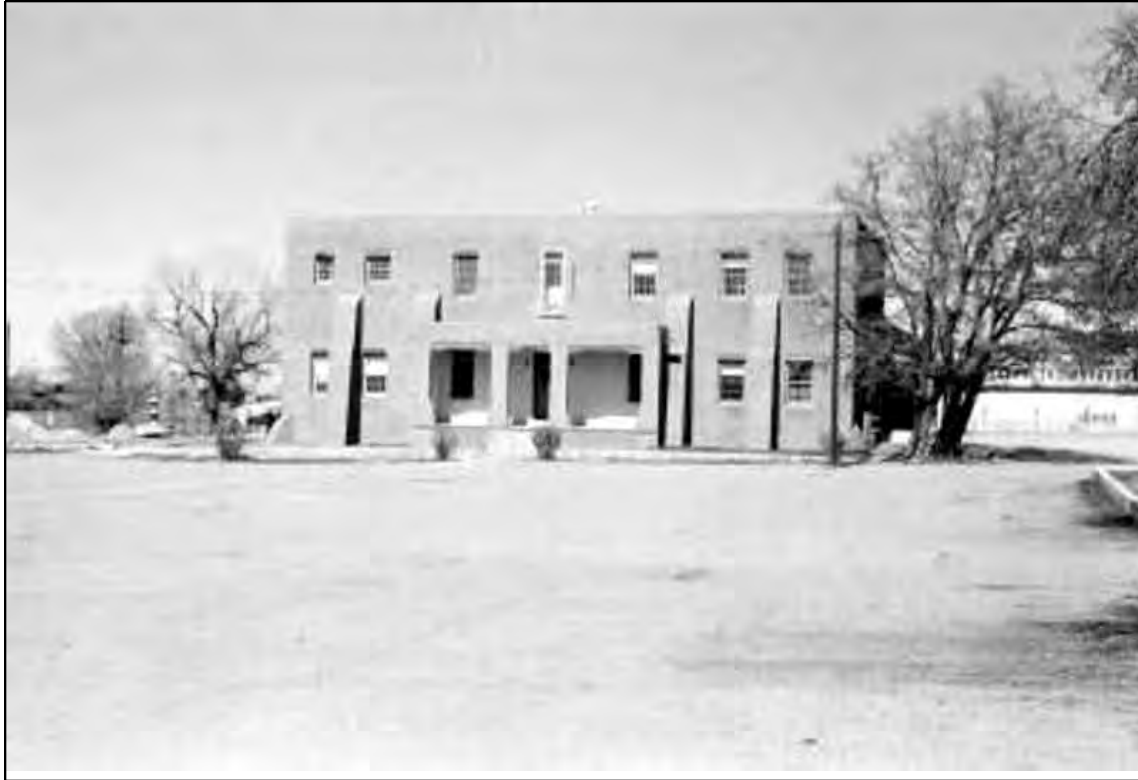
PHOTOGRAPH VIEW: **south**

The centrally-located structure on the site addressed at 205 Don Fernando Street was built as the Loretto Academy and Convent. It is a partial two-story "U"-shaped textured stucco structure of no particular architectural style. The two story portion has a flat parapet; connecting structures to the north are gable-roofed. Windows are 8-over-8 double hung wooden units with exposed lintels. They have been blocked in at the lower area of them. The south elevation is buttressed and there is a raised partial width protecting portal with stuccoed piers. The entrance door is a single leaf wood panel unit with glazing in the upper area. There is a secondary entrance on the east elevation with a similarly designed door. A second story door on the south elevation previously provided access to the historic balcony illustrated in the historic photographs. Other windows in the remainder of the complex include modern single-lite wooden slider units and segmental windows with shutters and etched glass in the transom areas. The building has a central courtyard that is open at the southwest corner. There is a simply-

NOTES ON CONDITION: **Fair**

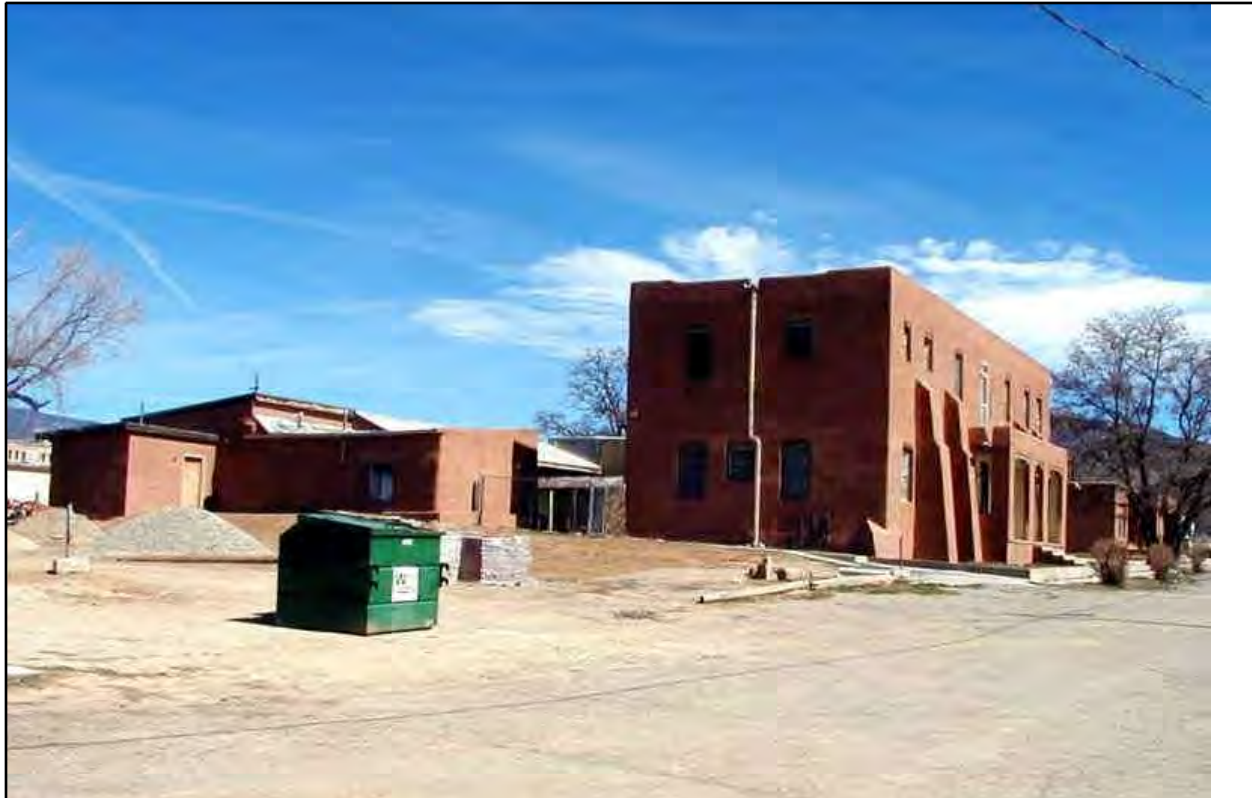
NOTES ON ADDITIONAL PERSPECTIVE: **west elevation**
 (If photo, include photo info, as in #10)

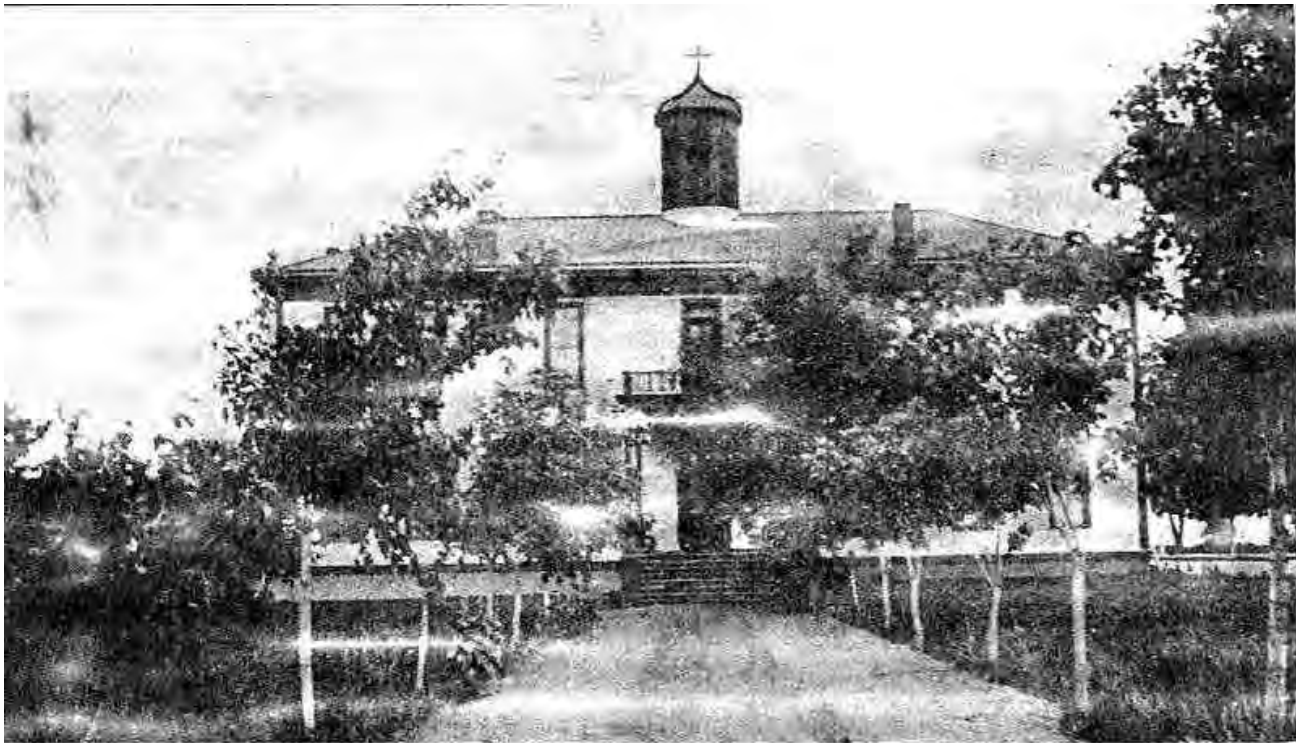
2005 Survey Photo 4

The Loretto Academy was a school run by the Sisters of Loretto. An attacehd pre-1958 photograph illustrates the original design of the building with a hipped roof and cupola. A small balcony extended over the front porch and window openings were taller than the current window units. On the north elevation of the U-shaped

St. Joseph's School, Taos, New Mexico.
