Historic Cultural Properties Inventory (HCPI) Base Form (FORM 1)

NAME OF PROPERTY: **Camino de la Placita 310 - Taos Elementary School**

LOCAL REFERENCE NUMBER: **2005063**

2005 CLG Survey

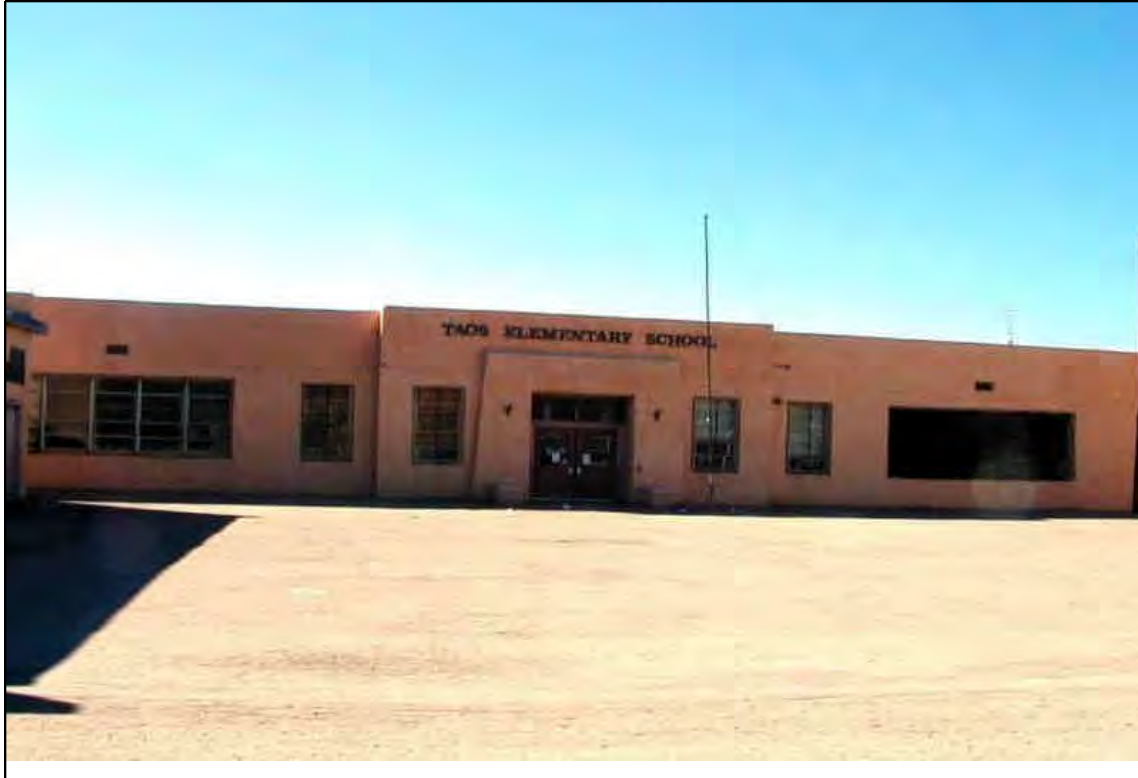
PHOTOGRAPH VIEW: **east elevation detail of central area/original building**

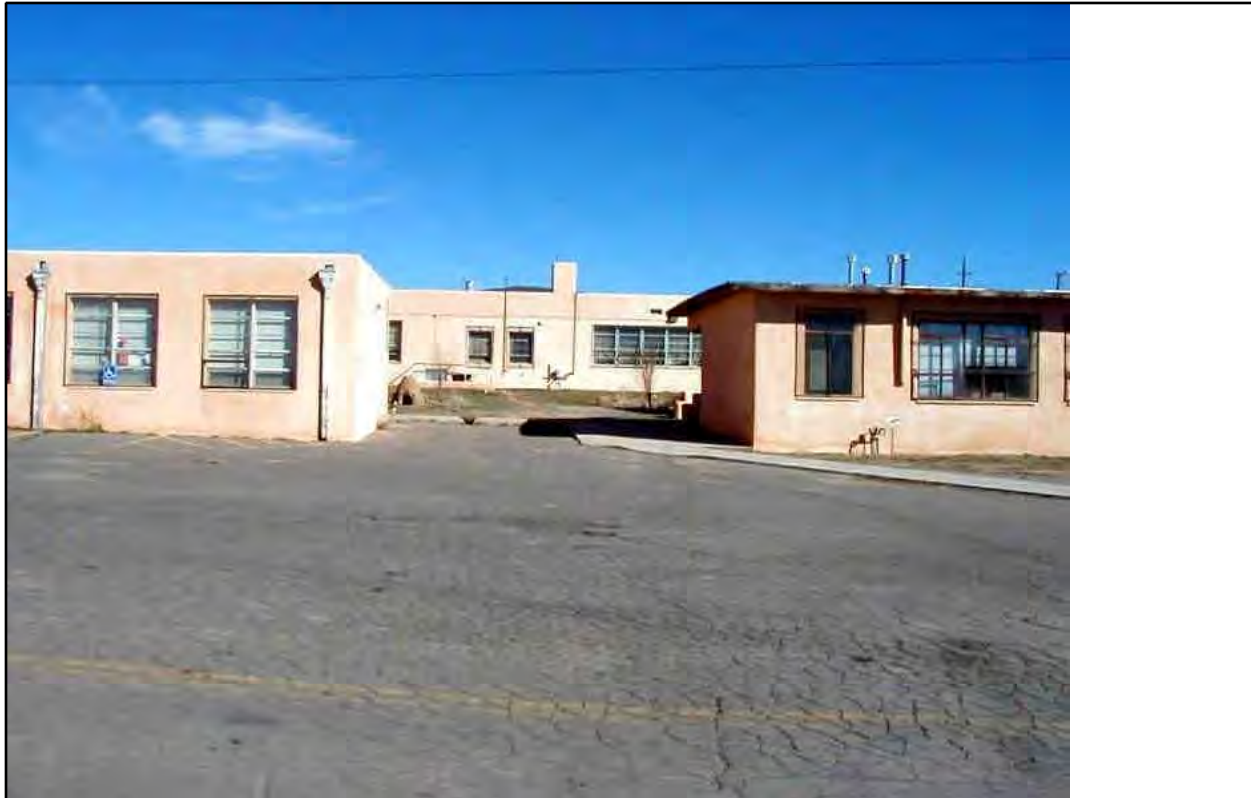
NOTES ON ADDITIONAL PERSPECTIVE: **west elevation**
 (If photo, include photo info, as in #10)
