Historic Cultural Properties Inventory (HCPI) Base Form (FORM 1)

NAME OF PROPERTY: **Don Fernando St 226**

LOCATION OF PROPERTY: **226 DON FERNANDO**

2005 CLG Survey

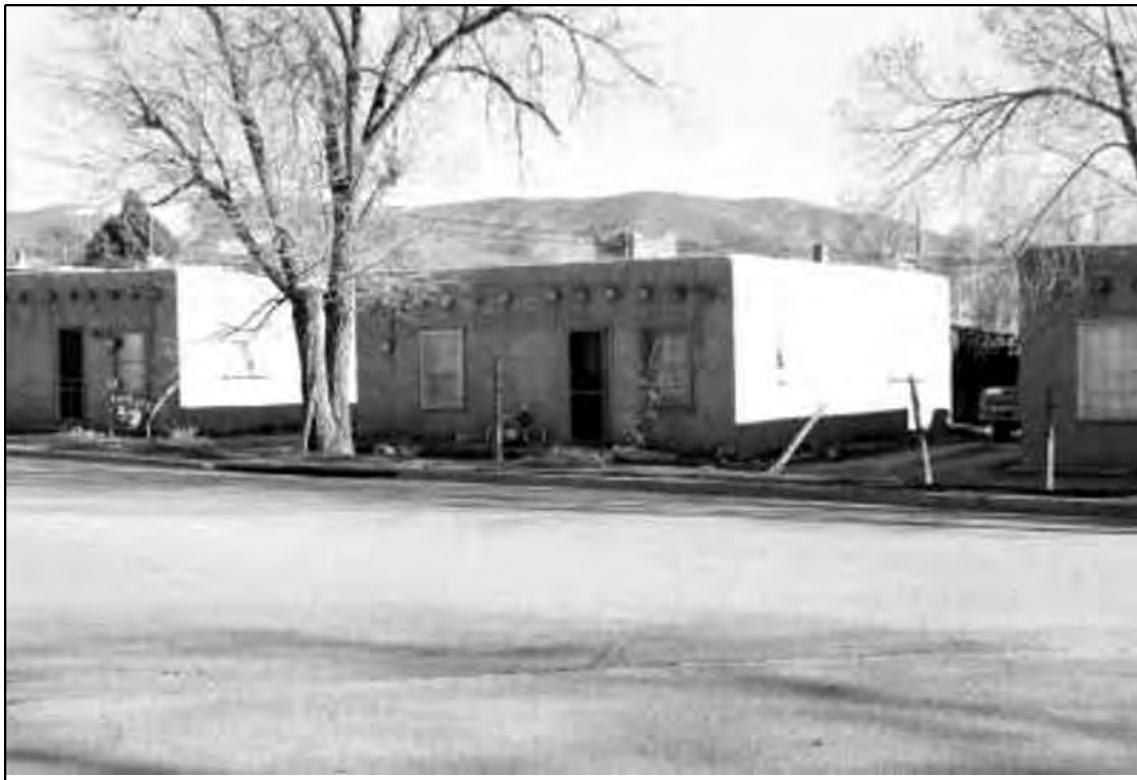
PHOTOGRAPH VIEW: **north and west elevations**

226 Don Fernando Street is a single story earth-tone stuccoed Spanish Pueblo Revival style residential structure with a flat parapet and projecting viga end on the north elevation. Windows are 6-over-6 double-hung wooden units that are concealed somewhat behind plastic which is aiding in weatherizing the structure. Wood trim surrounds the windows. There are 4-lite slider units on the west elevation. Access to the building is through a single-leaf wood panel unit with a single light and a wooden screen door. A secondary entrance is on the east side of the building. The building sits off the street and the front yard is void of vegetation.

plastic covering windows suggests that they are in need of repair
