Historic Cultural Properties Inventory (HCPI) Base Form (FORM 1)

NAME OF PROPERTY: **Don Fernando St 222**

LOCATION OF PROPERTY: **222 DON FERNANDO**

2005 CLG Survey

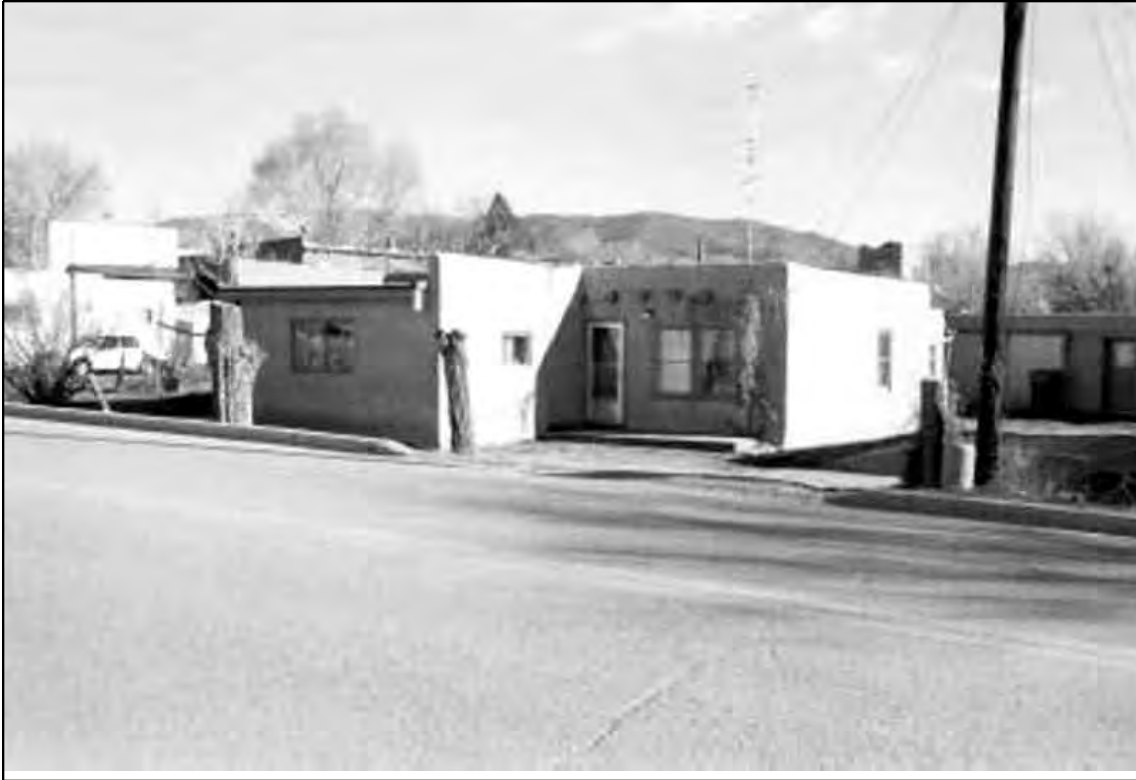
PHOTOGRAPH VIEW: **north and west**

222 Don Fernando Street is a single story earth-tone stuccoed Spanish Pueblo Revival style residential structure with a flat parapet and projecting viga ends on a portion of the north elevation. A partial-width modern shed-roofed addition has been placed on the structure's north elevation. Windows are 6-over-6 double-hung wooden units. Wood trim surrounds these windows. The addition on the north elevation has 2-lite metal slider units. Access to the building is through a single-leaf wood panel unit with a single light and a metal screen door. The building sits off the street and the front yard is void of vegetation, save 2 tall tree stumps.
