Historic Cultural Properties Inventory (HCPI) Base Form (FORM 1)

NAME OF PROPERTY: **Don Fernando St 224**

LOCATION OF PROPERTY: **220 DON FERNANDO**

2005 CLG Survey

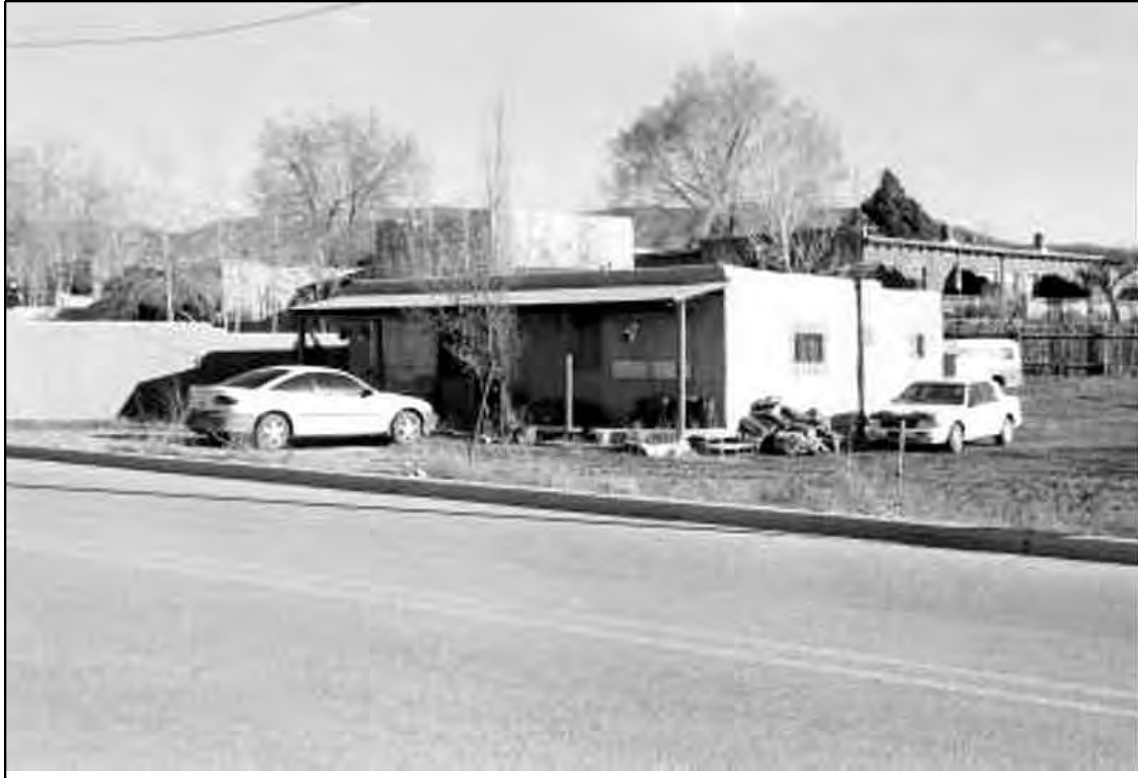
PHOTOGRAPH VIEW: **north and west**

220 Don Fernando Street is a single story earth-tone stuccoed Spanish Pueblo Vernacular style residential structure with a flat parapet the steps toward the south. There is a full-width shed-roofed portal with square posts and exposed roof joists on the north elevation. Windows are modern aluminum slider units. Entrance to the building is via a wooden paneled single leaf door with a single window and wooden storm door on the north elevation. The structure sits a bit below street grade in a grassy flat-land.

plastic covering windows suggests that they are in need of repair

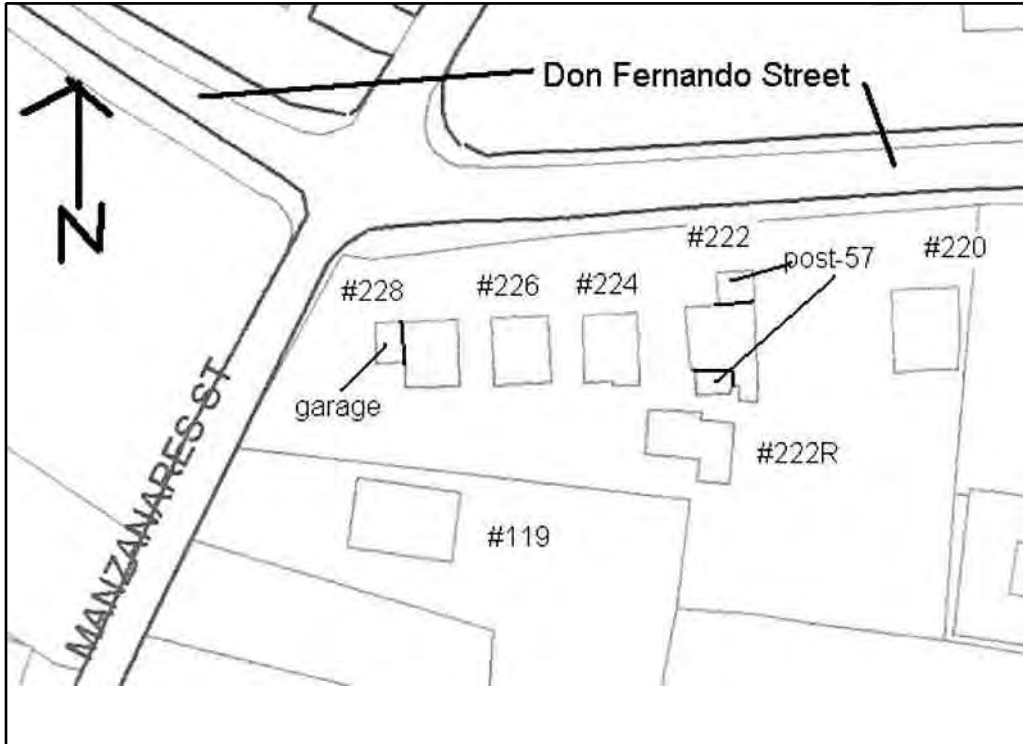
Site. Base map provided by Taos GIS. NTS.

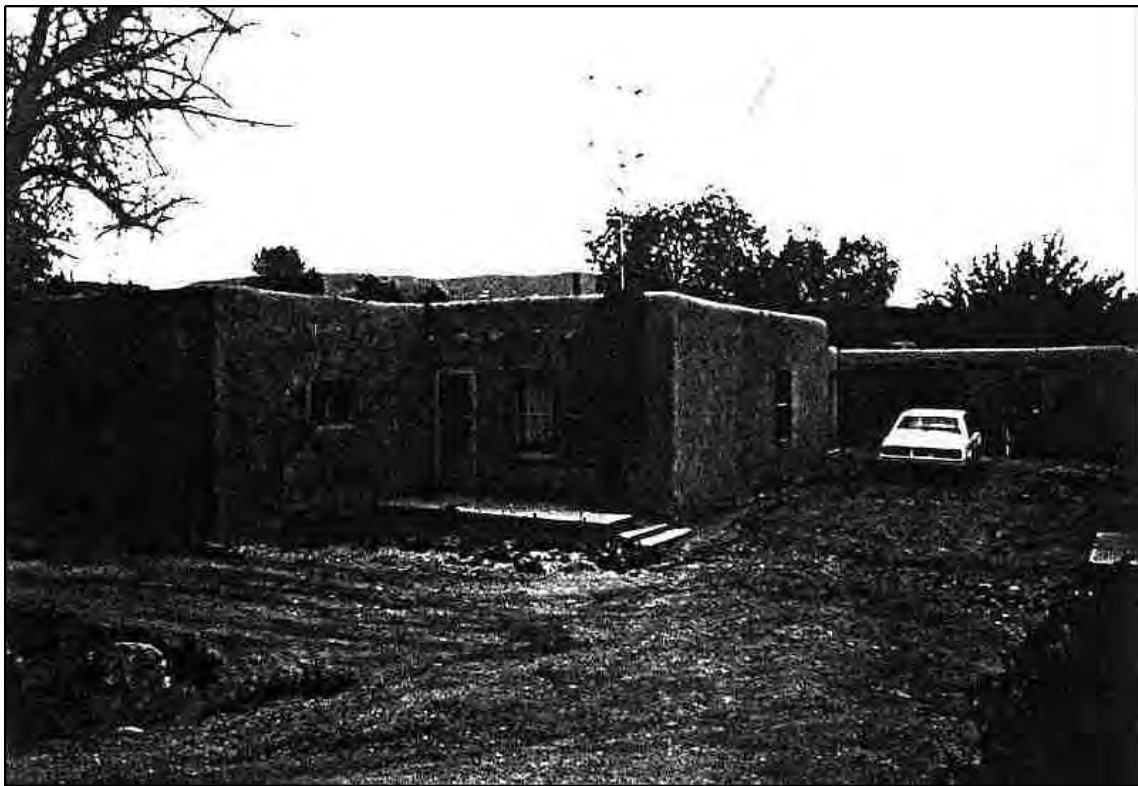
PHOTOGRAPH VIEW: **older**

220 Don Fernando Street is a single story earth-tone stuccoed Spanish Pueblo Vernacular style residential structure with a flat parapet the steps toward the south. There is a full-width shed-roofed portal with square posts and exposed roof joists on the north elevation. Windows are modern aluminum slider units. Entrance to the building is via a wooden paneled single leaf door with a single window and wooden storm door on the north elevation. The structure sits a bit below street grade in a grassy flat-land.

GENERAL: Notes
garage; two additions
