Historic Cultural Properties Inventory (HCPI) Base Form (FORM 1)

NAME OF PROPERTY: **Don Fernando St 214 - Garage**

LOCATION OF PROPERTY: **214 DON FERNANDO**

2005 CLG Survey

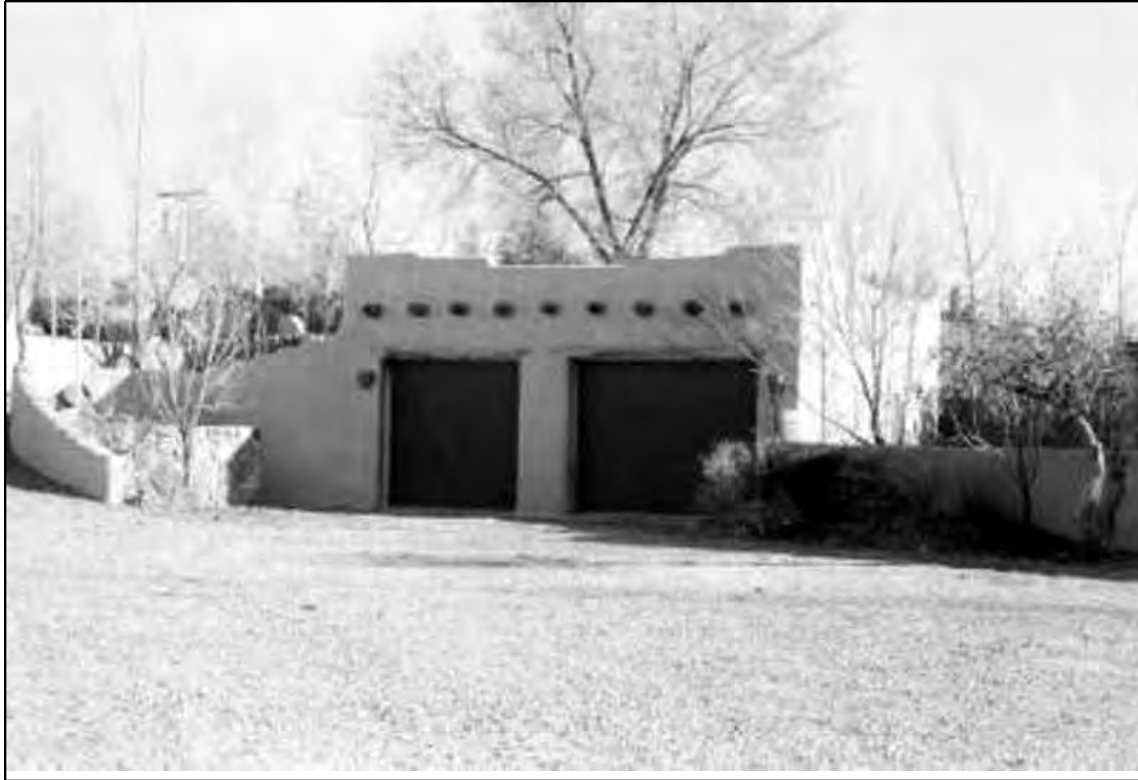
PHOTOGRAPH VIEW: **north and west elevations**

The 2-car garage at 214 Don Fernando Street is a single story stuccoed Spanish Pueblo Revival style structure. Its parapet is flat with steps at the corners. There are exposed viga ends which project from the north elevation about the paneled overhead doors. The door openings have exposed wood lintels. There is a diagonal wood single leaf pedestrian door on the west elevation which faces a flagstone patio. A sloping and stepped yard wall extends from the building's northeast corner creating a small courtyard space to the building's east side. The garage sits at the rear of the lot and fronts on to the site's large gravel parking area. There is a tall stucco yard wall along the north property line at the street.

no obvious maintenance needs
