# Historic Cultural Properties Inventory (HCPI) Base Form (FORM 1)

NAME OF PROPERTY: **Ranchitos Rd 209 - Quintana-Montoya House - demolished?** LOCAL REFERENCE NUMBER: **2005077**  
LOCATION OF PROPERTY: **209 RANCHITOS** UTM ZONE:  
CITY OR TOWN: **Taos** UTM EASTING:  
COUNTY: **Taos** UTM NORTHING:

DATE OF SURVEY:  
**3/12/2005**  
PREVIOUS SURVEY?  
**Not Available**

NAME OF PROJECT:  
**2005 CLG Survey**

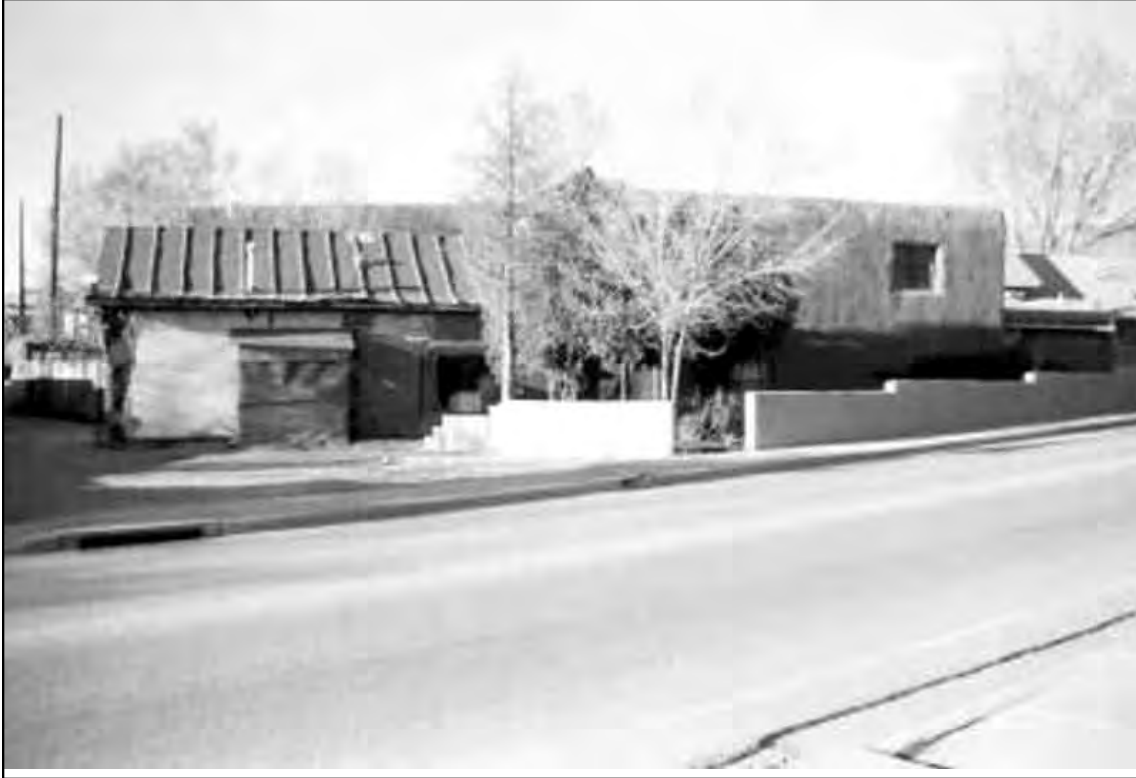
PROPERTY TYPE: **Primary** PHOTOGRAPH VIEW: **south**

**209 Ranchitos Road is a stuccoed adobe structure composed of two separately designed buildings. The western part of the building is a single story gable-roofed form with standing seam metal covered roof. The eastern part of the building is a two-story mass with a single story addition on the east end. The eastern part is finished with a flat parapet. It has a small gable-roofed portal [covered with clay tile] with square posts at the centrally-located entrance on the south elevation. The entrance door is a single leaf wooden unit with 3 upper windows with a wooden screen door. Windows are a mix of 6-lite wooden casement units on the second floor and large fixed plate glass on the south and west elevations. The south and north elevation of the western end of the structure is roughly finished with exposed adobes and displays evidence of wings having been removed. There is a stuccoed block yard wall along the south property line that steps toward the west. A wood slat fence on the west encloses the rear yard.**

SIGNIFICANT MODIFICATIONS? **post-1957 removal of north and south wings of building, what remains is a remnant of the historic structure**

adobe structure composed of two separately designed buildings. severe deterioration with exposed adobes on north and south wall, crumbled corners, and exposed parapets

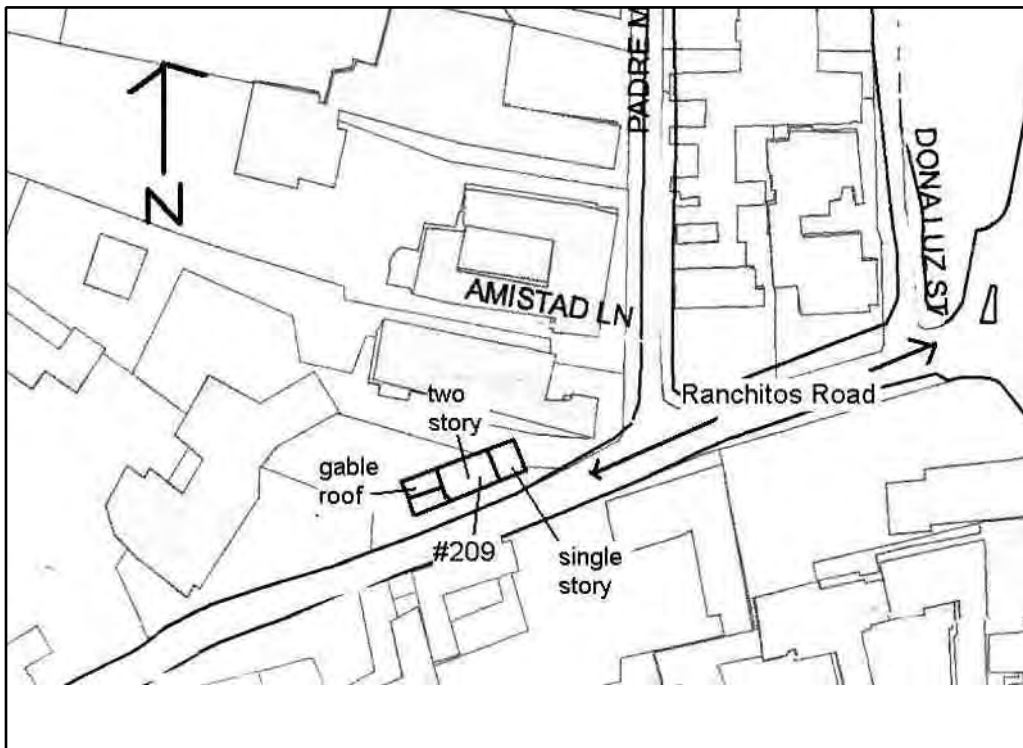
Site. Base map provided by Taos GIS. NTS.

Endangered: exposure to elements

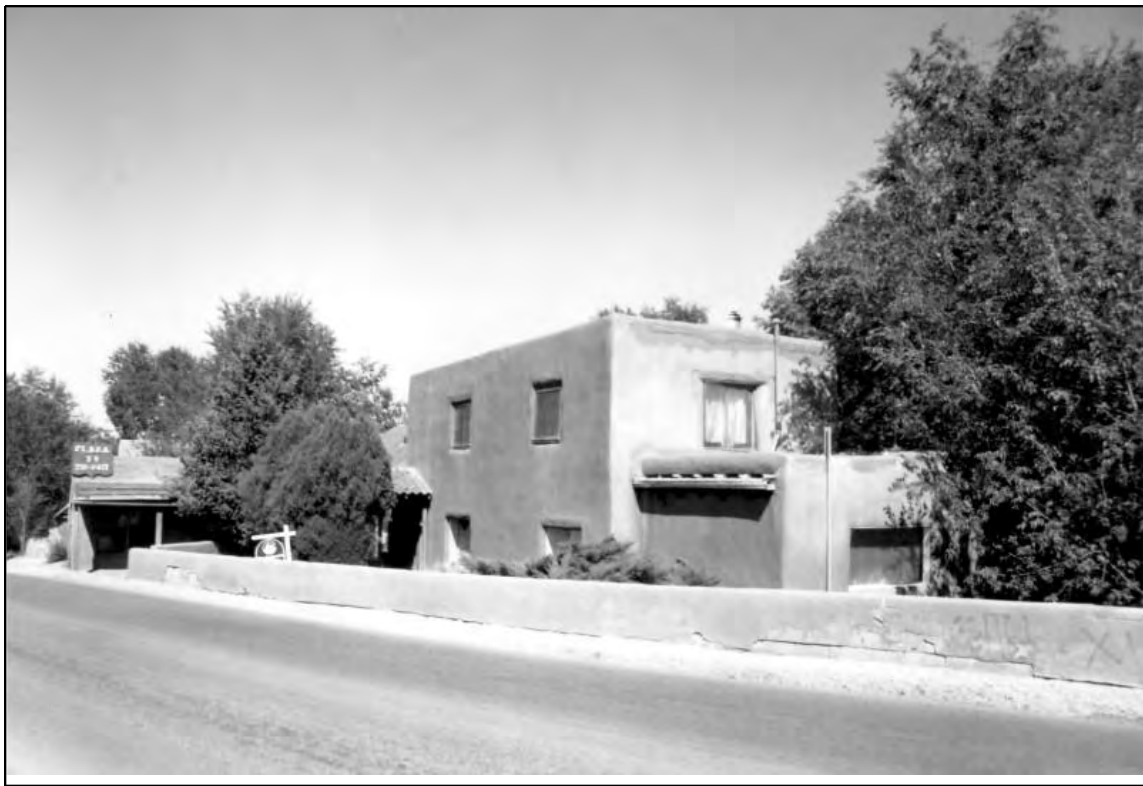
PHOTOGRAPH VIEW: **older**

209 Ranchitos Road is a stuccoed adobe structure composed of two separately designed buildings. The western part of the building is a single story gable-roofed form with standing seam metal covered roof. The eastern part of the building is a two-story mass with a single story addition on the east end. The eastern part is finished with a flat parapet. It has a small gable-roofed portal [covered with clay tile] with square posts at the centrally-located entrance on the south elevation. The entrance door is a single leaf wooden unit with 3 upper windows with a wooden screen door. Windows are a mix of 6-lite wooden casement units on the second floor and large fixed plate glass on the south and west elevations. The south and north elevation of the western end of the structure is roughly finished with exposed adobes and displays evidence of wings having been removed. There is a stuccoed block yard wall along the south property line that steps toward the west. A wood slat fence on the west encloses the rear yard.

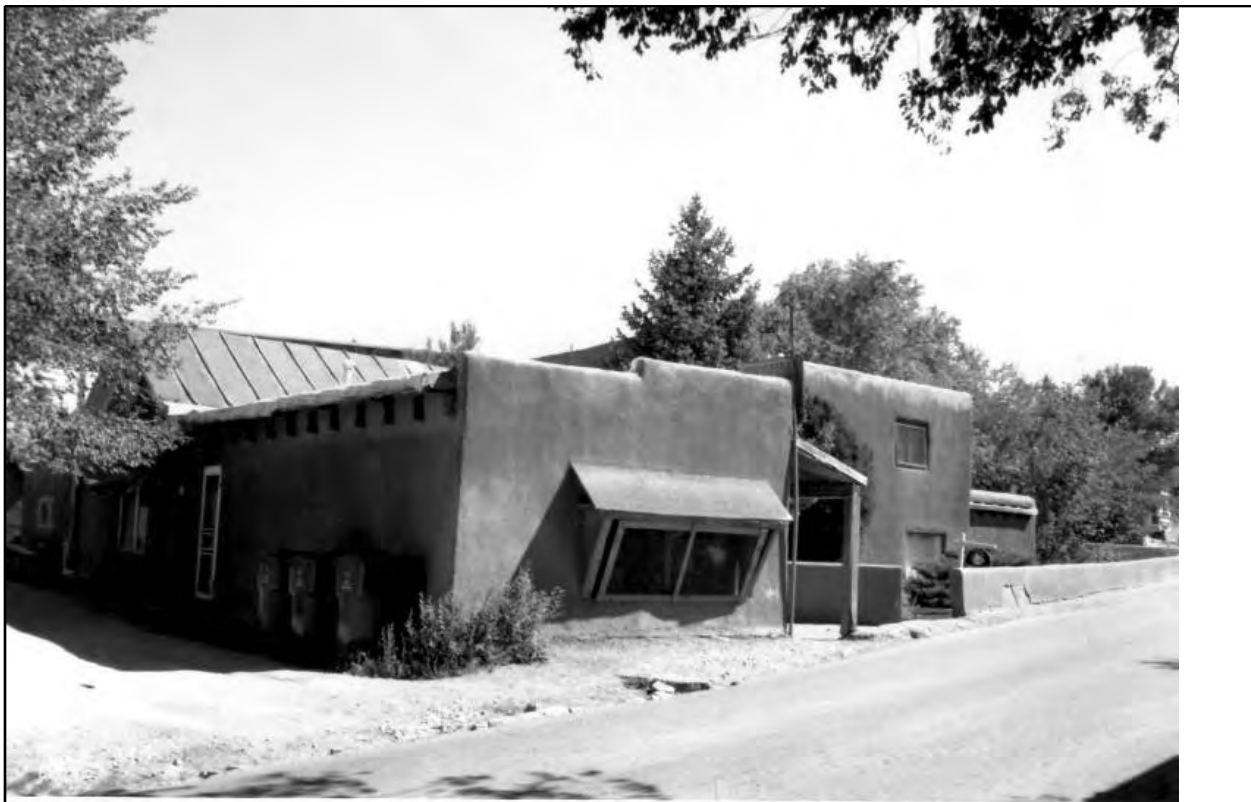
NOTES ON ADDITIONAL PERSPECTIVE: **older**  
*(If photo, include photo info, as in #10)*

part is gabled with one end exposed and 1 end joins second story -  
 exposed end is stuccoed

single leaf wood with 3 small decorative lite panes at top; tile hood  
 over door - 2" x 2" posts; has wood surround

second story 6/6 casement; first story fixed medium picture lite; has  
 wood surround

over repair shop entrance - 5 square (2 x 4" framed) posts  
 supporting 2 x 4" & 2 x 6" lumber beams - plywood ceiling;  
 flagstone at entrance; back portal with round beams 2 x 4 support

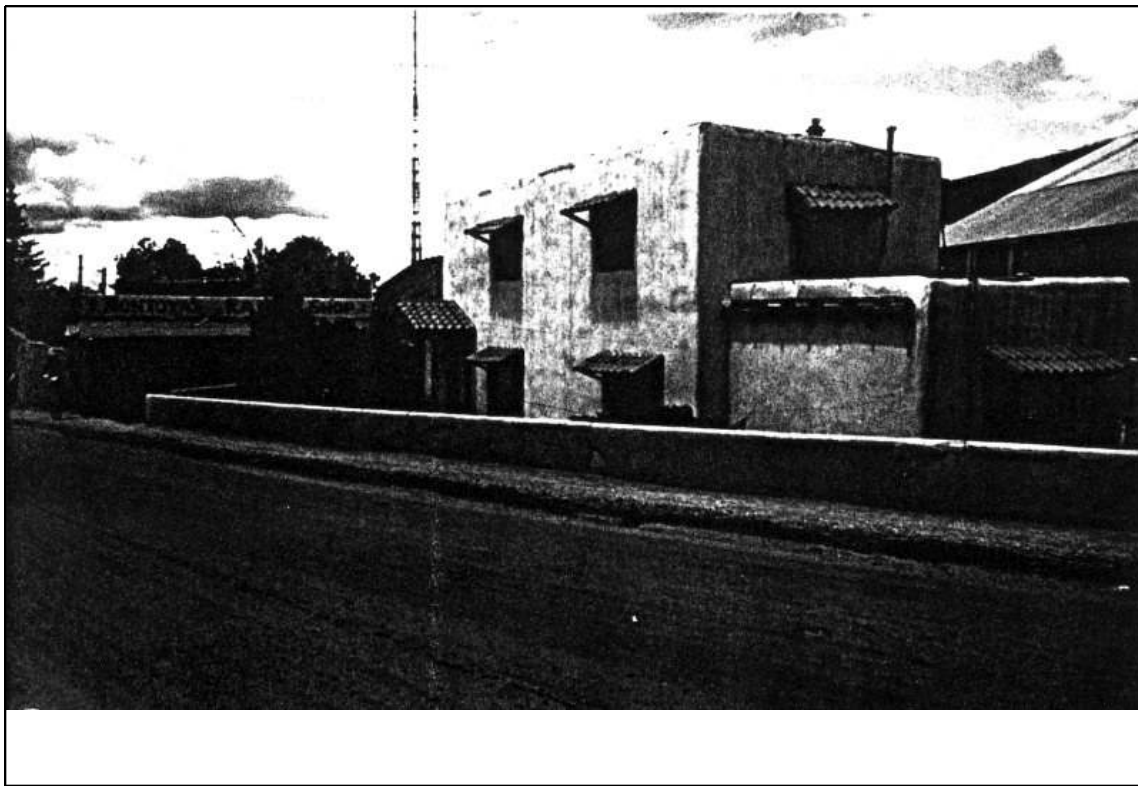
PHOTOGRAPH VIEW: **older**

209 Ranchitos Road is a stuccoed adobe structure composed of two separately designed buildings. The western part of the building is a single story gable-roofed form with standing seam metal covered roof. The eastern part of the building is a two-story mass with a single story addition on the east end. The eastern part is finished with a flat parapet. It has a small gable-roofed portal [covered with clay tile] with square posts at the centrally-located entrance on the south elevation. The entrance door is a single leaf wooden unit with 3 upper windows with a wooden screen door. Windows are a mix of 6-lite wooden casement units on the second floor and large fixed plate glass on the south and west elevations. The south and north elevation of the western end of the structure is roughly finished with exposed adobes and displays evidence of wings having been removed. There is a stuccoed block yard wall along the south property line that steps toward the west. A wood slat fence on the west encloses the rear yard.
