Historic Cultural Properties Inventory (HCPI) Base Form (FORM 1)

NAME OF PROPERTY: **Manzanares St 123 - Padre Martinez Church**

LOCATION OF PROPERTY: **119 MANZANARES**

2005 CLG Survey

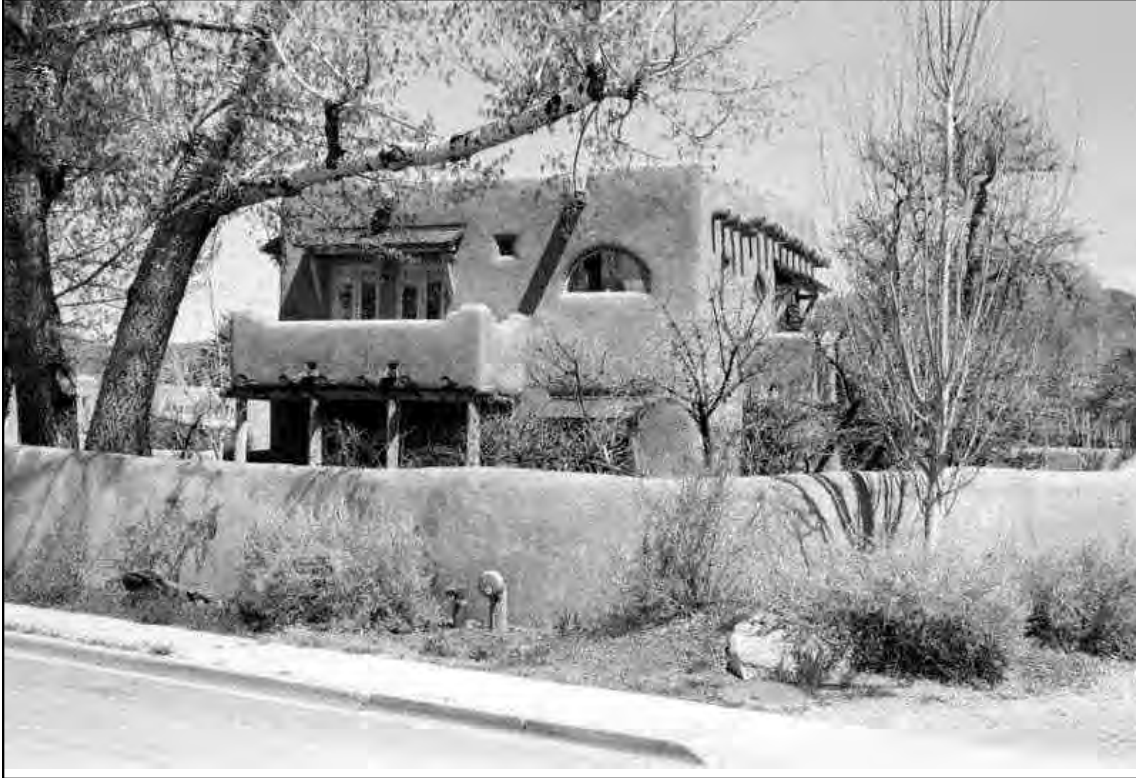
PHOTOGRAPH VIEW: **west and south elevations**

119 Manzanares Street is a two story earth-toned stucco Spanish Pueblo Revival Style structure. It has a flat parapet [which conceals a roof that sheds toward the north] that steps along the north and south elevations, as well as along the parapets on the partial width portales. Wooden canales perforate the parapets, and the thickness of the building walls is accentuated. There are exposed viga ends on the upper floor on the south elevation. Windows are large lite fixed [some in a half-circle shape] and wooden casement units. Doors are large-lite French style units set in pairs and protected by bracketed standing seam metal overhangs. There is an undulating stucco yard wall at the street with a vehicular wooden gate at the south end of the west side of the wall. Large deciduous trees stand at the site's west side.

NOTES ON CONDITION: **Good**
