Historic Cultural Properties Inventory (HCPI) Base Form (FORM 1)

NAME OF PROPERTY: **Ranchitos Rd 215**

LOCATION OF PROPERTY: **215 RANCHITOS**

2005 CLG Survey

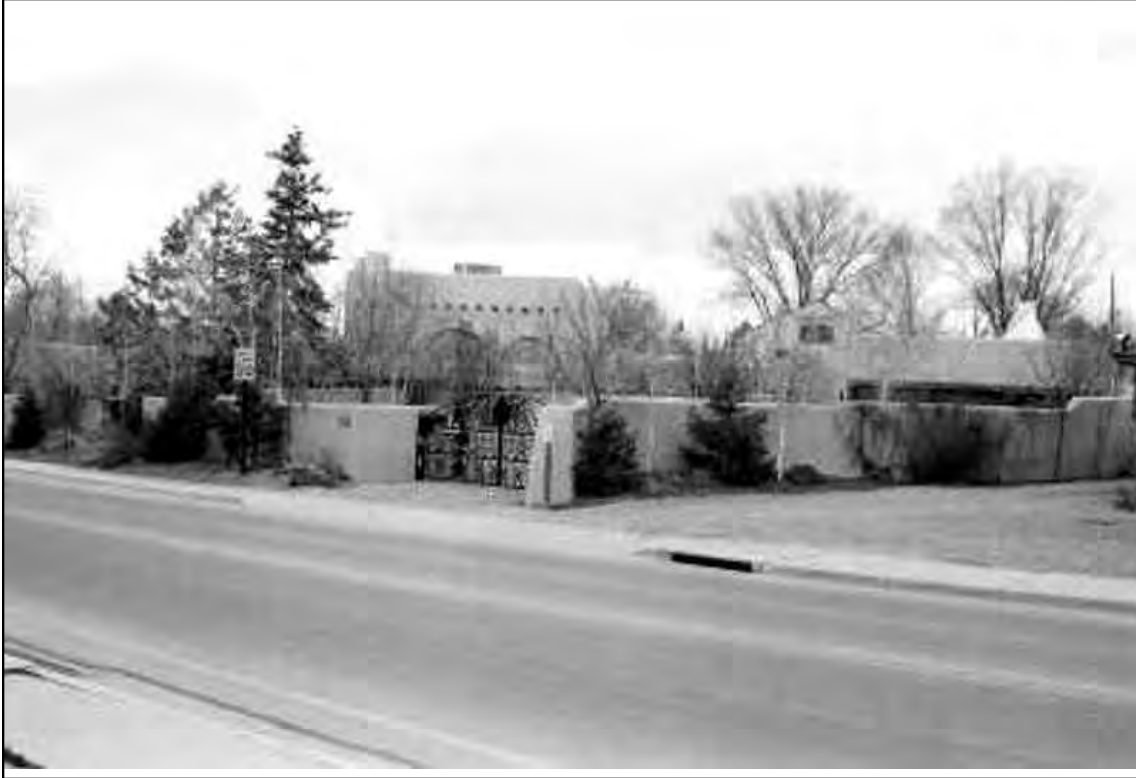
PHOTOGRAPH VIEW: **south**

215 Ranchitos Road is a Spanish Pueblo Revival style stuccoed residential structure with a partial second story and flat parapets. Windows visible from the street include fixed arched units on the second floor, including on the area of the building with the pitched roof. There is a partial-width portal with rough hewn timber posts and lintel on the south elevation. An exterior chimney extends through the second floor roof at the southwest corner of the building. There are exposed viga ends across the façade of the second floor south elevation. An attached garage on the east has 3 wooden overhead doors. The site is enclosed by an undulating stucco yard wall at the street with a decorative iron vehicular gate.

NOTES ON CONDITION: **Good**

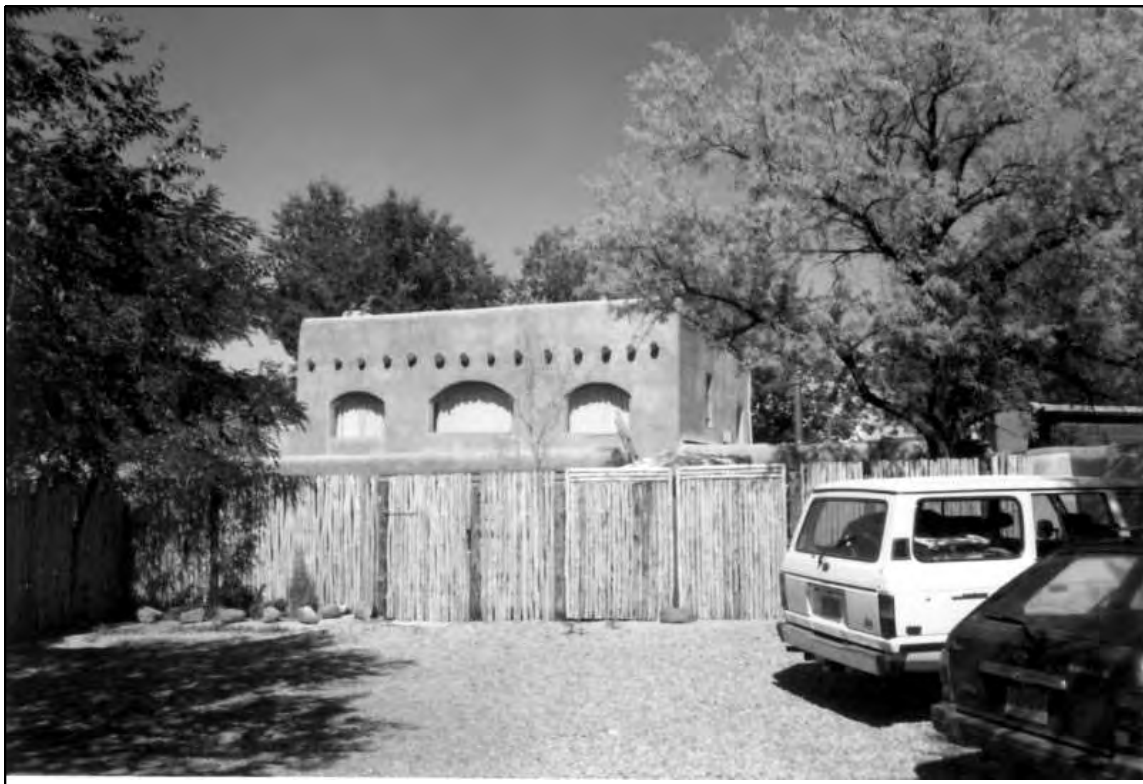
PHOTOGRAPH VIEW: **older**

215 Ranchitos Road is a Spanish Pueblo Revival style stuccoed residential structure with a partial second story and flat parapets. Windows visible from the street include fixed arched units on the second floor, including on the area of the building with the pitched roof. There is a partial-width portal with rough hewn timber posts and lintel on the south elevation. An exterior chimney extends through the second floor roof at the southwest corner of the building. There are exposed viga ends across the façade of the second floor south elevation. An attached garage on the east has 3 wooden overhead doors. The site is enclosed by an undulating stucco yard wall at the street with a decorative iron vehicular gate.

Excellent

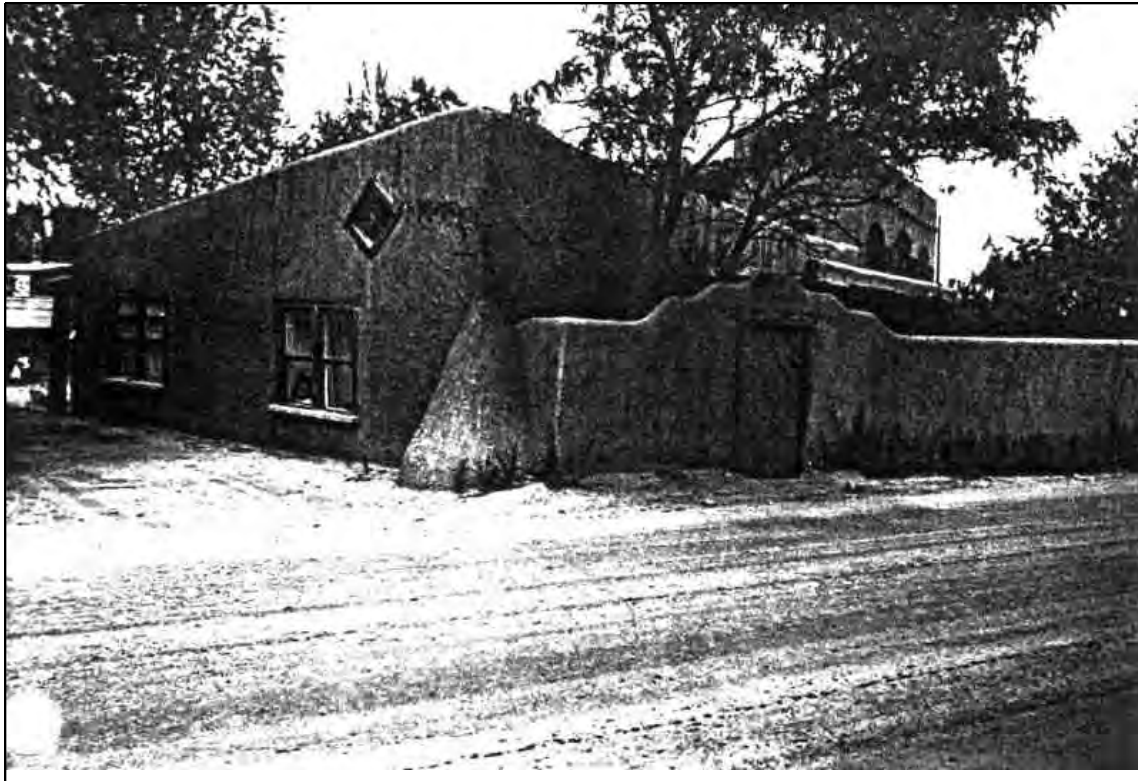
PHOTOGRAPH VIEW: **older**

215 Ranchitos Road is a Spanish Pueblo Revival style stuccoed residential structure with a partial second story and flat parapets. Windows visible from the street include fixed arched units on the second floor, including on the area of the building with the pitched roof. There is a partial-width portal with rough hewn timber posts and lintel on the south elevation. An exterior chimney extends through the second floor roof at the southwest corner of the building. There are exposed viga ends across the façade of the second floor south elevation. An attached garage on the east has 3 wooden overhead doors. The site is enclosed by an undulating stucco yard wall at the street with a decorative iron vehicular gate.

Good
