Historic Cultural Properties Inventory (HCPI) Base Form (FORM 1)

NAME OF PROPERTY: **Ranchitos Rd 223 - Guadalupe Montoya House**

LOCATION OF PROPERTY: **223 RANCHITOS**

2005 CLG Survey

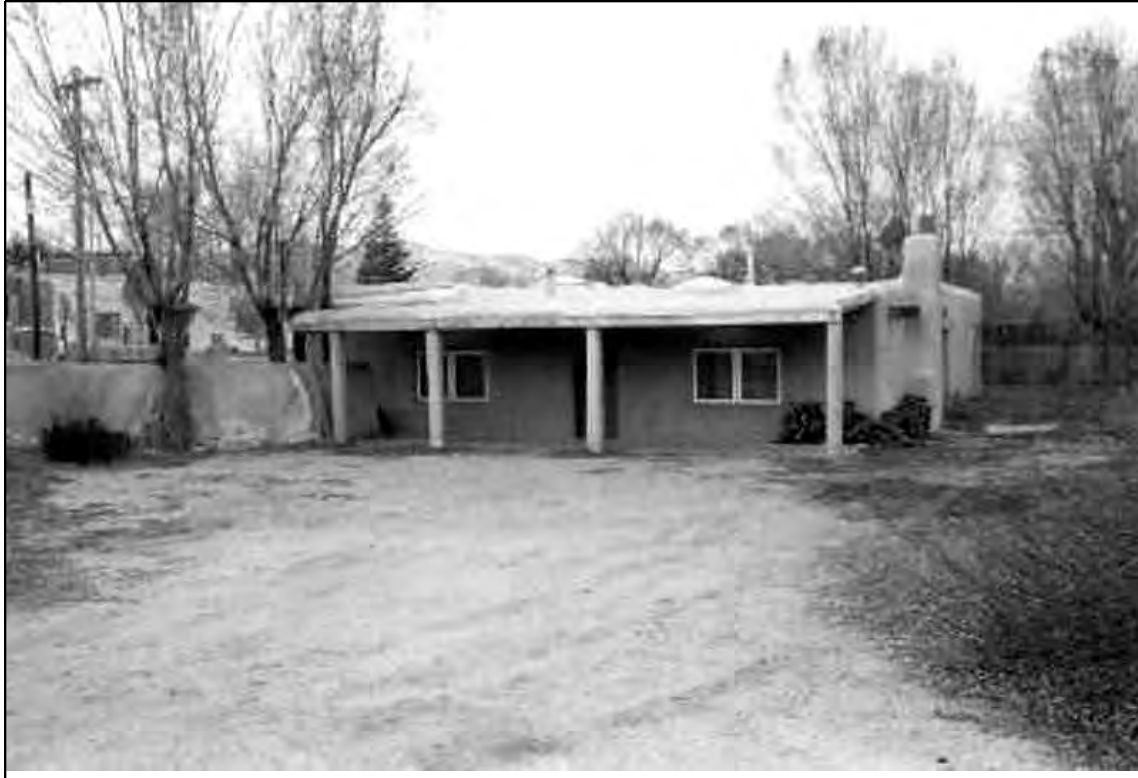
PHOTOGRAPH VIEW: **east and north**

223 Ranchitos Road is a single story Spanish Pueblo Revival style residential structure with a slight shed roof. There is a low parapet at the north and south ends. The roof is covered with insulating foam. Skylights are visible on the roof. A partial-width shed-roofed portal with stuccoed columns stands on the east elevation. Roof joists are exposed on the south elevation. Windows are pairs of single lite wooden casement units on the east elevation and fixed units on the west elevation. There is an exterior chimney on the north elevation. Entry to the building is through a centrally-located single leaf wood panel door with a single lite. The building sits directly at the sidewalk on the south elevation. There is a low stuccoed yard wall along the south property line. The building sits on a large lot that is otherwise vacant.

NOTES ON CONDITION: **Good**

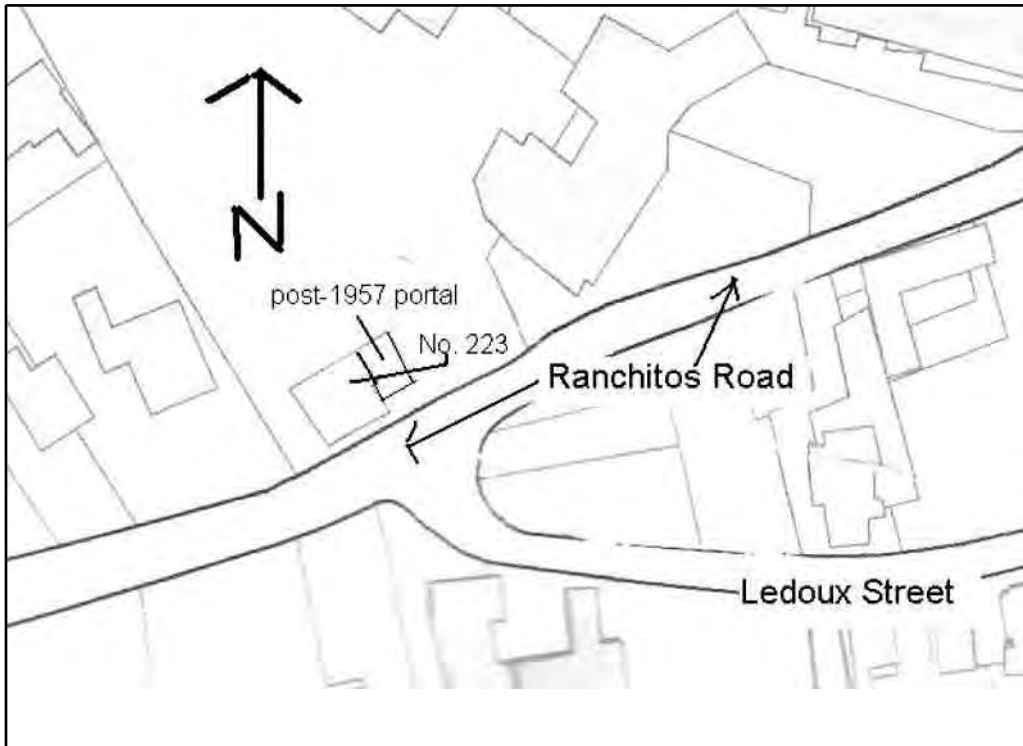
Site. Base map provided by Taos GIS. NTS.

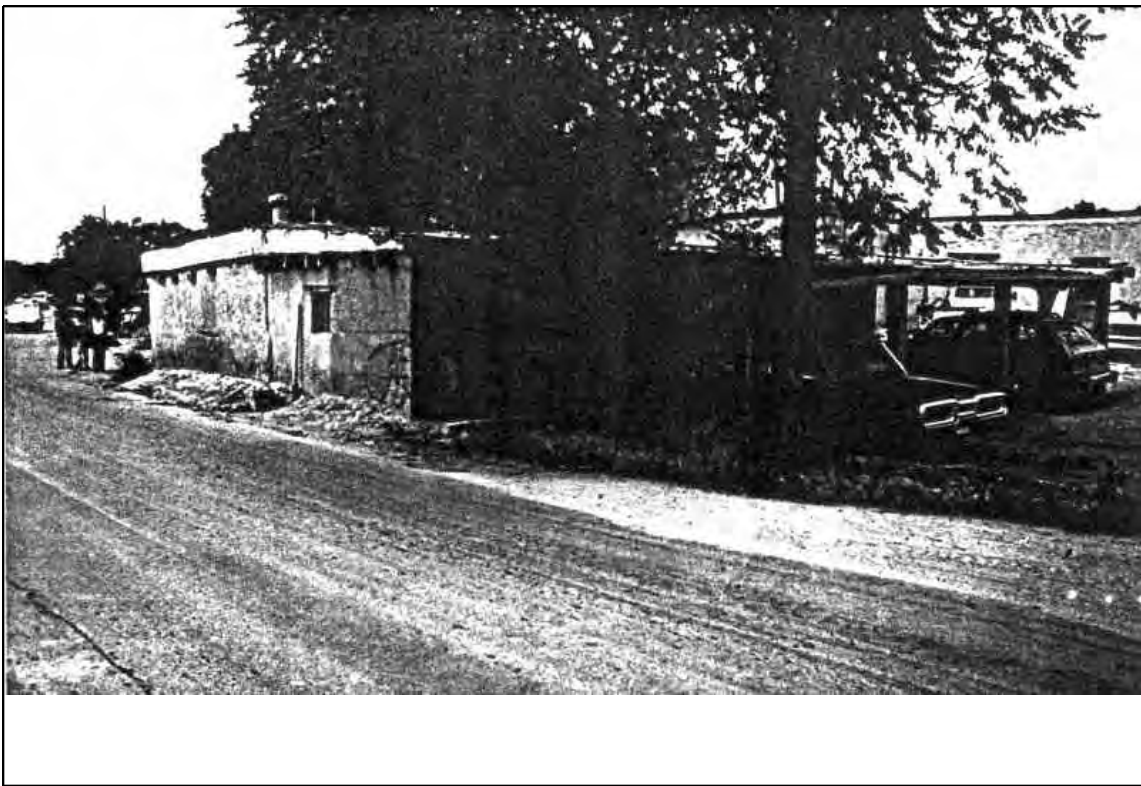
PHOTOGRAPH VIEW: **older**

223 Ranchitos Road is a single story Spanish Pueblo Revival style residential structure with a slight shed roof. There is a low parapet at the north and south ends. The roof is covered with insulating foam. Skylights are visible on the roof. A partial-width shed-roofed portal with stuccoed columns stands on the east elevation. Roof joists are exposed on the south elevation. Windows are pairs of single lite wooden casement units on the east elevation and fixed units on the west elevation. There is an exterior chimney on the north elevation. Entry to the building is through a centrally-located single leaf wood panel door with a single lite. The building sits directly at the sidewalk on the south elevation. There is a low stuccoed yard wall along the south property line. The building sits on a large lot that is otherwise vacant.
