Historic Cultural Properties Inventory (HCPI) Base Form (FORM 1)

NAME OF PROPERTY: **Ranchitos Rd 227 - Joseph Sanchez House** LOCAL REFERENCE NUMBER: **2005088**

LOCATION OF PROPERTY: **227 RANCHITOS**

2005 CLG Survey

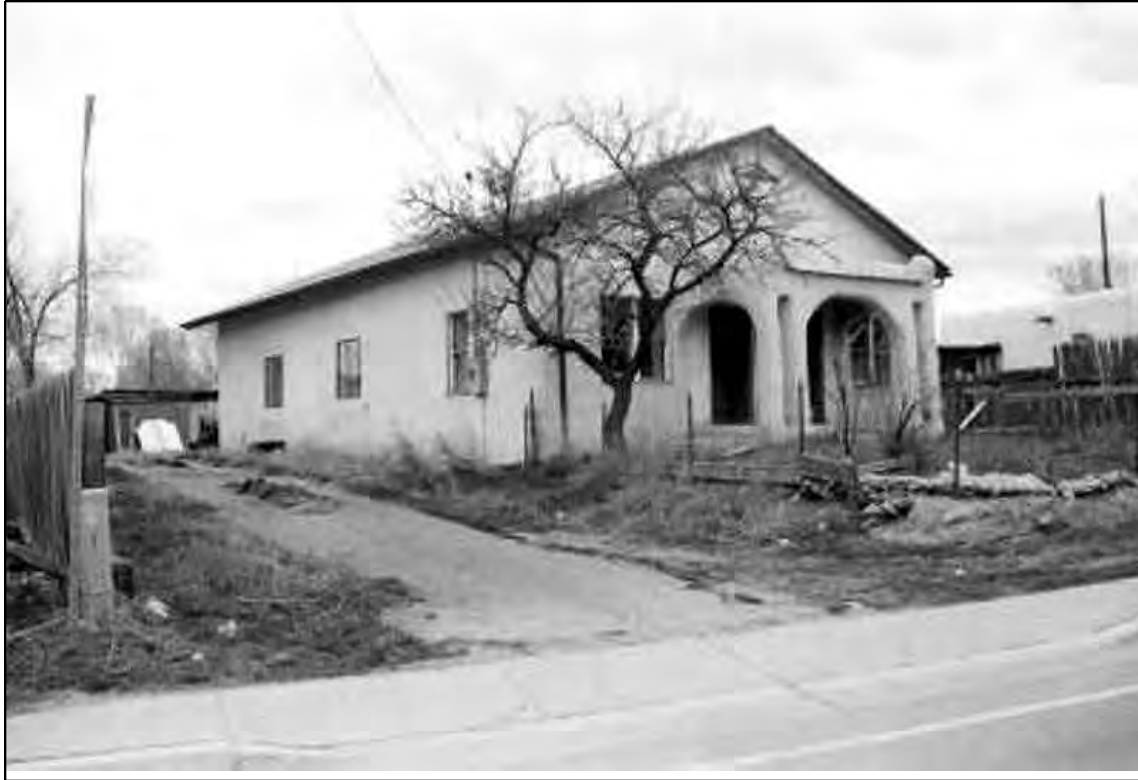
PHOTOGRAPH VIEW: **south and west**

227 Ranchitos Road is a single story stuccoed gable roofed duplex residential building. The gable is covered with red Propanel. Windows are 1-over-1 double-hung wooden units on the south elevation and modern aluminum slider units on the remaining facades. Windows sit at the exterior building plane without recess. A partial-width portal with a shed roof and end parapets stands on the south elevation. It is elevated above grade with paired stucco columns. Entrances to the building are through single leaf wood panel doors with 9 lites. The site is raised above street grade with a crumbling rock retaining wall. There is a coyote and sheep wire fence about the site.

Site is raised above street grade with a crumbling rock retaining wall.
Deteriorated shed at rear/northwest, broken window panes.

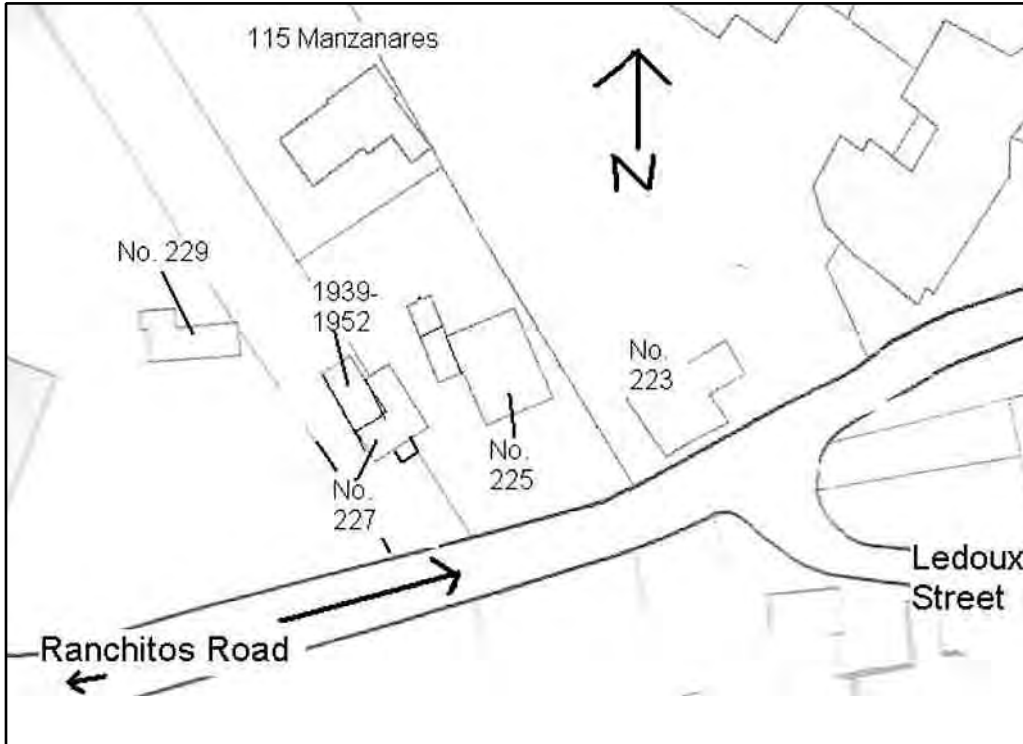
Site. Base map provided by Taos GIS. NTS.

Site is raised above street grade with a crumbling rock retaining wall. Deteriorated shed at rear/northwest, broken window panes.

Endangered: exposure to elements, vacant

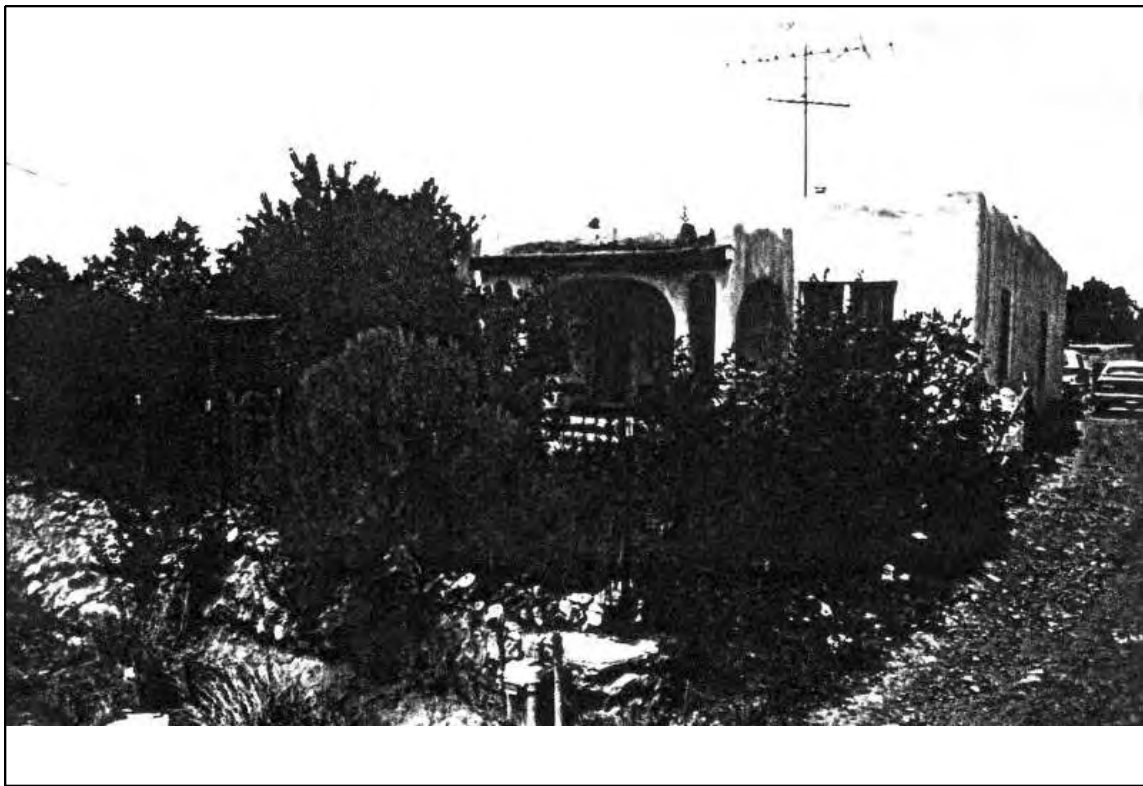
PHOTOGRAPH VIEW: **older**

227 Ranchitos Road is a single story stuccoed gable roofed duplex residential building. The gable is covered with red Propanel. Windows are 1-over-1 double-hung wooden units on the south elevation and modern aluminum slider units on the remaining facades. Windows sit at the exterior building plane without recess. A partial-width portal with a shed roof and end parapets stands on the south elevation. It is elevated above grade with paired stucco columns. Entrances to the building are through single leaf wood panel doors with 9 lites. The site is raised above street grade with a crumbling rock retaining wall. There is a coyote and sheep wire fence about the site.
