Historic Cultural Properties Inventory (HCPI) Base Form (FORM 1)

NAME OF PROPERTY: **San Antonio St 103 - Templeton Laundry, Larry Bell Studio** LOCAL REFERENCE NUMBER: **2005091**
LOCATION OF PROPERTY: **103 SAN ANTONIO** UTM ZONE:
CITY OR TOWN: **Taos** UTM EASTING:
COUNTY: **Taos** UTM NORTHING:

2005 CLG Survey

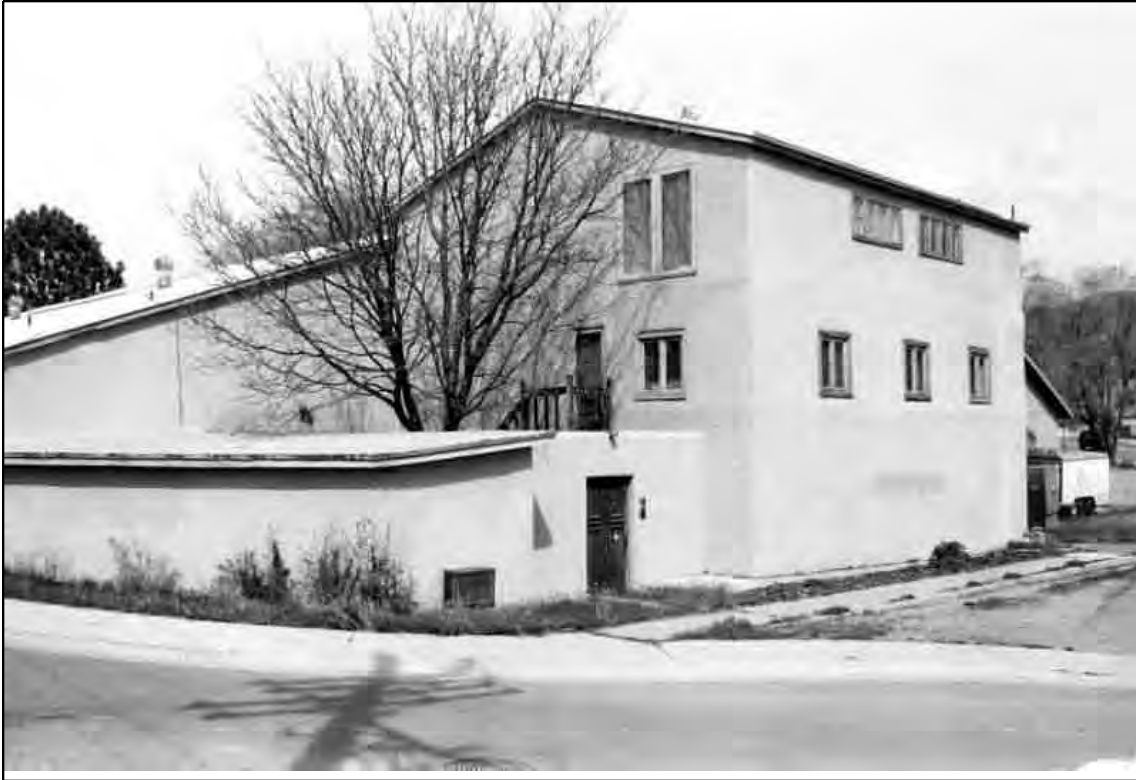
PHOTOGRAPH:

PROPERTY TYPE: **Primary** PHOTOGRAPH VIEW: **south and west**

103 San Antonio is a multi-story stuccoed Northern New Mexico style commercial/artist studio structure. Its roof form includes a gable surrounded by lower level sheds, finished with Propanel. Windows are wooden casement single lite units set in pairs and quadruple. Doors include single-leaf multi-panel wooden pedestrian units and double panel studio doors. There is a stucco courtyard wall with a gate at the southwestern corner of the site. Wooden plank and coyote fencing encloses the site on the west and north. The building sits close to its neighboring structure to the east and is separated only by a driveway court. The structures are functionally related and are commonly owned.

SIGNIFICANT MODIFICATIONS? **ca. 1975 renovation included addition of upper story and gable roofline, new windows, combining of formerly detached structures on site into this single building**

NOTES ON CONDITION: **Good**
