Historic Cultural Properties Inventory (HCPI) Base Form (FORM 1)

NAME OF PROPERTY: **Villa Maria Ln 105-107**

LOCATION OF PROPERTY: **107 VILLA MARIA**

2005 CLG Survey

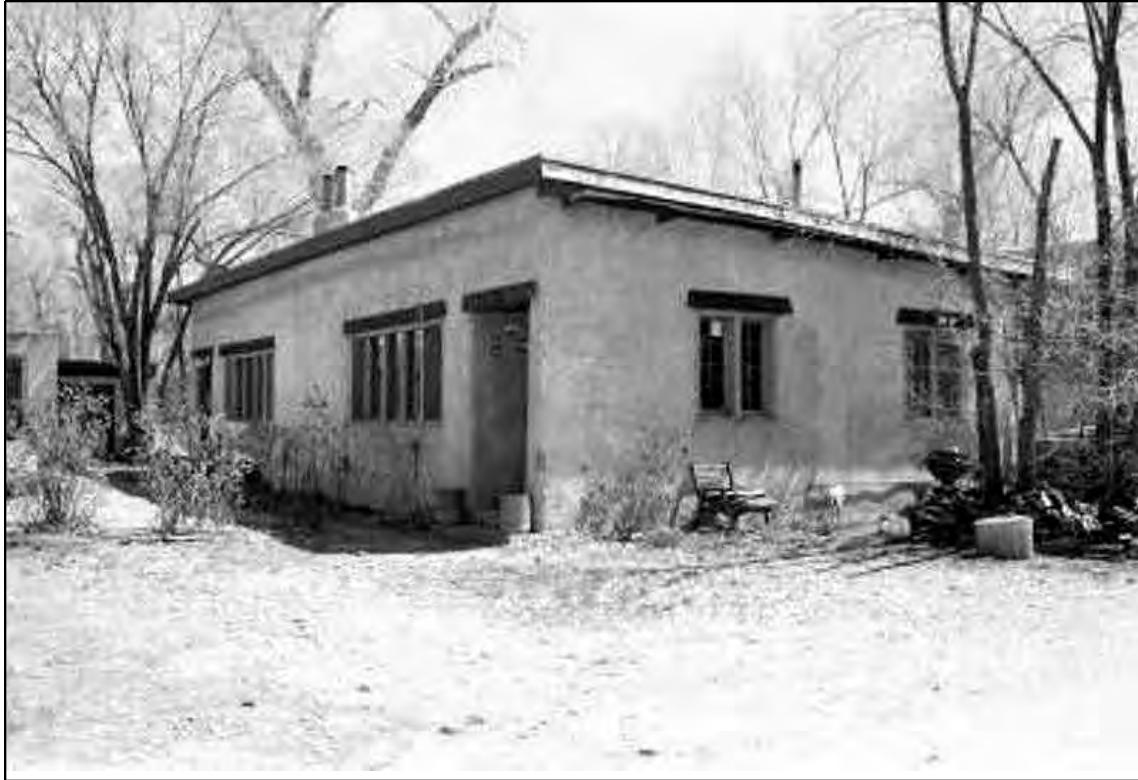
PHOTOGRAPH VIEW: **south and west**

105-107 Villa Maria is a single-story textured stucco residential duplex with a shed roof that overhangs on the north and south elevations. Windows are 8-lite wooden casement units recessed into the building walls in pairs and quadruples. There are exposed window and door lintels. There is a simply-detailed shed-roofed partial width portal centrally located on the east elevation. Access to the 2 units in the building is through separate recessed entrances located at the northwest and south west corners. Doors are single-leaf multi-panel wood units with a single window. There is an interior double-flue chimney on the west side of the roof. The building site is open to Villa Maria on the south; it is unpaved.

The building site is open to Villa Maria on the south; it is unpaved.
Residential duplex. stucco patching needed
