Historic Cultural Properties Inventory (HCPI) Base Form (FORM 1)

NAME OF PROPERTY: **Civic Plaza Dr 115 - Carson National Forest/UNM**

LOCATION OF PROPERTY: **115 CIVIC PLAZA**

2005 CLG Survey

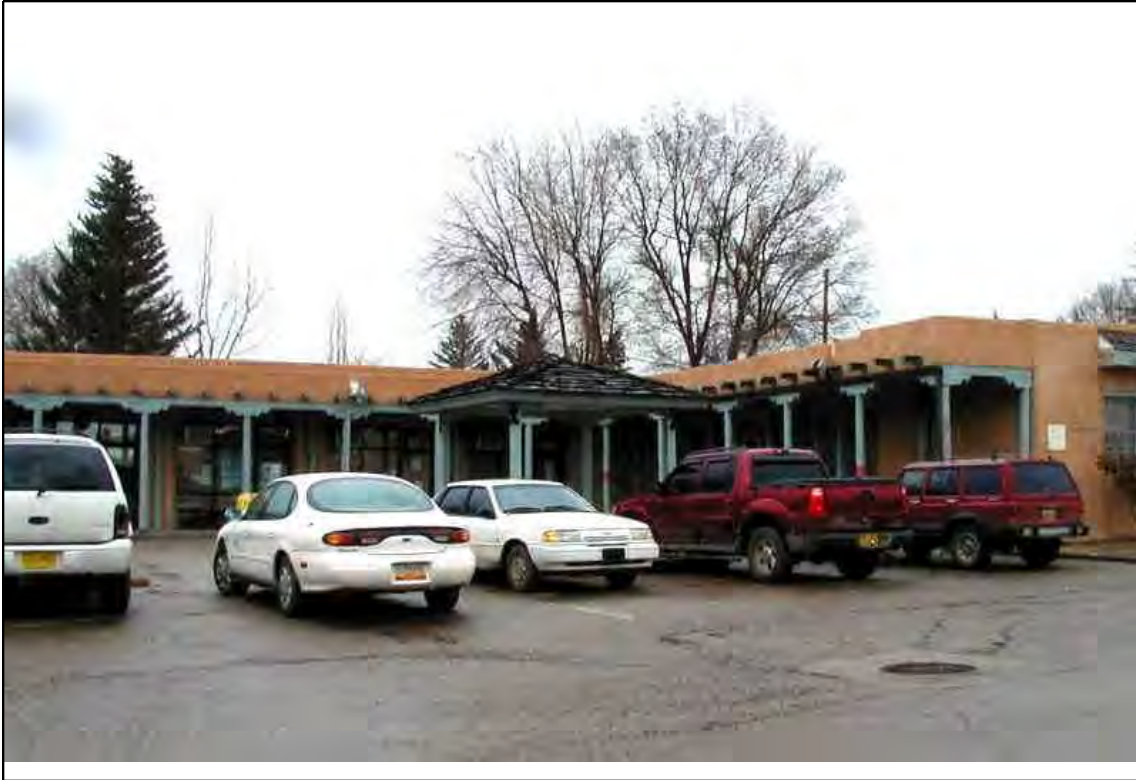
PHOTOGRAPH VIEW: **2005 Survey Photo 1**

115 Civic Plaza Drive is a single-story Spanish Pueblo Revival style adobe/stucco office building with a flat parapet and wide canales. There is a central recessed portal with posts and corbels and exposed vigas on the south elevation. Windows are 6-over-6 and 8-over-8 lite wooden double hung units in pairs and single arrangements within bull-nosed openings. Some units have exterior screens. Entrance to the building is through the main door under the portal and is a single leaf wood panel door with spindles and windows in the upper half. On the rear of the building, the former warehouse and garage structures have been physically attached to the main building by way of an addition. The north, west, and south elevations of the rear "C"-shaped wing are faced with a traditionally-designed portal with posts, corbels, exposed vigas, and a parapet with canales. Large-lite windows and glass doors provide access to the individual offices from under the portal. Parking is provided to the west of the building within the "C."

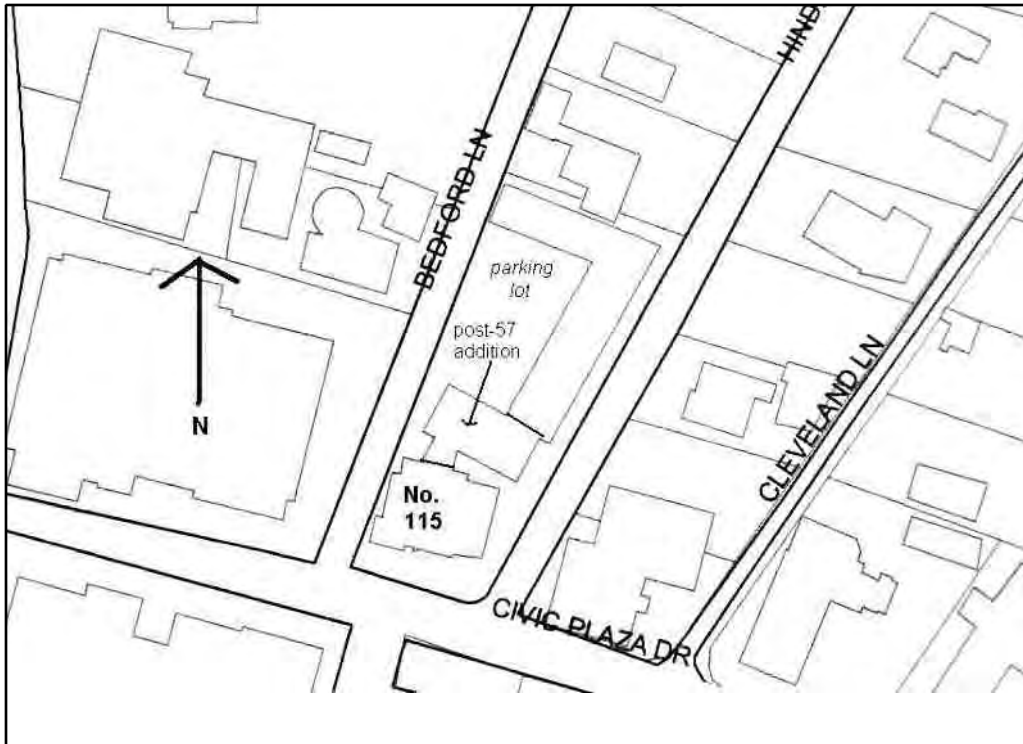
SITE PLAN:

Site. Base map provided by Taos GIS. NTS.
