Historic Cultural Properties Inventory (HCPI) Base Form (FORM 1)

NAME OF PROPERTY: **Paseo del Pueblo Norte 204 - Plaza del Norte** LOCAL REFERENCE NUMBER: **2005005**
LOCATION OF PROPERTY: **204 PASEO DEL PUEBLO NORTE** UTM ZONE:
CITY OR TOWN: **Taos** UTM EASTING:
COUNTY: **Taos** UTM NORTHING:

NAME OF PROJECT: **2005 CLG Survey**

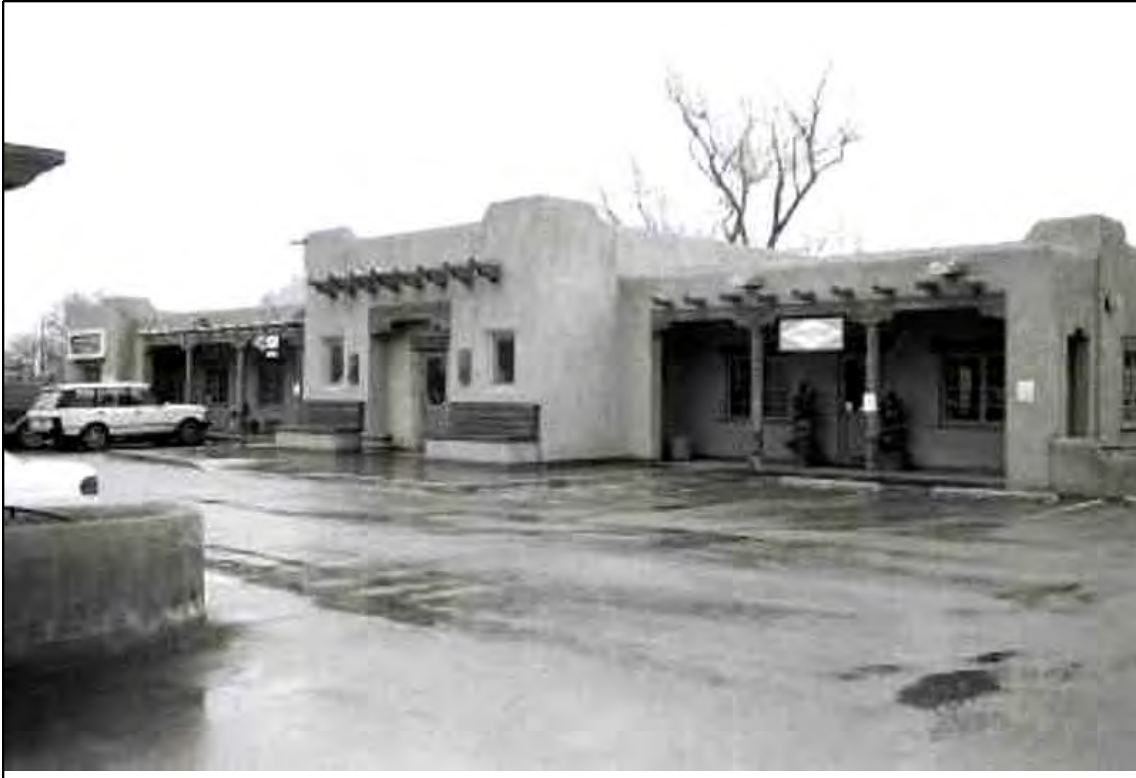
PROPERTY TYPE: **Primary** PHOTOGRAPH VIEW: **2005 Survey Photo 1**

204 Paseo del Pueblo Norte is a single story Spanish Pueblo Revival style modern structure with a flat parapet that steps up at the building's corners. It has a central projecting mass that is hugged with recessed portales on its north and south wings. Portales are detailed with round posts that are carved at the base, corbels, exposed lintels, and projecting vigas. Windows are 8-lite metal clad casement units with exposed lintels and sills. Individual wood panel and glass doors provide access to the various commercial units in the structure. There is a low stucco yard wall on the east side of the building at the street that defines the paved parking area for the building.

NOTES ON CONDITION: **Good**

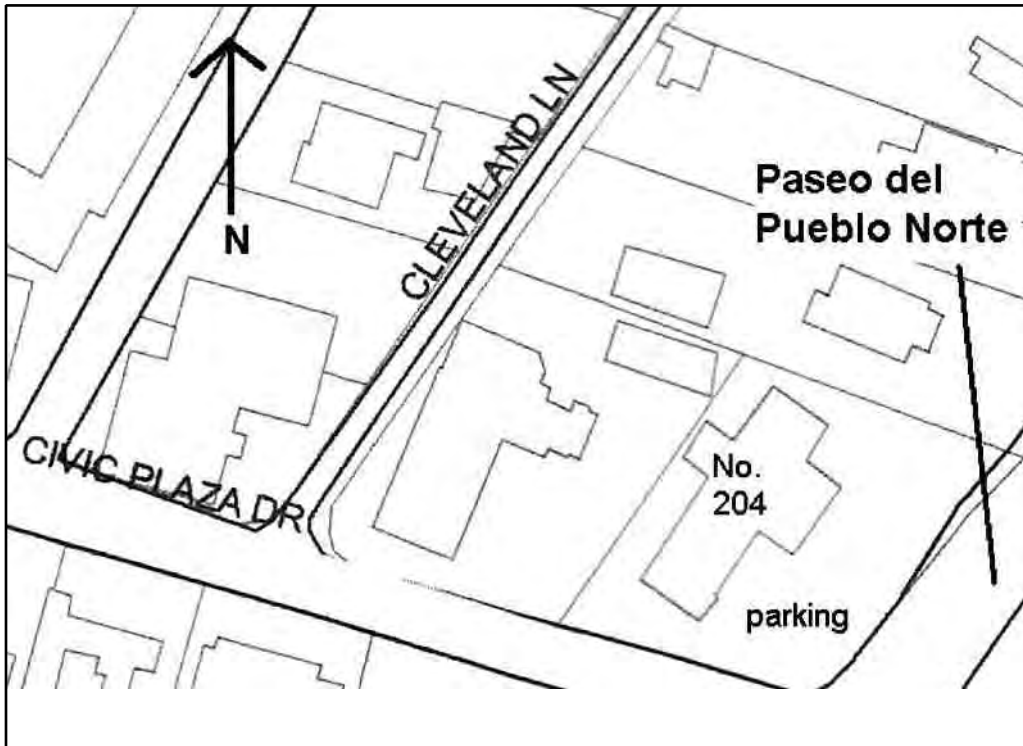
SITE PLAN:

Site. Base map provided by Taos GIS. NTS.
