# Historic Cultural Properties Inventory (HCPI) Base Form (FORM 1)

NAME OF PROPERTY: **Bent St 131B - Former Garage**

LOCATION OF PROPERTY: **131 BENT**

**2005 CLG Survey**

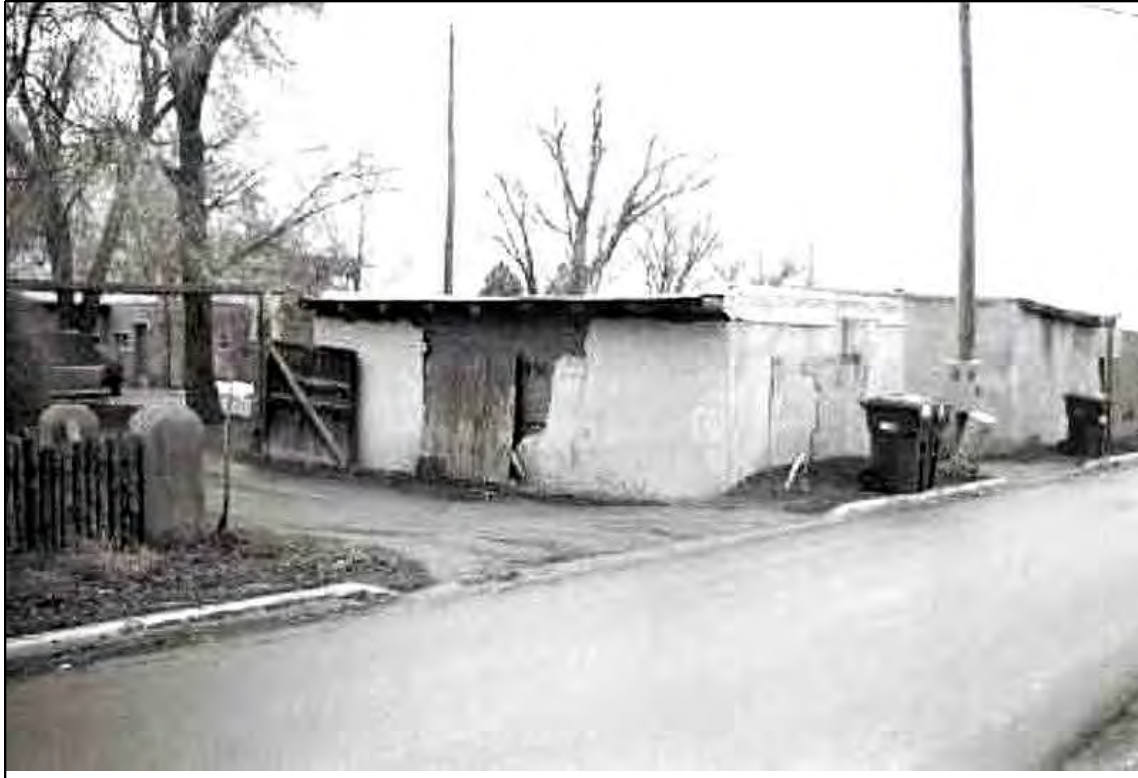
PHOTOGRAPH VIEW: **2005 Survey Photo 1**

The single car garage at the rear of 131 Bent Street is a one-story stuccoed adobe structure with a shed roof and low flat parapet. The parapet is covered with sheet metal. There are projecting vigas under the shed on the east elevation. This building is in severe disrepair with exposed adobe and in a state of partial collapse. An east elevation window has been partially infilled. There is a wooden single leaf pedestrian door on the south elevation. The building sits to the west and adjacent to the driveway access to the site. A vehicular gate across the driveway stands at the building's southeast corner.

NOTES ON CONDITION: **Poor**

severe disrepair with exposed adobe and in a state of partial collapse. An east elevation window has been partially infilled.

The main building on the site was surveyed as #022503010 in 1981. The site is owned by the Taos Historic Museums and leased to the gallery. The garage appears first on the 1939 Sanborn Maps. The building has lost its architectural integrity through neglect and exposure to the elements. Were it to be shored up and renovated consistent to its character, it's designation should be upgraded to "contributing."
