Historic Cultural Properties Inventory (HCPI) Base Form (FORM 1)

NAME OF PROPERTY: **Bent St 122 - Justin McCarthy Garage?**

LOCATION OF PROPERTY: **122 PASEO DEL PUEBLO NORTE**

2005 CLG Survey

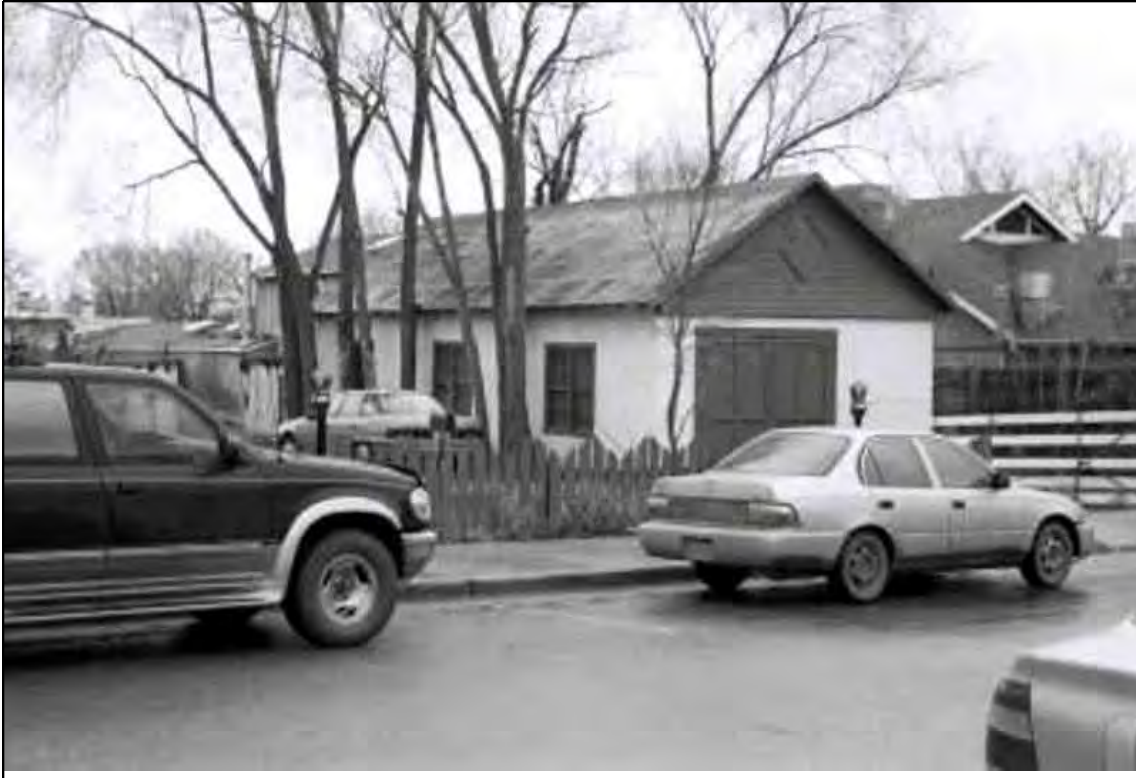
PHOTOGRAPH VIEW: **2005 Survey Photo 1**

The former garage at 122 Paseo del Pueblo Norte is a one and one-half story painted and stuccoed adobe structure with a gable roofline. The roof is covered with rolled roofing material and there are decorative shingles under the gable that are painted green. Windows are wood double-hung units in a 4-over-4 configuration set in pairs along the east and west elevations. On the north elevation there is a double leaf wood paneled vehicular gate. A pedestrian door is located on the east elevation. The building sits at the rear of the large lot and there is a low wood slat fence along the north property line.

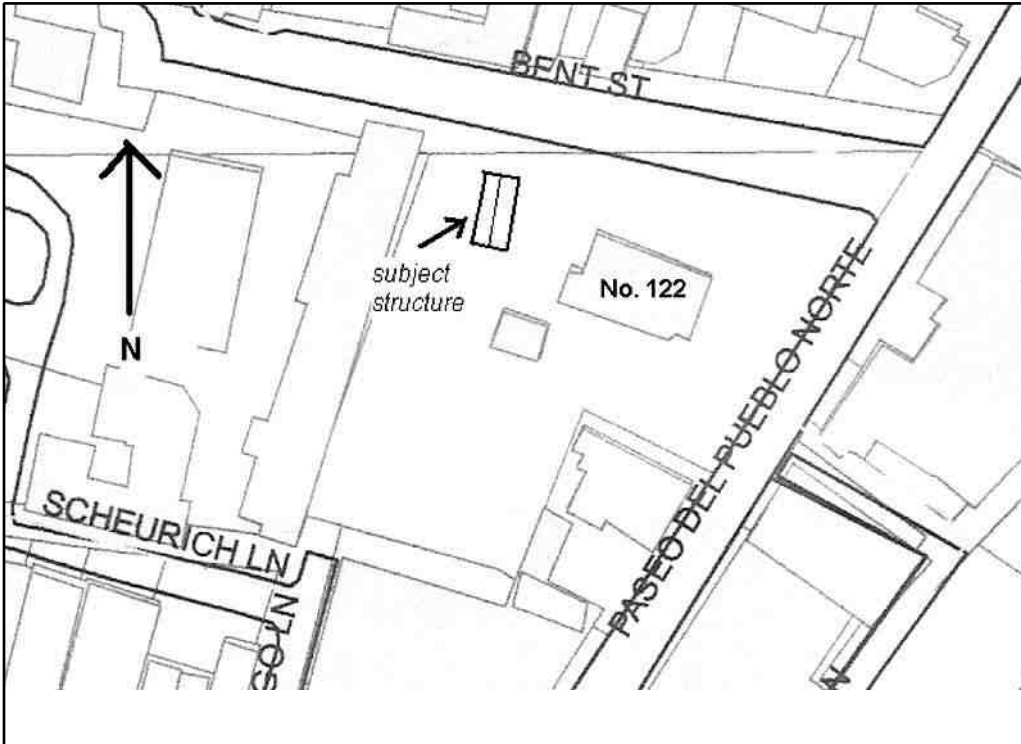
SITE PLAN:

Site. Base map provided by Taos GIS. NTS.
