Historic Cultural Properties Inventory (HCPI) Base Form (FORM 1)

NAME OF PROPERTY: **Quesnel St 110 - Kibby & Lucille Couse Rental House**
LOCATION OF PROPERTY: **110 QUESNEL**
CITY OR TOWN: **Taos**
COUNTY: **Taos**

NAME OF PROJECT:
2005 CLG Survey

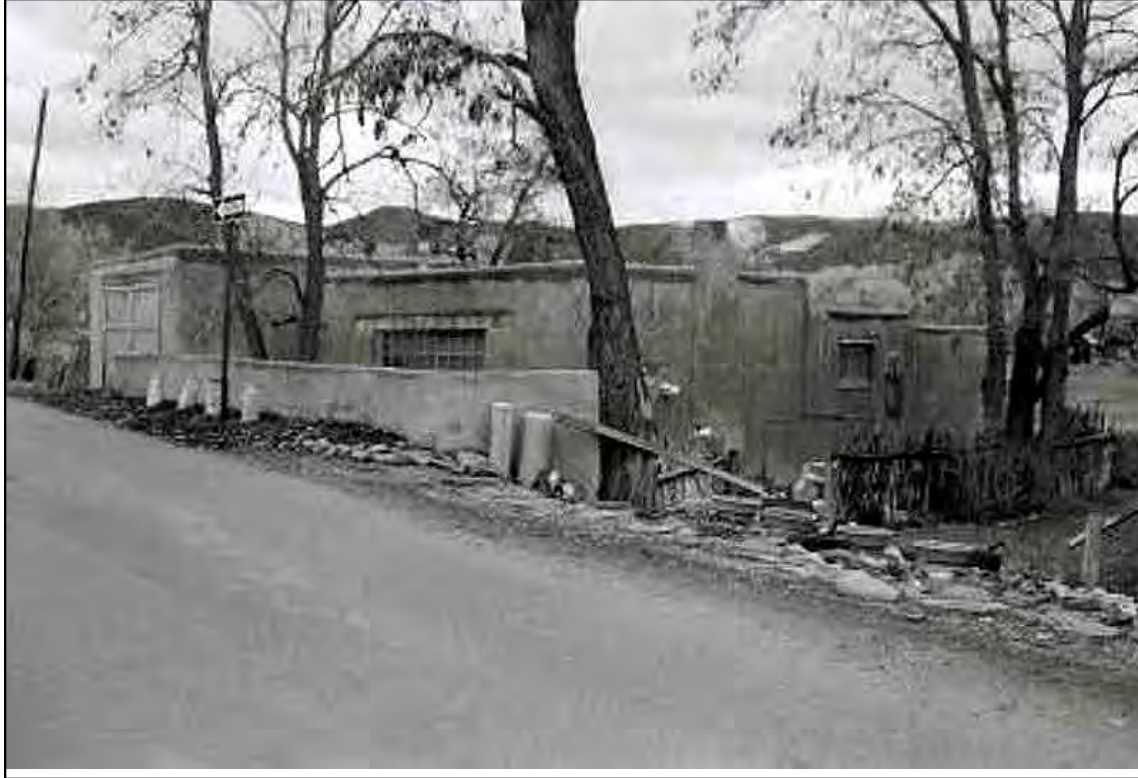
PROPERTY TYPE: **Primary** PHOTOGRAPH VIEW: **north and west elevations**

110 Quesnel Street is a single story Spanish Pueblo Revival style stuccoed adobe residence with a flat parapet. It has remarkable architectural integrity with preserved historic features including a wooden 27-lite fixed window on the north with an exposed lintel/structural beam, and a pair of wooden diagonal slat paneled garage doors on the north as well. An exterior chimney is visible on the west elevation. A single leaf wood panel door on the west elevation provides access to the structure. Other windows include a pair of 4-lite slider units on the west elevation. The massing of the structure is such that it steps toward the south following the topography of the site on which it stands. The site is below street grade and is surrounded on the south and west by picturesque open pasture lands. There are low block and coyote fencing along the north and west sides of the house.

NOTES ON CONDITION: **Fair**

stucco cracking at roofline and chimney, parapet needs stucco color coat
