# Historic Cultural Properties Inventory (HCPI) Base Form (FORM 1)

NAME OF PROPERTY: **Paseo del Pueblo Norte 208**

LOCATION OF PROPERTY: **208 PASEO DEL PUEBLO NORTE**

**2005 CLG Survey**

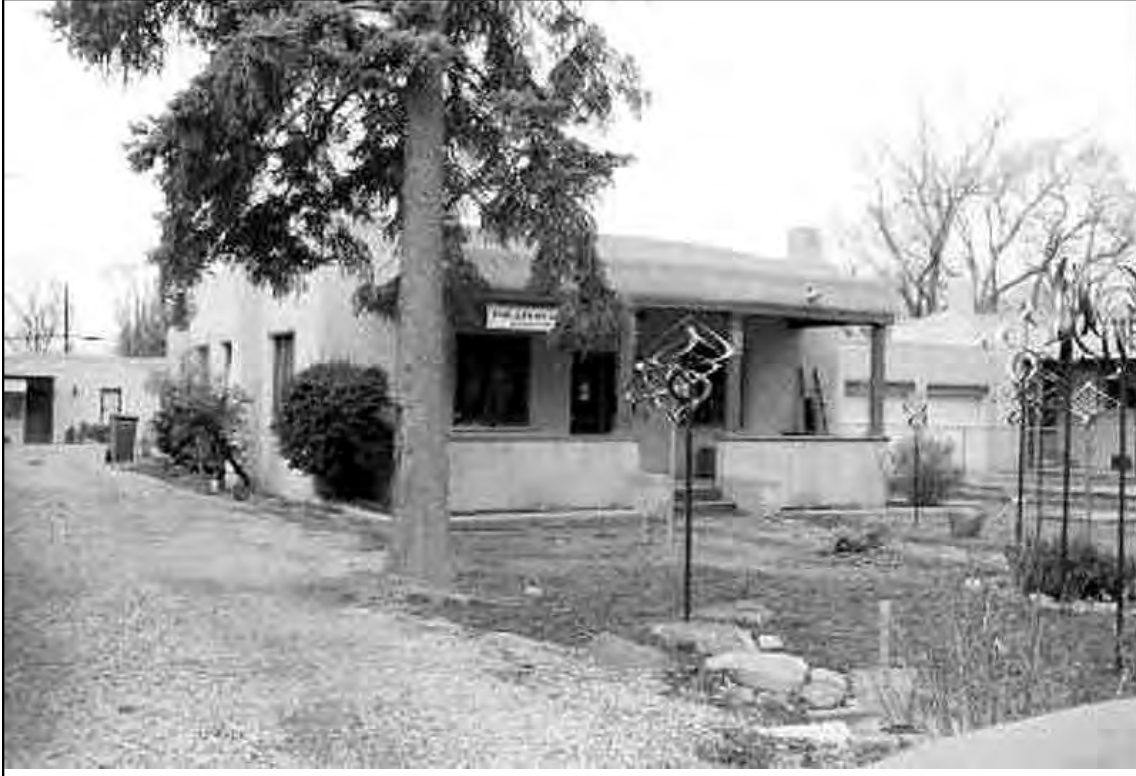
PHOTOGRAPH:

PHOTOGRAPH VIEW: **east and south elevations**

**208 Paseo del Pueblo Norte is a single story stuccoed adobe Spanish Pueblo Revival style residential building that has been converted to commercial use. It has a flat parapet and 6- and 8-lite wooden casement window units that are recessed into the build walls and placed in pairs and triplicate. There is a centrally-located partial width raised portal on the east elevation with round posts resting on a knee wall which partially encloses the space. Access to the structure is through central opening in the knee wall and through a 15-lite single leaf French door under the portal. There are two chimneys, one at the northeast corner and the other on south elevation. To the southwest of the building stands a former historic garage which has also been converted to commercial use. It is single story with an undulating parapet and a simple partial-width shed roofed portal at the south end of the east elevation. Windows in the former garage are 3-over-1 wooden double hung and slider units. The front yard of the site is separated from the sidewalk to the east by a low stuccoed block wall. Along the south property line**

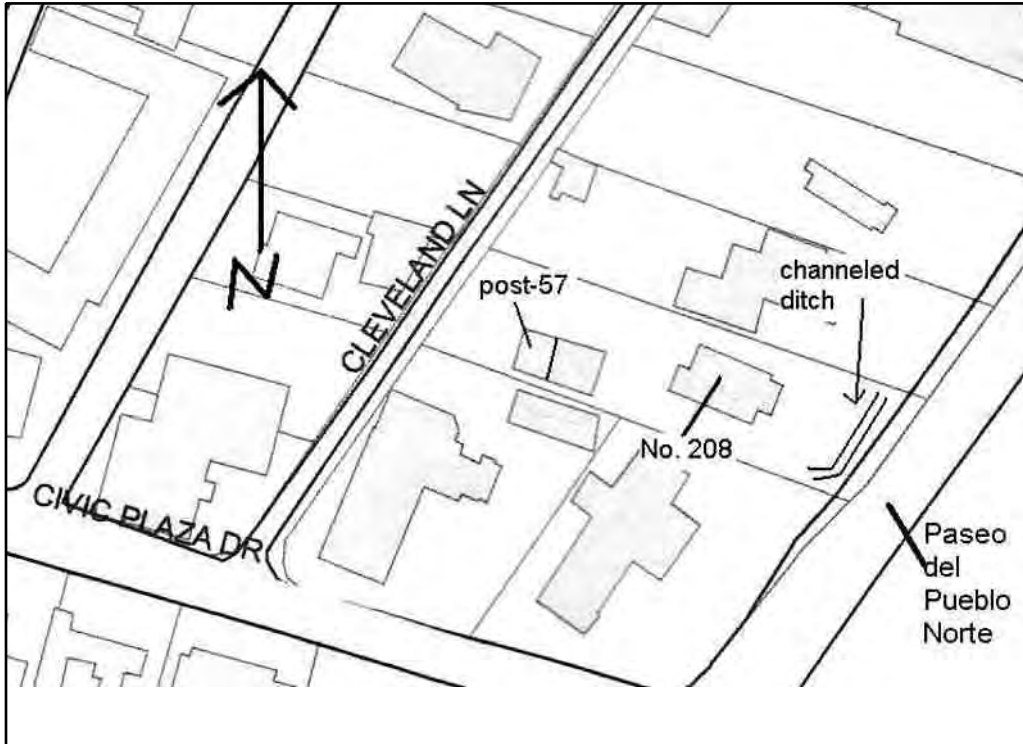
SITE PLAN:

Site. Base map provided by Taos GIS. NTS.

Both the main building and converted garage are reflected on the 1957 NM DOT aerial photo. The main structure shows on this photo in the current configuration. The western half of the converted garage appears in 1957 as an unroofed though walled area and may have been under
