# Historic Cultural Properties Inventory (HCPI) Base Form (FORM 1)

NAME OF PROPERTY: **Paseo del Pueblo Norte 210 - Hinde House** LOCAL REFERENCE NUMBER: **2005017**

LOCATION OF PROPERTY: **210 PASEO DEL PUEBLO NORTE** UTM ZONE:

**2005 CLG Survey**

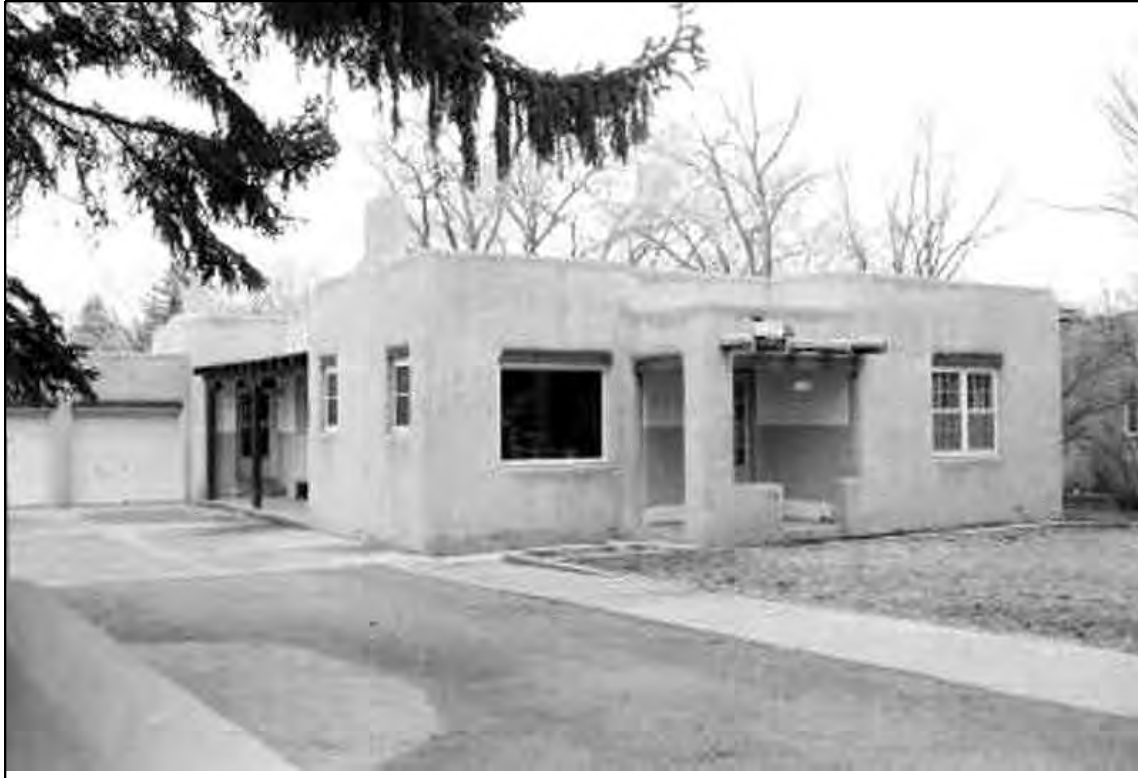
PROPERTY TYPE: **Primary** PHOTOGRAPH VIEW: **east and south elevations**

210 Paseo del Pueblo Norte is a single story stuccoed Spanish Pueblo Revival style residential building with a flat parapet. Windows are recessed 6-over-6 double-hung wooden units with exposed lintels on the east and south elevations. There is a single fixed plate unit on the east elevation. There is a recessed portal centrally located on the east elevation with a stucco pier and low knee wall. Its height is below that of the remainder of the house and it has projecting vigas. A secondary recessed portal with posts and corbels is centrally located on the south elevation. Both portales have painted dado areas under them. Doors are multi-lite wooden single leaf units. There are two interior chimneys on the south. A two-car garage with metal overhead doors is attached at the building's south elevation at the west end. There is a concrete ditch across the east end of the front yard.

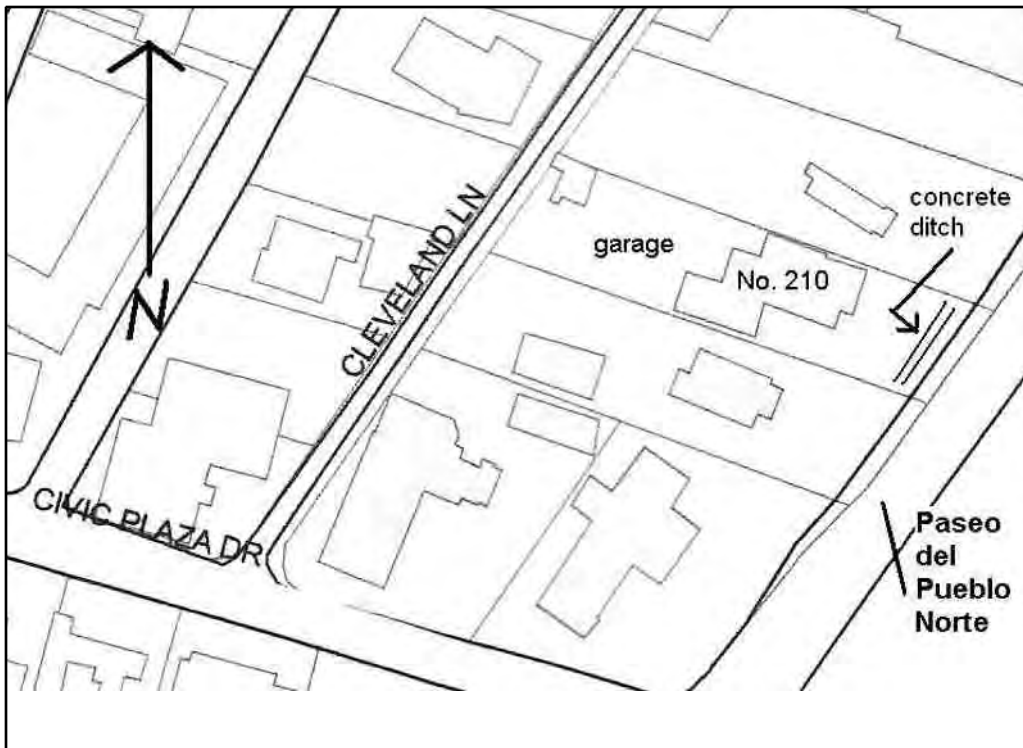
SITE PLAN:

Site. Base map provided by Taos GIS. NTS.
