Historic Cultural Properties Inventory (HCPI) Base Form (FORM 1)

NAME OF PROPERTY: Paseo del Pueblo Norte 212

LOCATION OF PROPERTY: 212 PASEO DEL PUEBLO NORTE

2005 CLG Survey

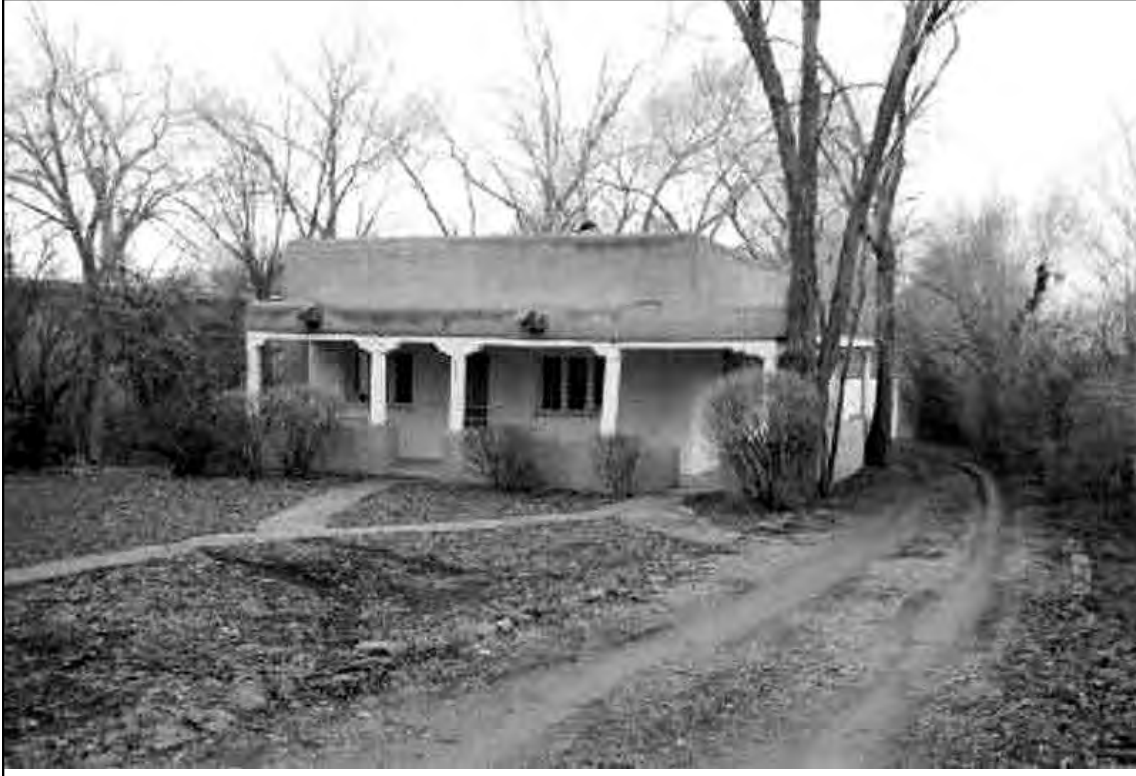
PHOTOGRAPH VIEW: 2005 Survey Photo 1

212 Paseo del Pueblo Norte is a single story stuccoed Spanish Pueblo Revival style residential building with a flat parapet. Windows are recessed 8-lite wooden casement units placed in triplicate. There is a wrap-around flat roofed porch on the east and north elevations with posts, corbels, and an exposed lintel. The posts rest on a knee wall. Entrance to the building is through a centrally located single-leaf vertical panel wooden door with a wood storm/screen. A secondary entrance on the north includes a glass and wood panel unit with sidelights. There is a chimney at the northwest corner of the building. A freestanding historic single car garage with a vertical slat wooden door stands to the north and west of the main structure. The site slopes gently away from street grade.

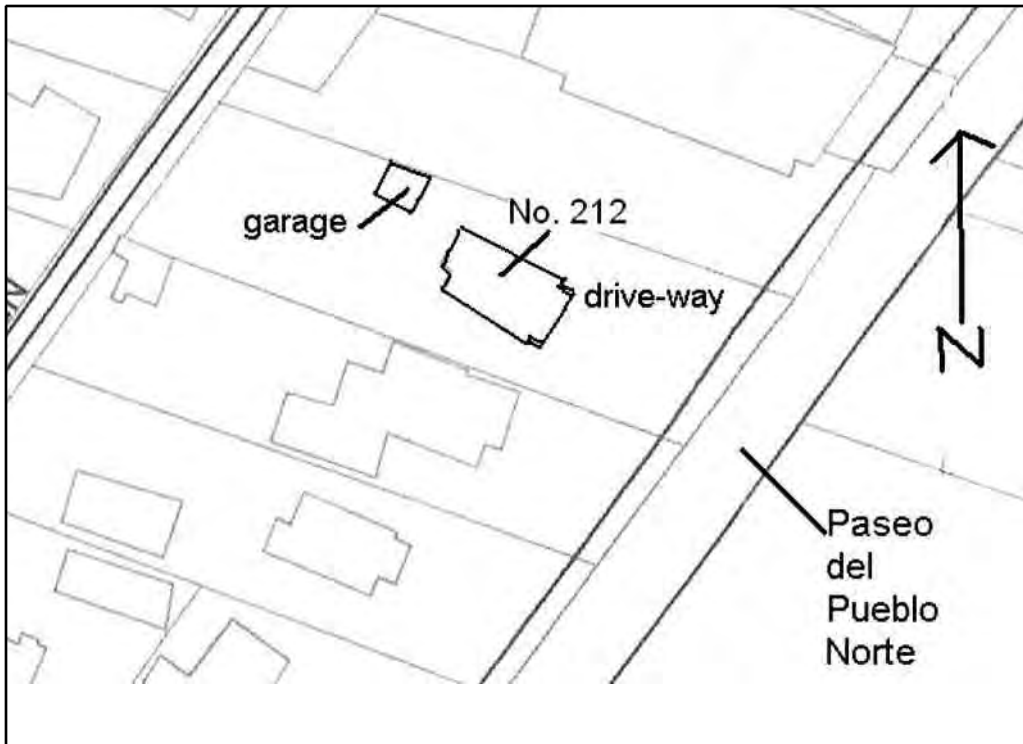
SITE PLAN:

Site. Base map provided by Taos GIS. NTS.
