Historic Cultural Properties Inventory (HCPI) Base Form (FORM 1)

NAME OF PROPERTY: **Paseo del Pueblo Norte 308 - Chacon's Accounting** LOCAL REFERENCE NUMBER: **2005029**
LOCATION OF PROPERTY: **308 PASEO DEL PUEBLO NORTE** UTM ZONE:
CITY OR TOWN: **Taos** UTM EASTING:
COUNTY: **Taos** UTM NORTHING:

NAME OF PROJECT:
2005 CLG Survey

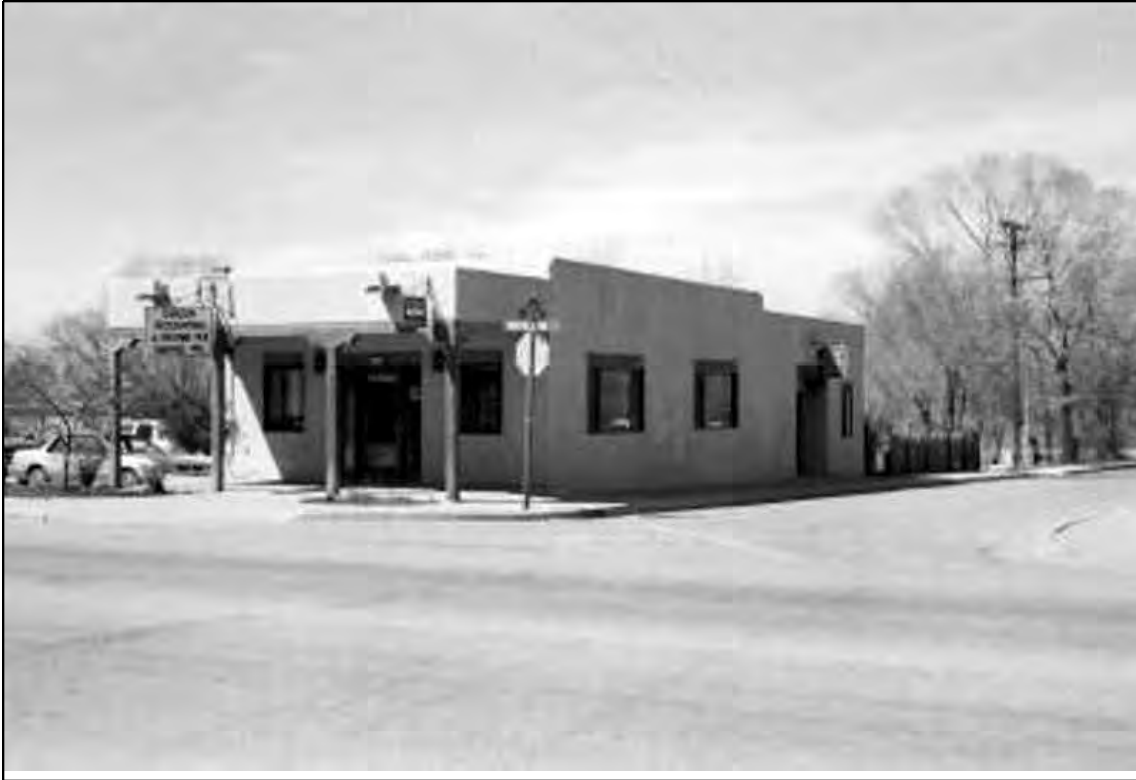
PROPERTY TYPE: **Primary** PHOTOGRAPH VIEW: **east and north elevations**

308 Paseo del Pueblo Norte is a single story modern Spanish Pueblo Revival style stuccoed commercial structure with a flat parapet that steps down on the north elevation. Windows are metal large lite slider units [on the east] and fixed large lite units with side sliders on the north. Windows are not recessed into the building walls and have exposed lintels. There is a full-width portal on the east elevation with canales, 6 x 6 square posts with corbels, and an exposed lintel. There is a recessed secondary entrance on the north elevation toward the west end of the building. Entrance to the building is through a single leaf undivided glass metal door with side lites that is centrally located under the portal. The building sits on a corner lot with parking to its west and south. There is a low coyote and railroad tie fence to the building's west.

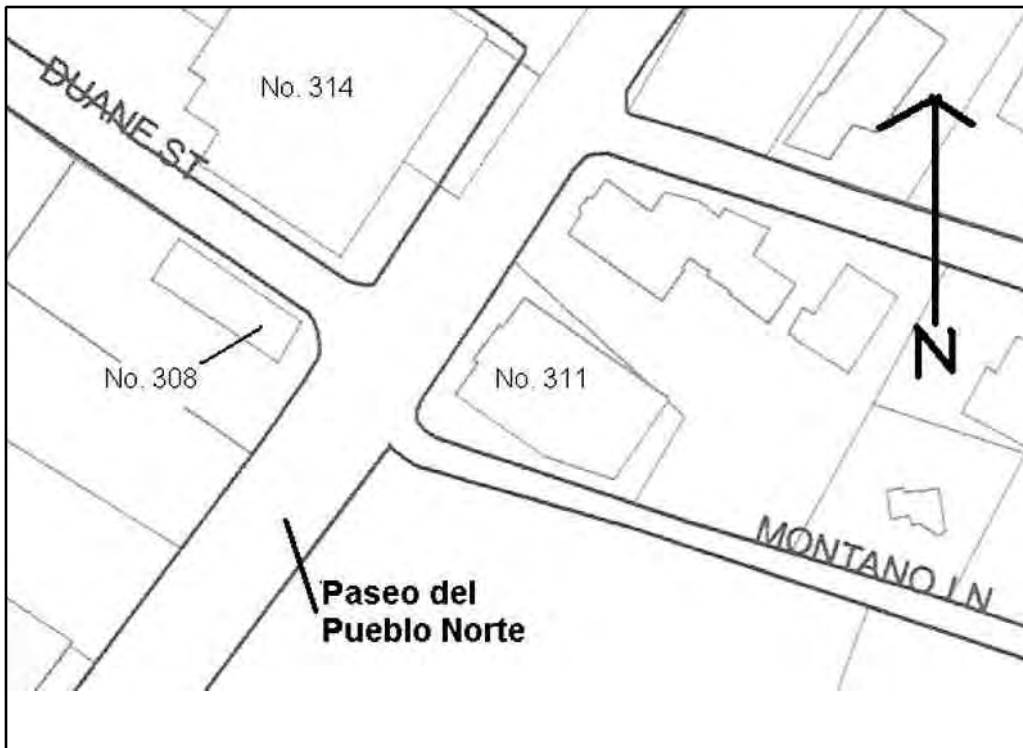
SITE PLAN:

Site. Base map provided by Taos GIS. NTS.
