# Historic Cultural Properties Inventory (HCPI) Base Form (FORM 1)

NAME OF PROPERTY: **Paseo del Pueblo Norte 412 - El Pueblo Lodge - Building 2** LOCAL REFERENCE NUMBER: **2005036**  
LOCATION OF PROPERTY: **412 PASEO DEL PUEBLO NORTE** UTM ZONE:  
CITY OR TOWN: **Taos** UTM EASTING:  
COUNTY: **Taos** UTM NORTHING:

NAME OF PROJECT:  
**2005 CLG Survey**

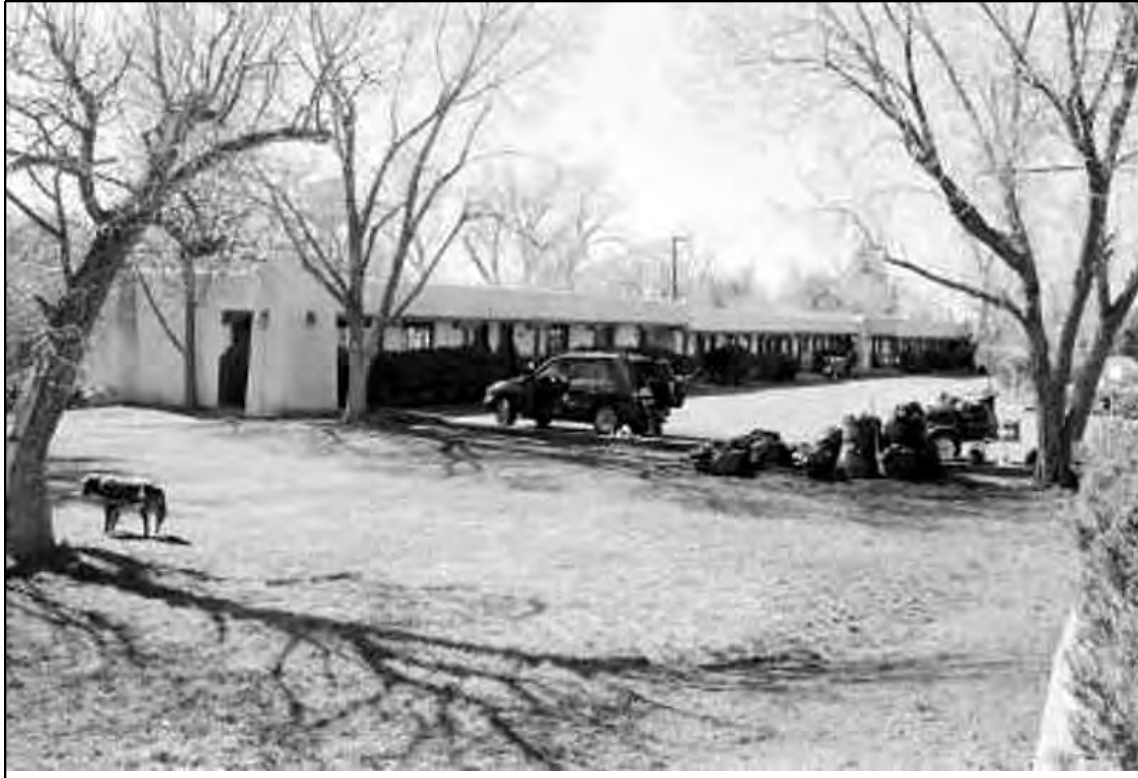
PROPERTY TYPE: **Primary** PHOTOGRAPH VIEW: **north and east**

Building #2 at 412 Paseo del Pueblo Norte [Rooms 101-119] is a single story stuccoed Spanish Pueblo Revival Style motel/residential structure with a flat parapet and massing which steps back along the north façade, separated by pier structures which define bays. There is a full-width portal with wooden posts and corbels on the north elevation. Windows are three-light steel fixed units with operable casement sidelights. Lintels are exposed. There is a single exterior chimney on the east end of the building. Entry to the units is through single leaf wooden panel doors under the portal. There is a painted dado on the building wall at the back of the portal. There is a large grassy lawn to the east and parking is located to the north of the building. An acequia passes across the east/front of the property at the street.

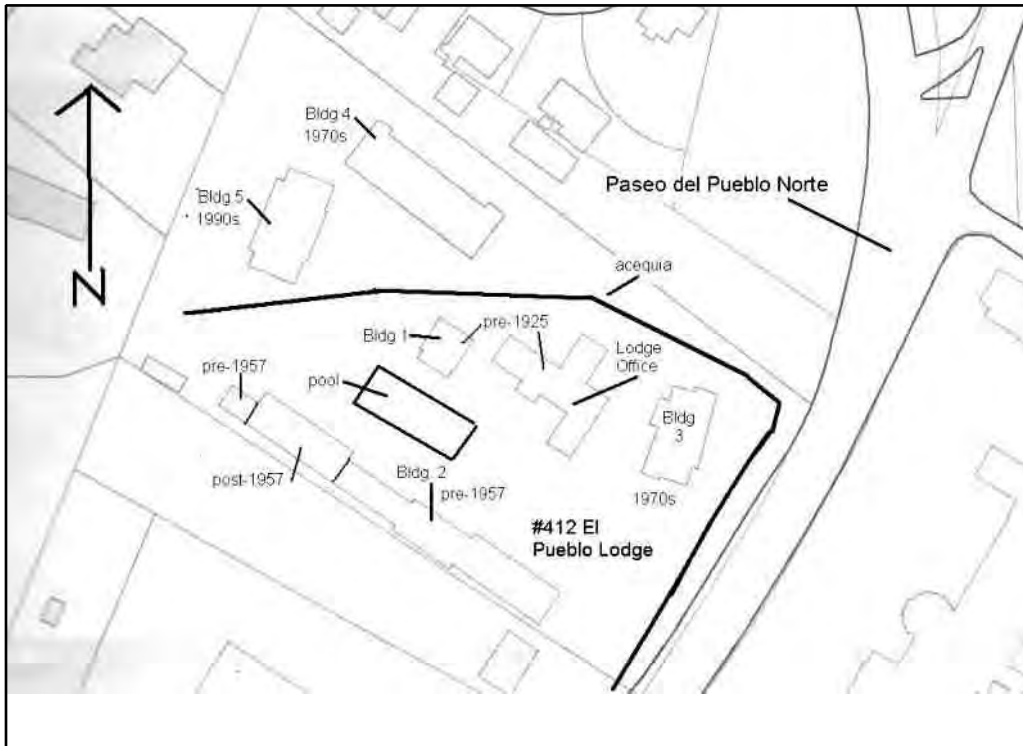
SITE PLAN:

Site. Base map provided by Taos GIS. NTS.
