Historic Cultural Properties Inventory (HCPI) Base Form (FORM 1)

NAME OF PROPERTY: **Paseo del Pueblo Norte 412 - El Pueblo Lodge - Building 5** LOCAL REFERENCE NUMBER: **2005039**
LOCATION OF PROPERTY: **412 PASEO DEL PUEBLO NORTE** UTM ZONE:
CITY OR TOWN: **Taos** UTM EASTING:
COUNTY: **Taos** UTM NORTHING:

NAME OF PROJECT:
2005 CLG Survey

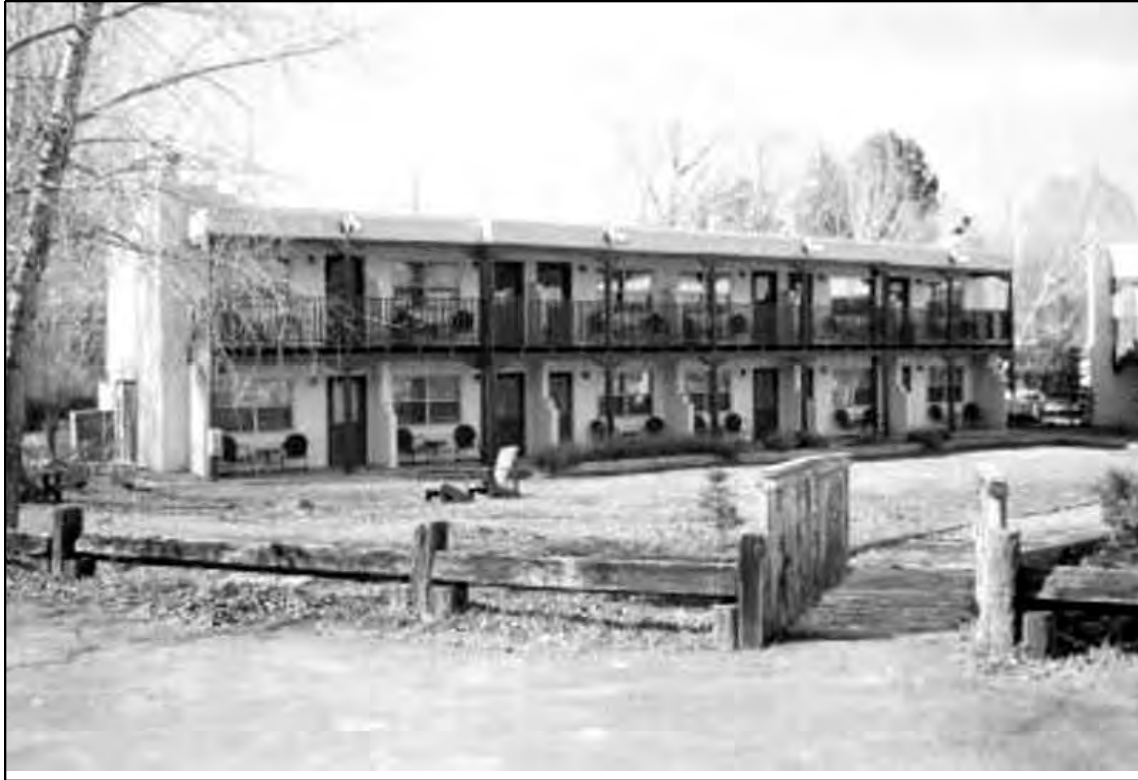
PROPERTY TYPE: **Primary** PHOTOGRAPH VIEW: **east and south**

Building #5 at 412 Paseo del Pueblo Norte [Rooms 301 – 406] is a two-story stuccoed Spanish Pueblo Revival style structure with a flat parapet. Windows are 1-over-1 paired double-hung vinyl units on the east elevation. A two-level full-width portal runs across the east and west elevations. The portales are details with round posts and corbels, and a wooden railing across the upper level. Canales punctuate the parapet on the portales. The ground floor units are separated by stepped half-walls under the roof of the portal. The west elevation also has an enclosed stairwell which provides access to the upper level units. At the north and south end of the building, there are clustered exterior chimneys. Entry to the units is through single-leaf wooden and glass doors with wooden storm doors. The structure is located at the northwest part of the site and faces a grassy lawn to its east.

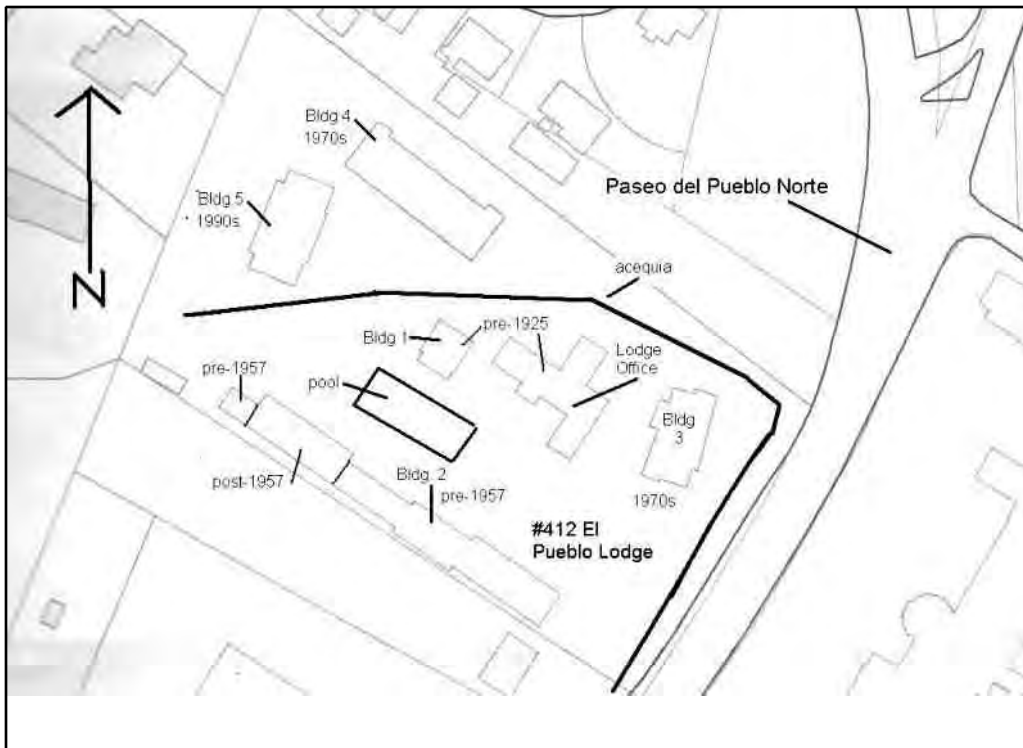
SITE PLAN:

Site. Base map provided by Taos GIS. NTS.
