Historic Cultural Properties Inventory (HCPI) Base Form (FORM 1)

NAME OF PROPERTY: Paseo del Pueblo Norte 413 - Kachina Lodge - Building 2

LOCATION OF PROPERTY: 413 PASEO DEL PUEBLO NORTE

2005 CLG Survey

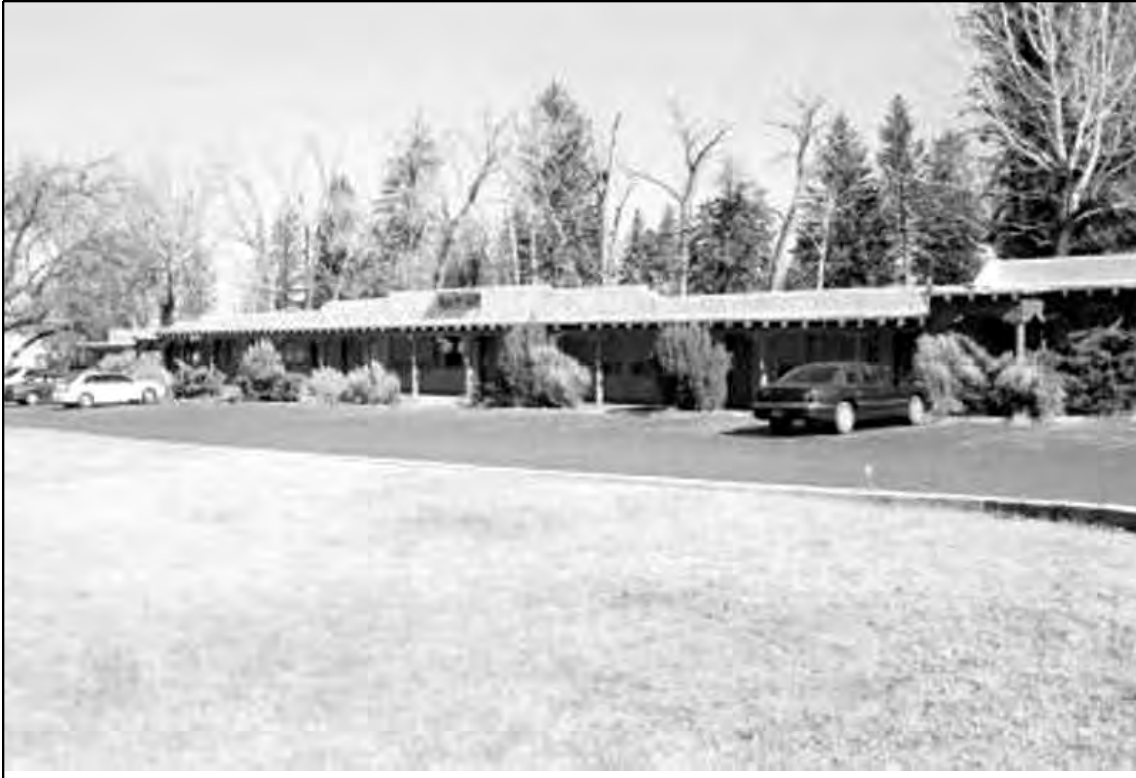
PHOTOGRAPH VIEW: south

Building #2 at 413 Paseo del Pueblo Norte [Kachina Lodge] is the Taos Casitas. It is a single story linear "L" shaped Spanish Pueblo Revival structure with a flat parapet which steps at a central area on the south elevation. Windows are fixed plate glass metal units with 4-lite casement sidelights. There is a full-width shed-roofed portal on the south elevation with posts, corbels, and exposed lintels. Roof joists are exposed. Doors accessing the lodge units are solid single leaf wooden units. There is a single interior chimney. The structure faces a grassy lawn in which is located the Indian Dance Circle. Parking is provided on its south side. Site driveways frame the structure on the south side at the east end.

Building #2 at 413 Paseo del Pueblo Norte [Kachina Lodge] is the Taos Casitas. Deterioration of viga ends on portal.

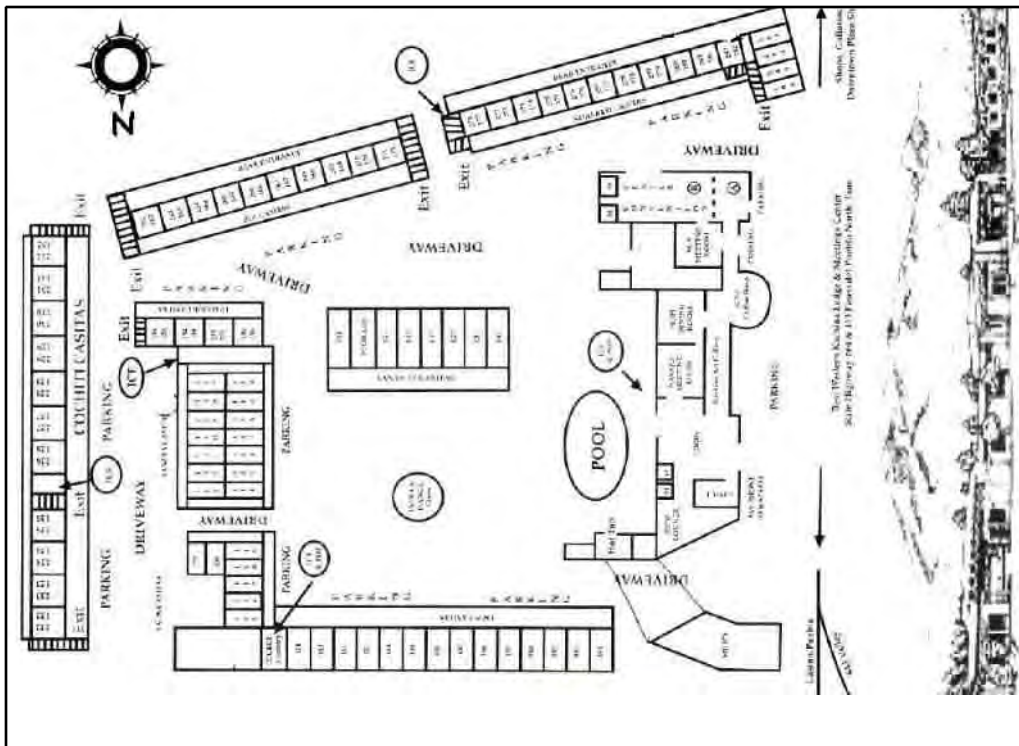
SITE PLAN:

Site. Map provided by Kachina Lodge. NTS.
