Historic Cultural Properties Inventory (HCPI) Base Form (FORM 1)

NAME OF PROPERTY: Paseo del Pueblo Norte 313

LOCATION OF PROPERTY: 313 PASEO DEL PUEBLO NORTE

2005 CLG Survey

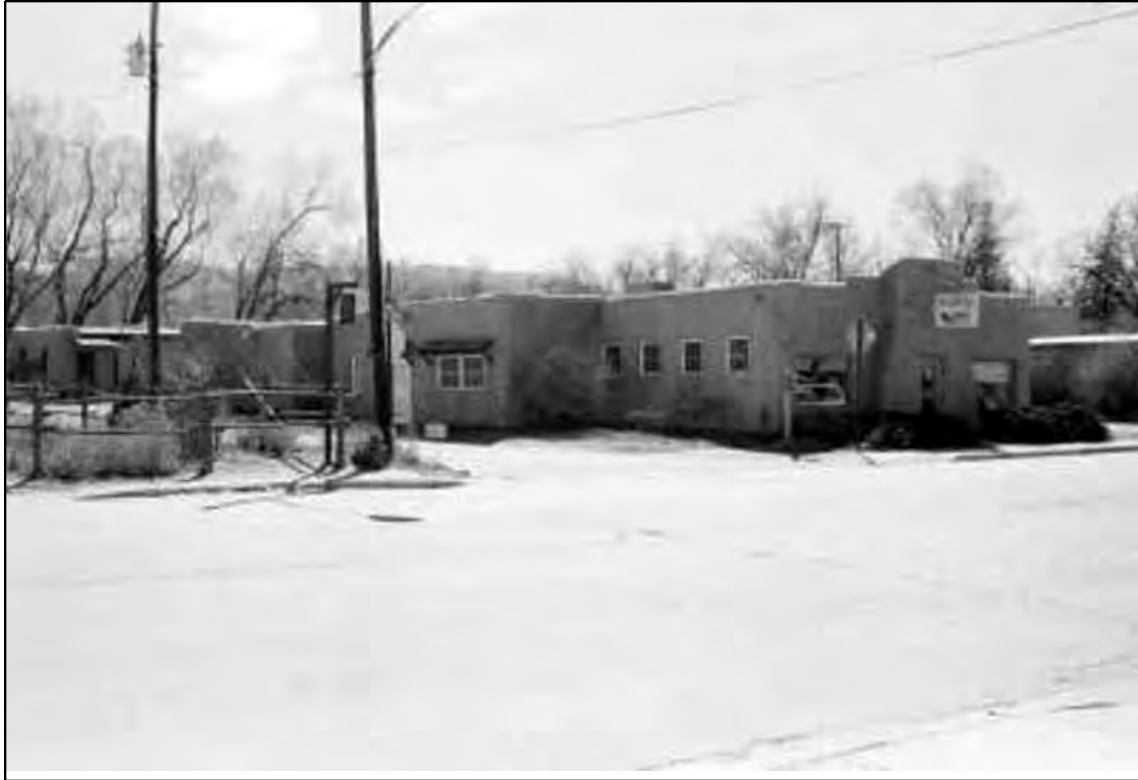
PHOTOGRAPH:

PHOTOGRAPH VIEW: north and west elevation

313 Paseo del Pueblo Norte is a single story Spanish Pueblo Revival style stuccoed commercial structure with a flat parapet that steps up at the west/front of the structure at the location of the projecting mass which holds the entrance to the building. There are large plate glass storefront windows on the west and 6-lite clad casement units on the north and south elevations. As well, there are paired 1-over-1 double hung units with shingled overhangs on the north. The entrance to the building is through a single leaf glass and wood door on the west. Secondary entrances on the north and south elevations are single leaf wood and glass doors. The building occupies a corner lot to the south of Brooks Street.

NOTES ON CONDITION: Good

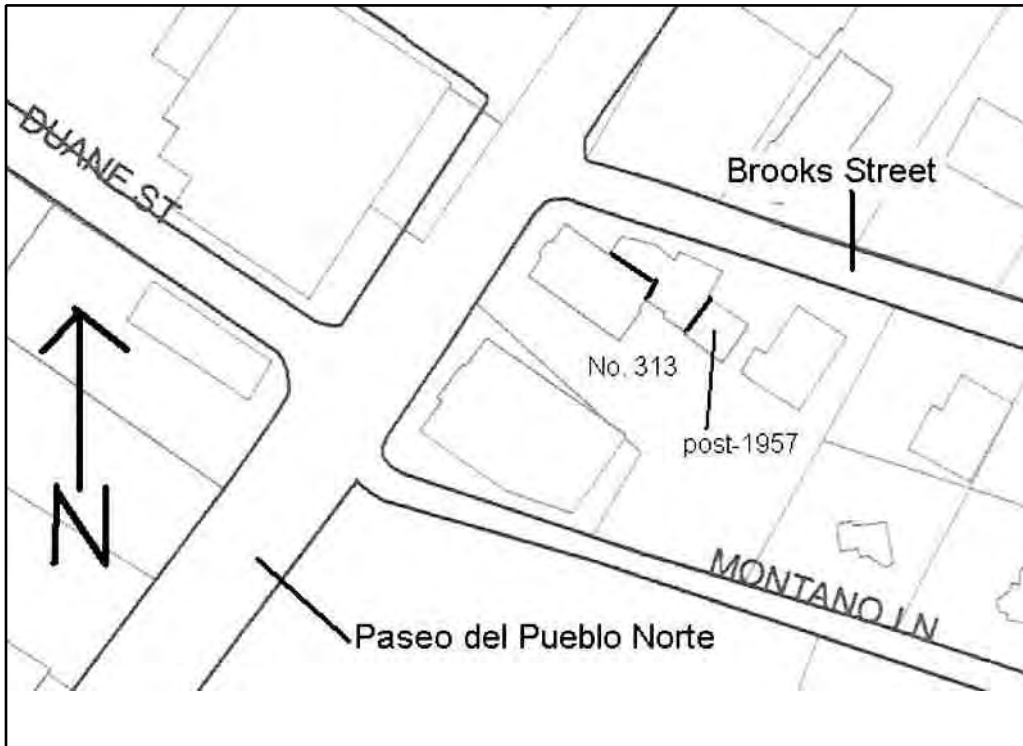
SITE PLAN:

Site. Base map provided by Taos GIS. NTS.
