Historic Cultural Properties Inventory (HCPI) Base Form (FORM 1)

NAME OF PROPERTY: **Paseo del Pueblo Norte 311 - Taos Lumber and Hardware Company/??** LOCAL REFERENCE NUMBER: **2005057**
LOCATION OF PROPERTY: **311 PASEO DEL PUEBLO NORTE** UTM ZONE:
CITY OR TOWN: **Taos** UTM EASTING:
COUNTY: **Taos** UTM NORTHING:

2005 CLG Survey

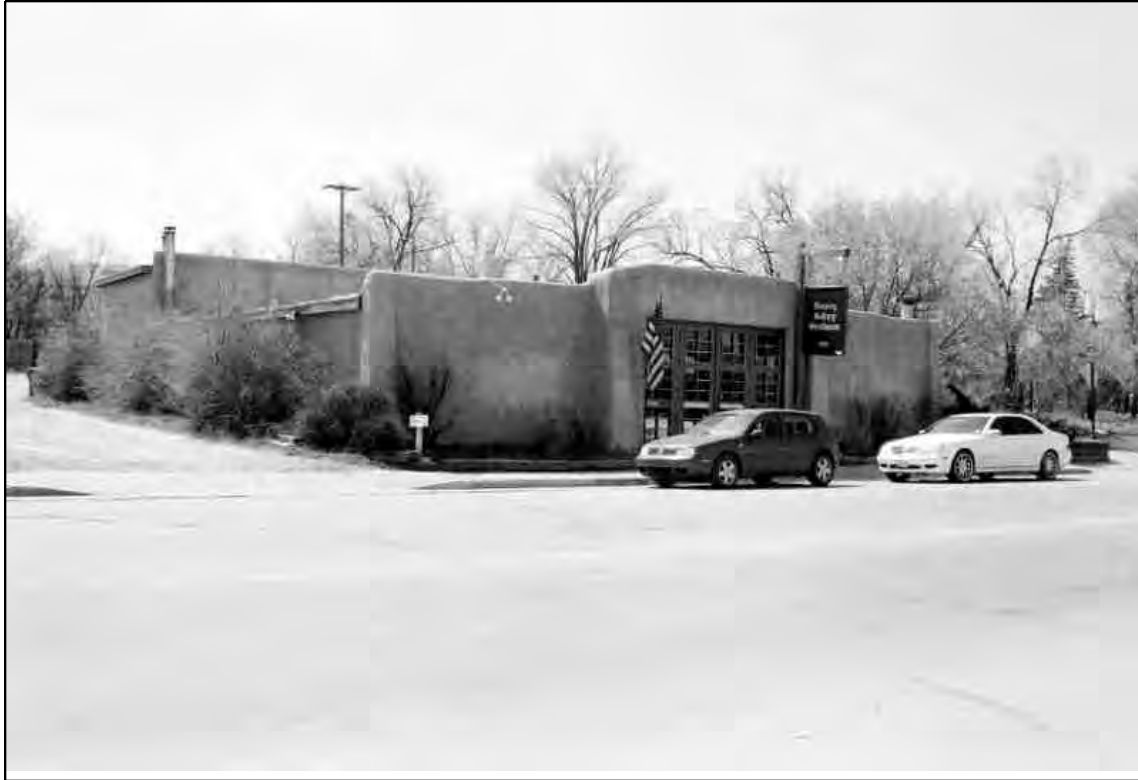
PHOTOGRAPH:

PHOTOGRAPH VIEW: **north and west elevations**

311 Paseo del Pueblo Norte is a single story stuccoed warehouse structure with two levels of building mass. The eastern mass is higher than that of the west/front. Flat parapets conceal the low gable and shed rooflines. Corner buttresses and a projecting central mass detail the west front. Windows are limited to the storefront on the west and include 3 rows of 6-lite wooden units set in quadruple. Entrance to the building is through a single leaf 12-lite wooden unit set within the storefront. There is a single centrally-located interior chimney. A massive hanging sign hangs on the west front over the sidewalk. The building occupies a corner lot at Montano Lane. There is a low railroad tie planter in front of the building at the sidewalk.

SIGNIFICANT MODIFICATIONS? **modern storefront windows**

NOTES ON CONDITION: **Good**

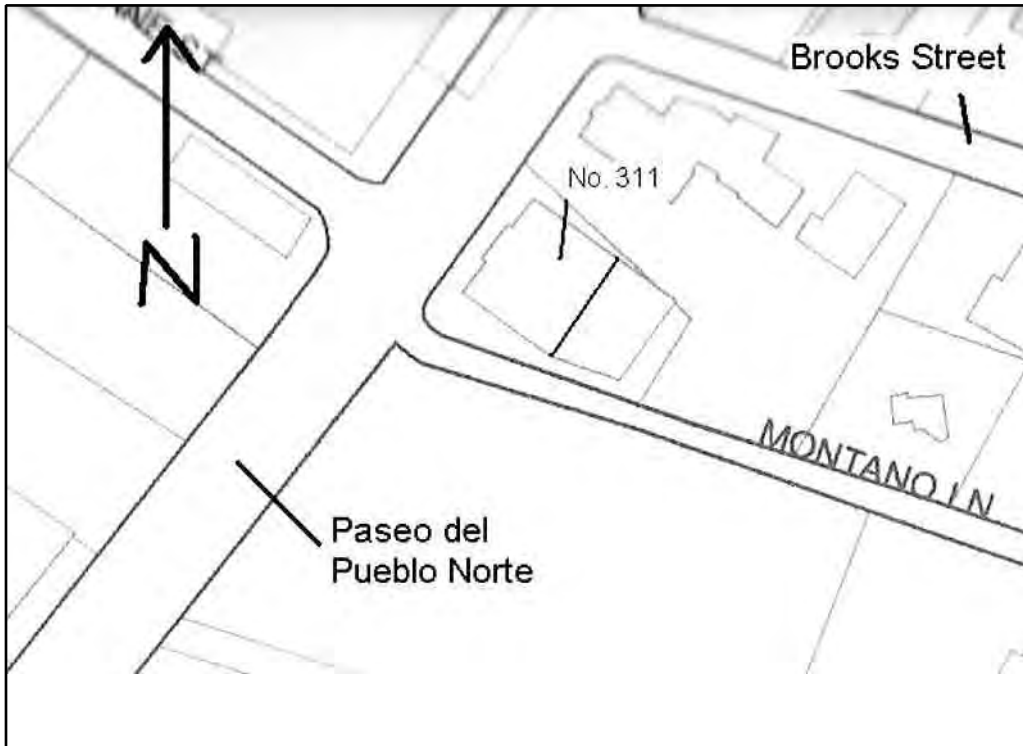
SITE PLAN:

Site. Base map provided by Taos GIS. NTS.
