Historic Cultural Properties Inventory (HCPI) Base Form (FORM 1)

NAME OF PROPERTY: **Don Fernando St 205 B - Classroom Building**

LOCATION OF PROPERTY: **205 DON FERNANDO**

2005 CLG Survey

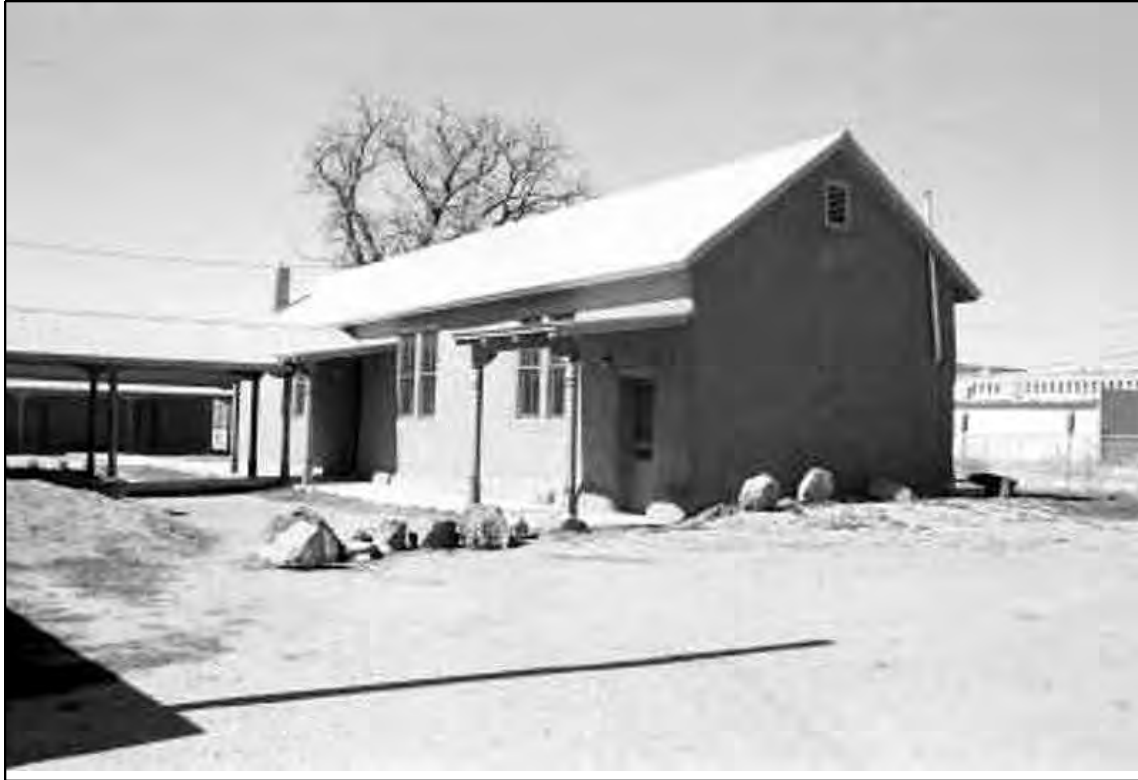
PHOTOGRAPH VIEW: **south and west elevations**

The small pitched roof structure on the site addressed at 205 Don Fernando Street is constructed of adobe and finished in textured stucco. It has a high gable roof covered with modern dark green Propanel material. Windows are modern paired 2-over-2 double hung clad units with exterior wood trim. There is a small shed-roofed partial width portal at the southeast corner with carved posts and corbels. A similarly designed pitched roof covered walkway connects this structure to the building immediately to the south. There is an exterior chimney on the west end. The main entrance is on the south side of the building through a deeply recessed wood panel single leaf door and decorative wood screen door located at the placement of the covered walkway. A secondary entrance of similar design exists under the portal. The structure stands on packed dirt or asphalt paved parking area immediately south of the Taos Elementary School.

NOTES ON CONDITION: **Good**

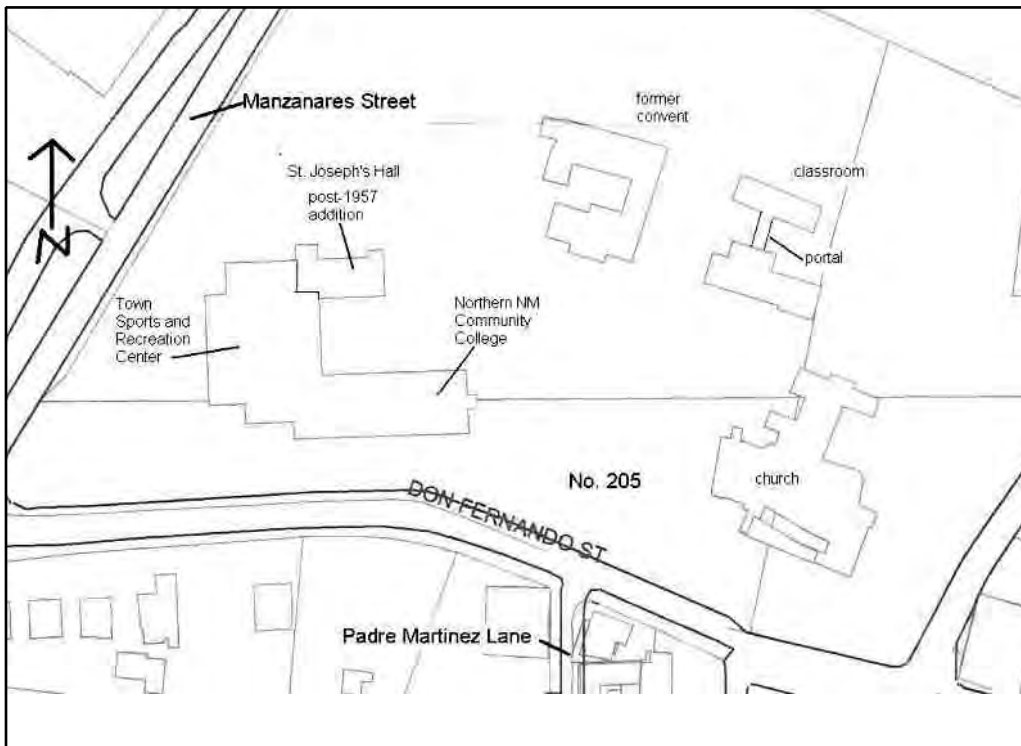
SITE PLAN:

Site. Base map provided by Taos GIS. NTS.
