Historic Cultural Properties Inventory (HCPI) Base Form (FORM 1)

NAME OF PROPERTY: **Camino de la Placita 302 - Parr House**

LOCATION OF PROPERTY: **302 CAMINO DE LA PLACITA**

2005 CLG Survey

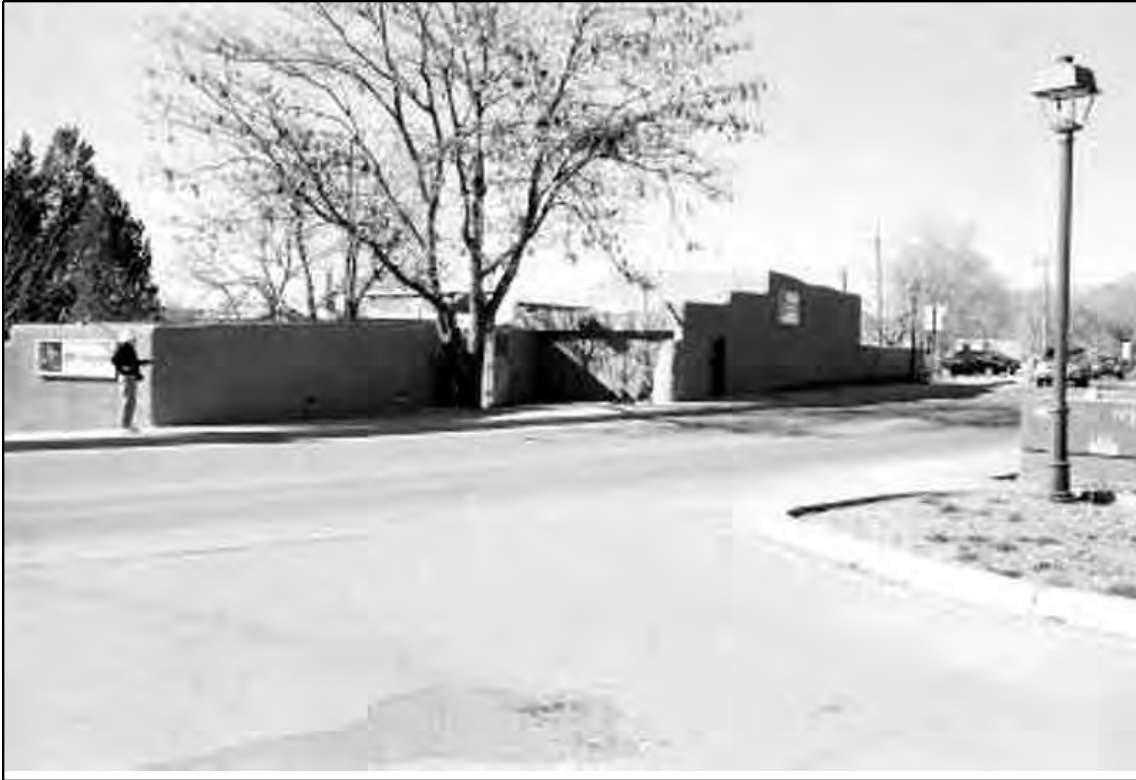
PHOTOGRAPH VIEW: **east**

302 Camino de la Placita is a single story stuccoed Spanish Pueblo Revival style residential structure with stepped parapets which conceal a series of shed roofs. The architectural details of the building are difficult to identify given the tall yard walls that surround the building. Visible windows are a combination of fixed large-lite plate glass units, 6-lite wooden casement units, and 1-over-1 wooden double hung units with wood trim surrounds. The main entrance door is not visible behind the decorative single leaf screen door. There are exposed/cut off viga ends and a shed roofed carport attached on the north side. The building stands directly at the sidewalk with no other setback from the street. Tall yard walls create a buffer from the street.

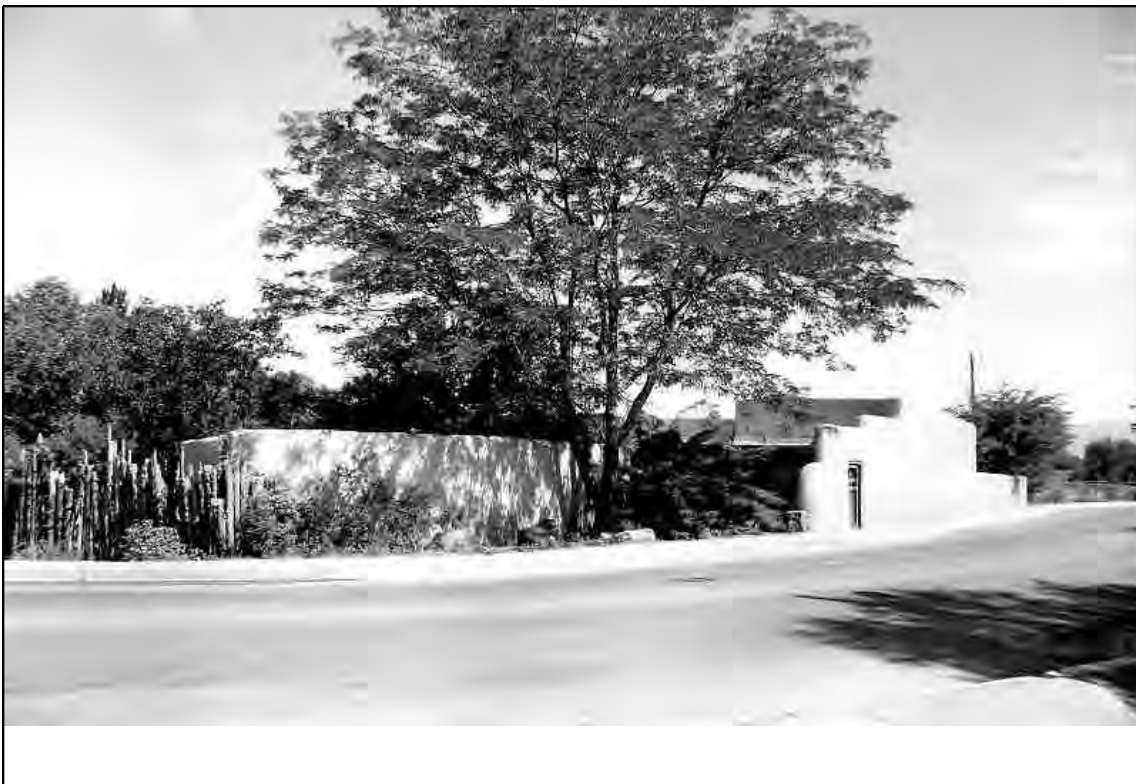
PHOTOGRAPH VIEW: **older**

302 Camino de la Placita is a single story stuccoed Spanish Pueblo Revival style residential structure with stepped parapets which conceal a series of shed roofs. The architectural details of the building are difficult to identify given the tall yard walls that surround the building. Visible windows are a combination of fixed large-lite plate glass units, 6-lite wooden casement units, and 1-over-1 wooden double hung units with wood trim surrounds. The main entrance door is not visible behind the decorative single leaf screen door. There are exposed/cut off viga ends and a shed roofed carport attached on the north side. The building stands directly at the sidewalk with no other setback from the street. Tall yard walls create a buffer from the street.
