# Historic Cultural Properties Inventory (HCPI) Base Form (FORM 1)

NAME OF PROPERTY: **Don Fernando St 224**

LOCATION OF PROPERTY: **224 DON FERNANDO**

**2005 CLG Survey**

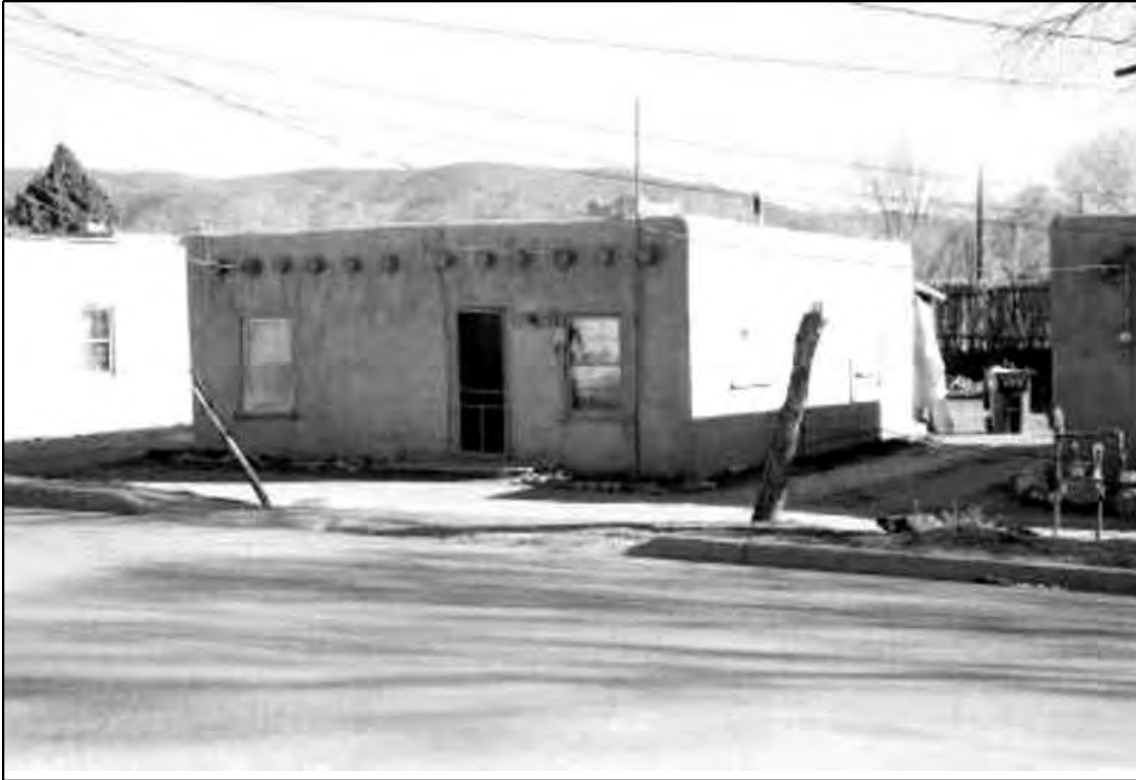
PHOTOGRAPH VIEW: **north and west elevations**

224 Don Fernando Street is a single story earth-tone stuccoed Spanish Pueblo Revival style residential structure with a flat parapet and projecting viga end on the north elevation. Windows are 6-over-6 double-hung wooden units that are concealed somewhat behind plastic which is aiding in weatherizing the structure. Wood trim surrounds the windows. There are 4-lite slider units on the west elevation. Access to the building is through a single-leaf wood panel unit with a single light and a wooden screen door. A secondary entrance is on the east side of the building. There is a simply-detailed shed-roofed portal on the south elevation. The building sits off the street and the front yard is void of vegetation.

plastic covering windows suggests that they are in need of repair

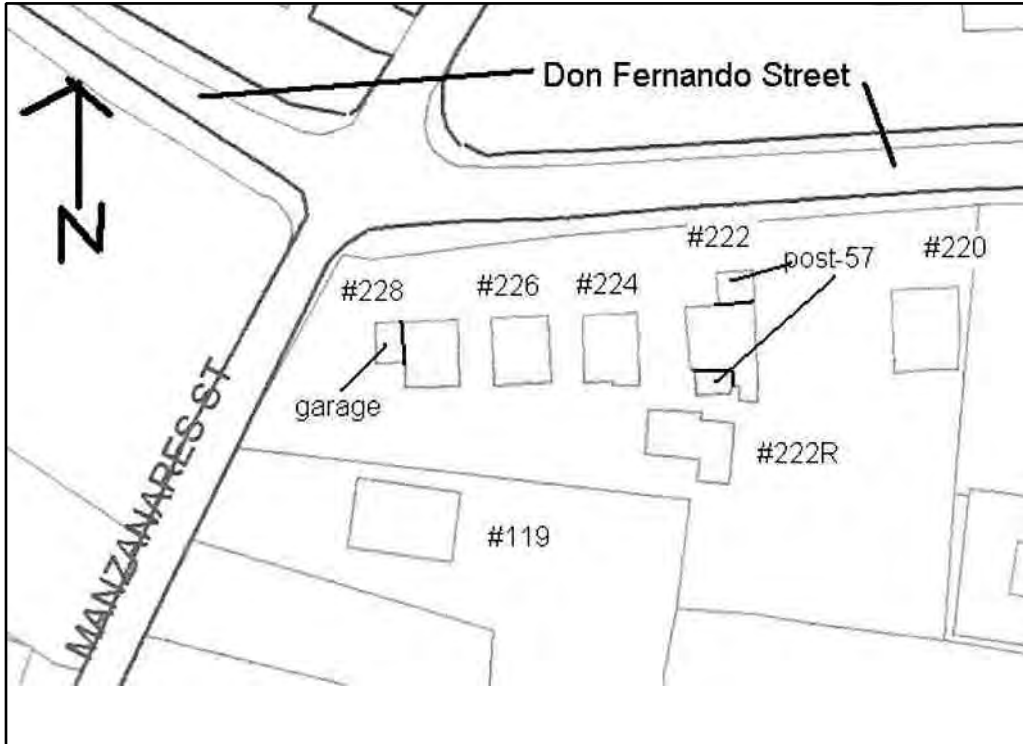
SITE PLAN:

Site. Base map provided by Taos GIS. NTS.

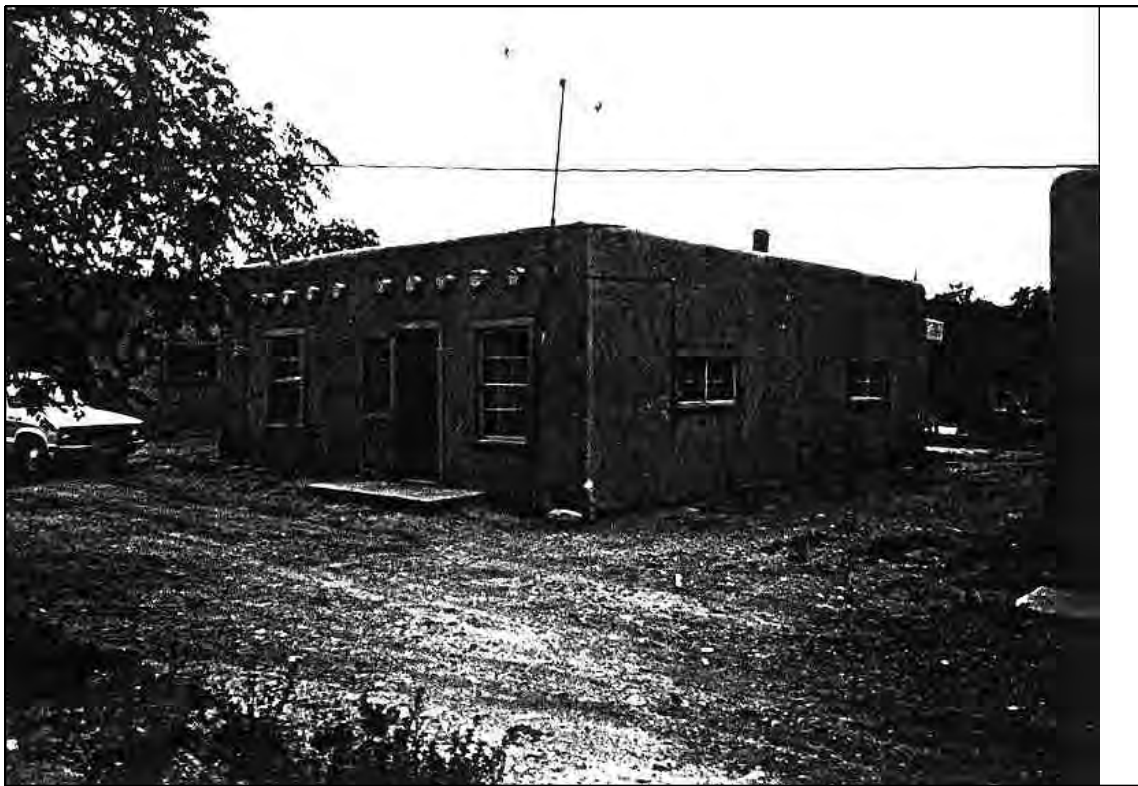
PHOTOGRAPH VIEW: **older**

224 Don Fernando Street is a single story earth-tone stuccoed Spanish Pueblo Revival style residential structure with a flat parapet and projecting viga end on the north elevation. Windows are 6-over-6 double-hung wooden units that are concealed somewhat behind plastic which is aiding in weatherizing the structure. Wood trim surrounds the windows. There are 4-lite slider units on the west elevation. Access to the building is through a single-leaf wood panel unit with a single light and a wooden screen door. A secondary entrance is on the east side of the building. There is a simply-detailed shed-roofed portal on the south elevation. The building sits off the street and the front yard is void of vegetation.
