Historic Cultural Properties Inventory (HCPI) Base Form (FORM 1)

NAME OF PROPERTY: **Don Fernando St 214**

LOCATION OF PROPERTY: **214 DON FERNANDO**

2005 CLG Survey

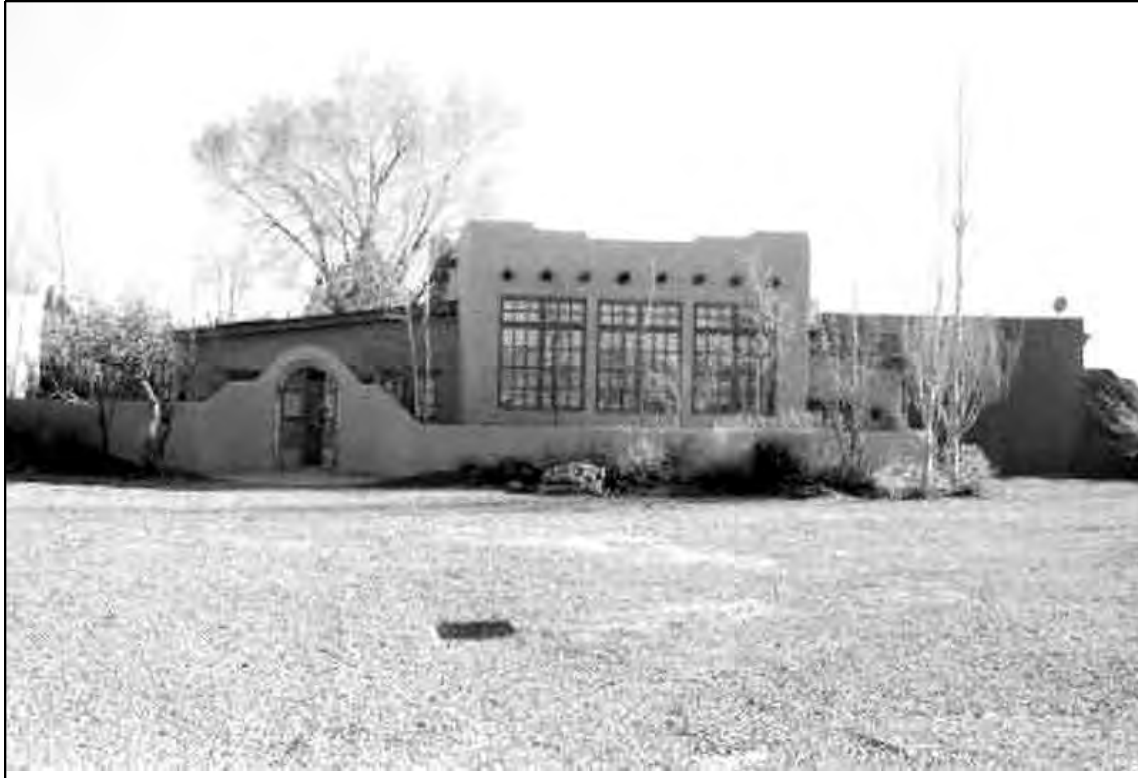
PHOTOGRAPH:

PHOTOGRAPH VIEW: **north**

214 Don Fernando Street is a tall single story stuccoed Spanish Pueblo Revival style structure with a stepped parapet on its high central mass and shed roofs on its east and west wings. There are paired 12-lite casements with divided lite transoms on the north elevation of the central mass. Other windows are 4- and 6-lite wooden casement units on the wings. Decorative viga ends project from the north elevation of the building. There are canales on the east elevation. There is a low stucco yard wall with an arched pedestrian gate separating the gravel parking area to the north of the structure and a landscaped patio area. The building sits nearly at 0 lot line along the south of the property. There is a 2 car garage to the building's east that was surveyed separately as #2005072.

Stepped parapet on its high central mass and shed roofs on its east and west wings. No obvious maintenance needs

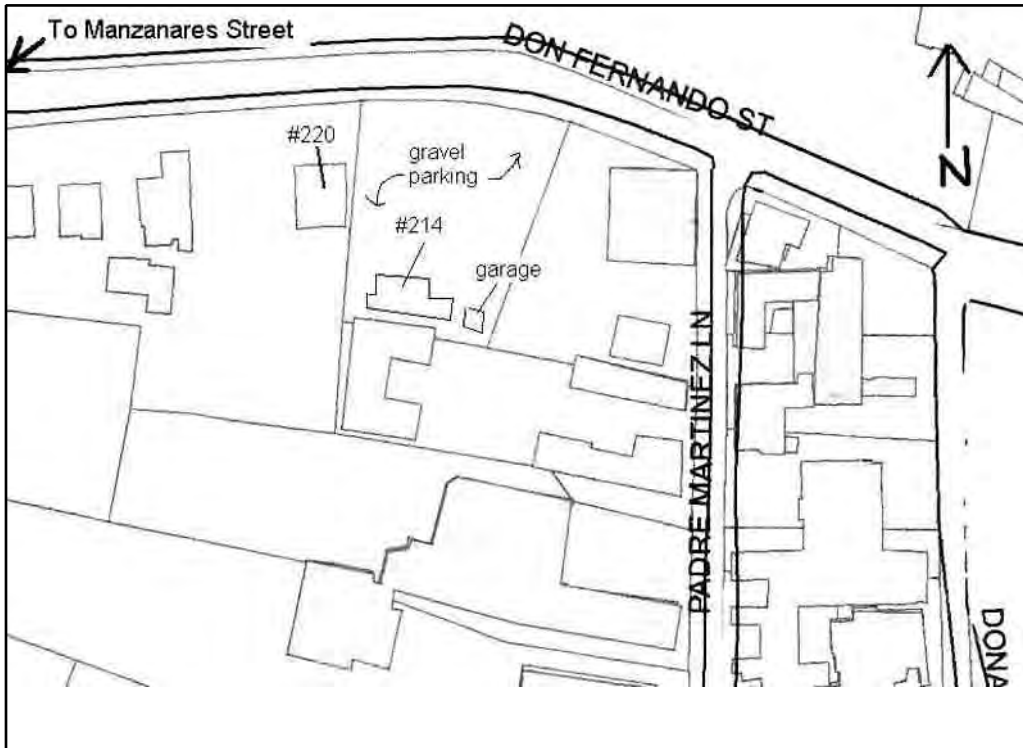
SITE PLAN:

Site. Base map provided by Taos GIS. NTS.
