# Historic Cultural Properties Inventory (HCPI) Base Form (FORM 1)

NAME OF PROPERTY: **Amistad Ln 216**

LOCATION OF PROPERTY: **216 AMISTAD**

**2005 CLG Survey**

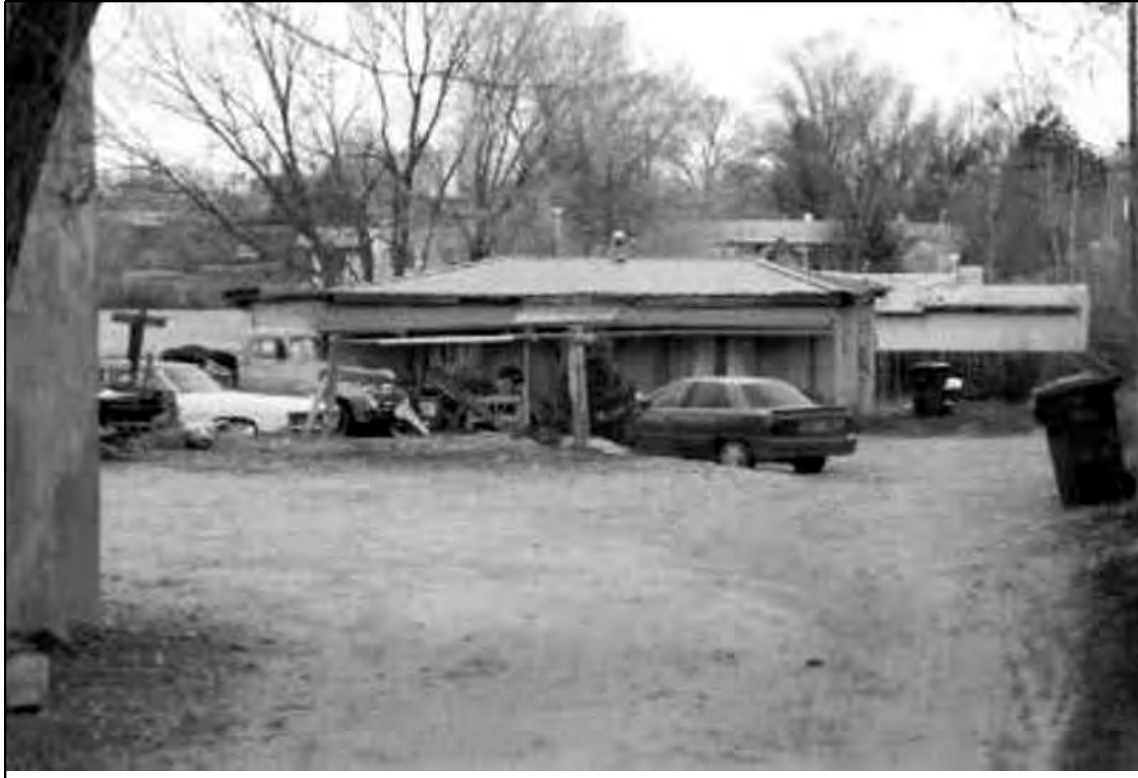
PHOTOGRAPH VIEW: **east and north elevations**

**216 Amistad Lane is a single story stuccoed adobe residential building with a low hipped roof covered with Propanel. Windows are modern aluminum units. There is a partial-width shed-roofed portal with square posts on the east elevation. Access to the interior is through a single leaf door on the east elevation. The building fronts on a dirt lane on a site that slopes toward the west.**

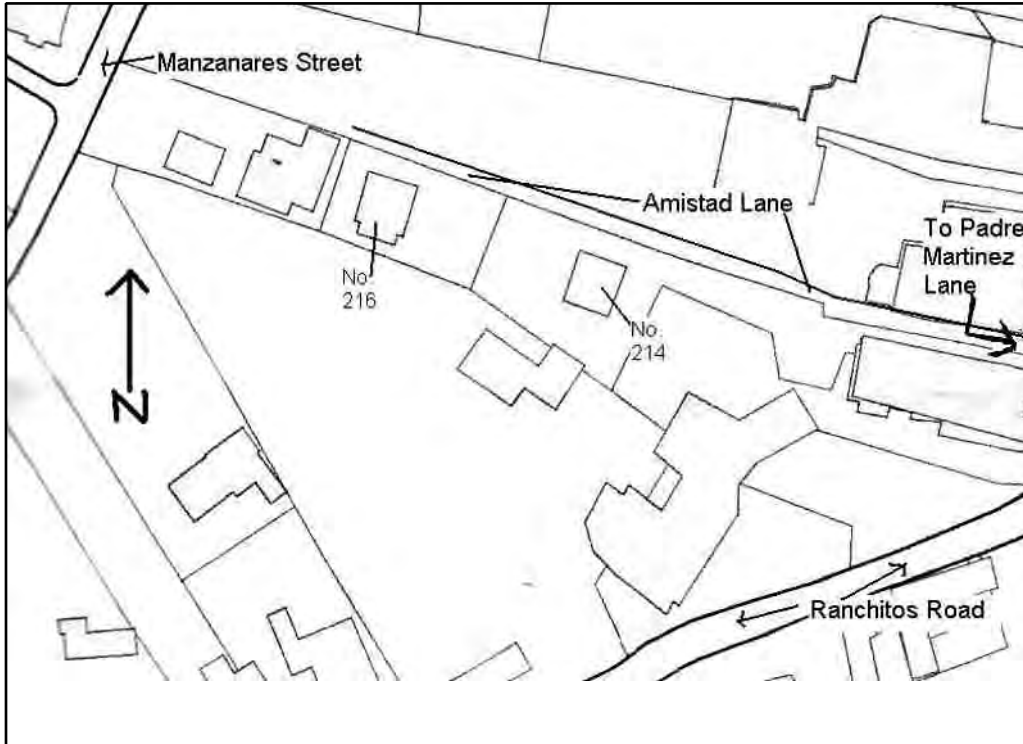
Site. Base map provided by Taos GIS. NTS.

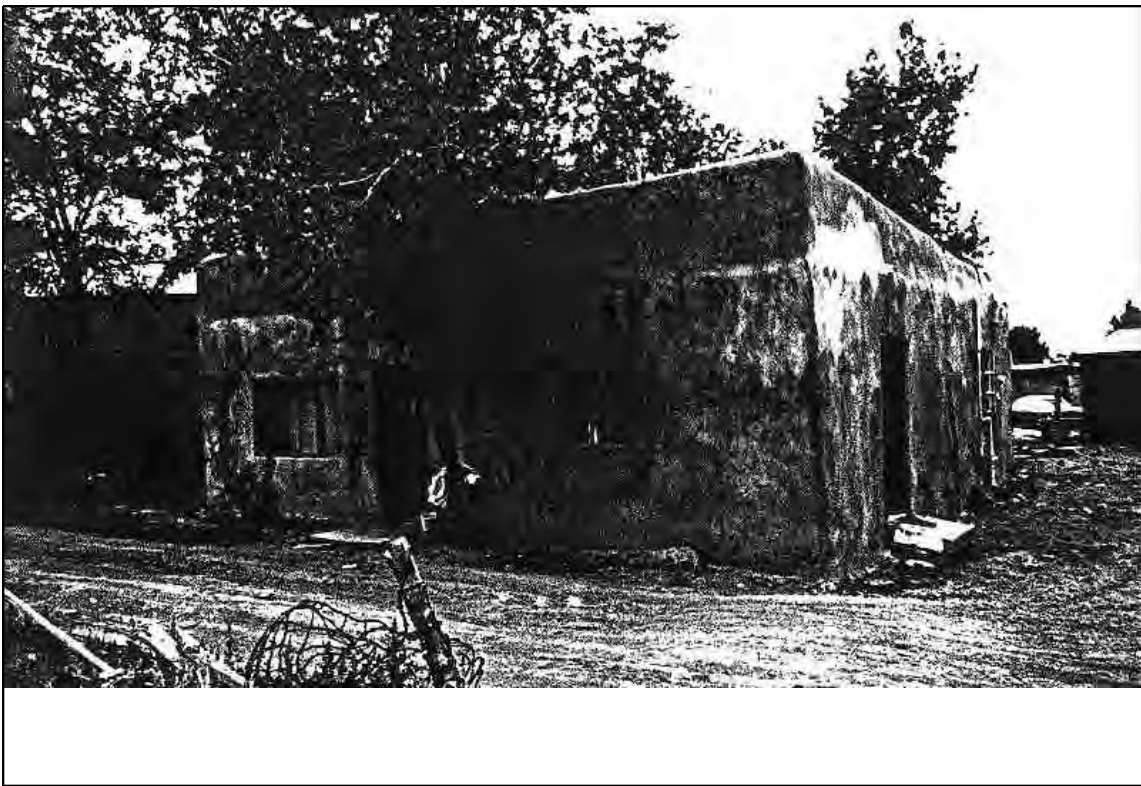
PHOTOGRAPH VIEW: **older**

216 Amistad Lane is a single story stuccoed adobe residential building with a low hipped roof covered with Propanel. Windows are modern aluminum units. There is a partial-width shed-roofed portal with square posts on the east elevation. Access to the interior is through a single leaf door on the east elevation. The building fronts on a dirt lane on a site that slopes toward the west.
