# Historic Cultural Properties Inventory (HCPI) Base Form (FORM 1)

NAME OF PROPERTY: **Manzanares St 117 - Joseph Sanchez House**  
LOCATION OF PROPERTY: **117 MANZANARES**  
CITY OR TOWN: **Taos**  
COUNTY: **Taos**

NAME OF PROJECT: **2005 CLG Survey**

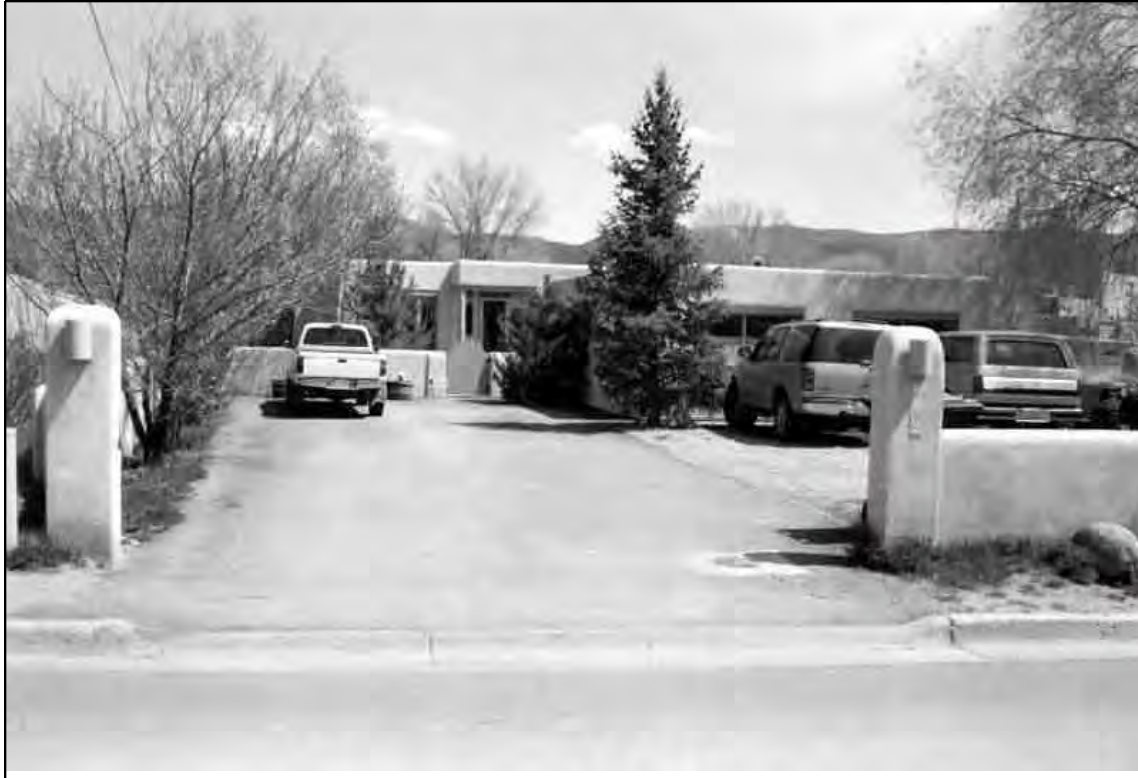
PROPERTY TYPE: **Primary** PHOTOGRAPH VIEW: **west**

117 Manzanares Street is a single story stuccoed residential building with a flat parapet. Windows in the structure are large lite modern casement units. There is a large lite fixed unit on the south elevation. There are two partial-width portales with simple round posts and plat parapets on the west elevation. A similarly-designed portal stands at the southeast corner of the building. The entrance is on the west elevation under a portal; the door is a single leaf wooden unit with a decorative window. The residence stands at a substantial setback from the street where a low stucco yard wall with end piers encloses the yard and marks the driveway entrance, respectively. A secondary low stucco wall encloses the driveway at a closer location to the house. A detached garage stands to the south and west of the residence. It is documented on a separate survey form.

NOTES ON CONDITION: **Good**
