Historic Cultural Properties Inventory (HCPI) Base Form (FORM 1)

NAME OF PROPERTY: **Ranchitos Rd 233 - History?**

LOCATION OF PROPERTY: **233 RANCHITOS**

2005 CLG Survey

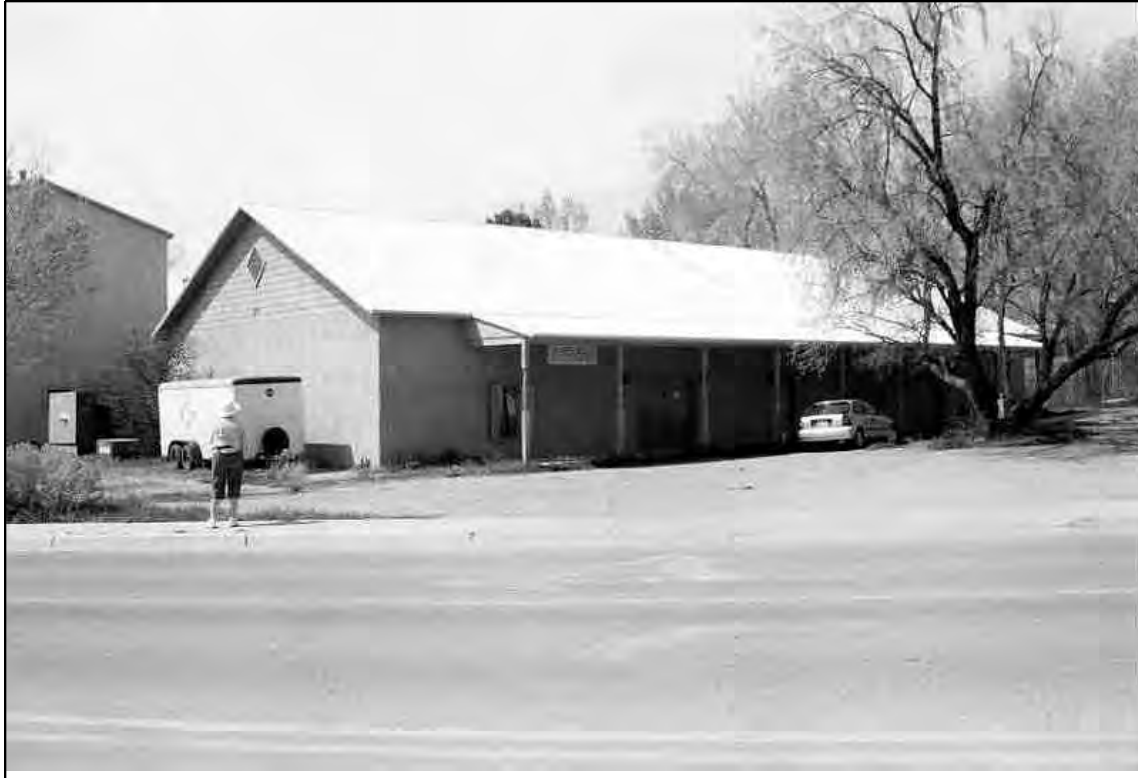
PHOTOGRAPH:

PHOTOGRAPH VIEW: **south and east**

233 Ranchitos Road is a Northern New Mexico style stucco structure with a modern gable roof covered with Propanel. The under-gable area is faced with wood siding. Windows are 12-lite fixed units with snap-in muntins. There is a partial-width portal with a shed roof on the east elevation. Details of the building on this elevation are modern "Territorial" and include turned wooden columns on the portal, wooden window surrounds and lintels, and operable wooden shutters. On the west elevation there is a small entry portal with similar details. Wooden double-leaf vehicular and single-leaf pedestrian entrances are on the east and west facades. A large dirt parking area stands to the building's east. On the west side, it is separated from the adjacent related building by a driveway "courtyard."
