Historic Cultural Properties Inventory (HCPI) Base Form (FORM 1)

NAME OF PROPERTY: **Bent St 119 - Fidel Cordova Building/Cabot Building** LOCAL REFERENCE NUMBER: **022503013**
LOCATION OF PROPERTY: **119 BENT** UTM ZONE:
CITY OR TOWN: **Taos** UTM EASTING:
COUNTY: **Taos** UTM NORTHING:

NAME OF PROJECT:
1996 CLG Survey

1981 CLG Survey

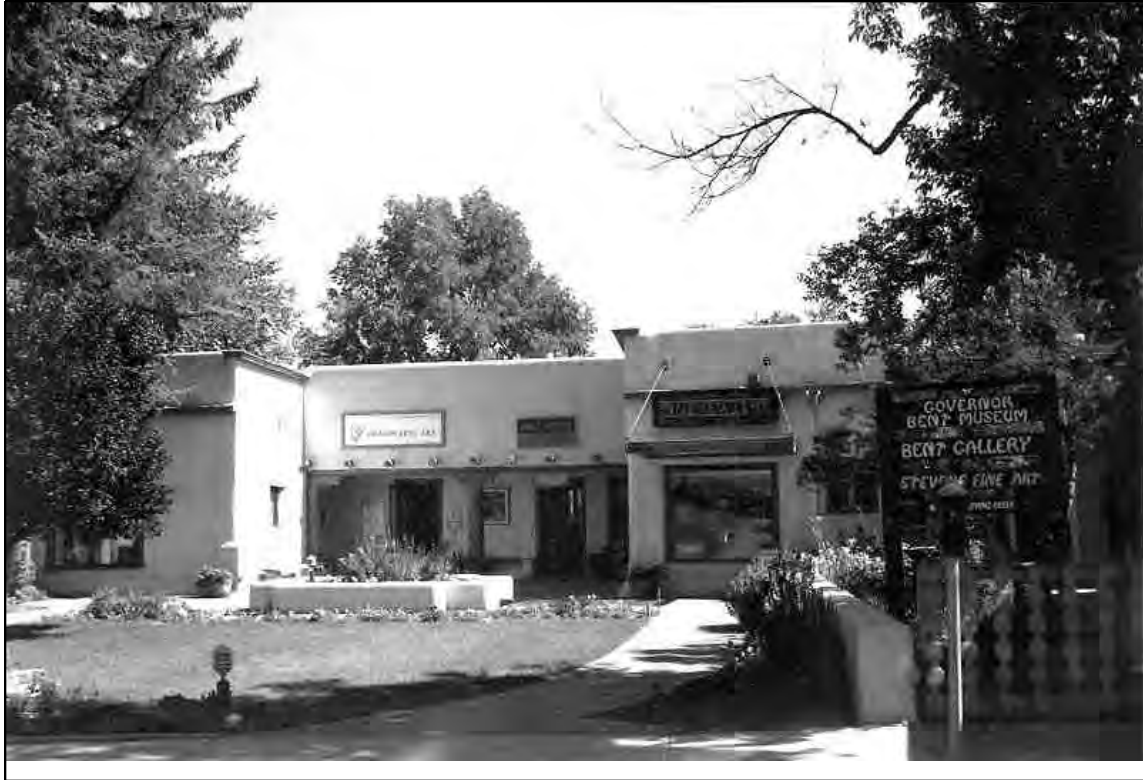
PHOTOGRAPH:
ROLL NUMBER:
FRAME NUMBER:
NEGATIVE LOCATION:

PRIMARY VISIBLE CONSTRUCTION MATERIAL: Adobe

NOTES ON VISIBLE CONSTRUCTION MATERIAL: adobe with stucco

Territorial molding inside "U," canales, tin shingled on north wing

6 single leaf with wood panels & 3 long lite

2 long display, 2 single lite display

3 - 20" carved Solomonian posts painted, with 2 end single corbels and over zapata at center, supporting round viga, ceiling stuccoed with projecting vigas

courtyard: in portal areas has flagstone, grass and planters, banco

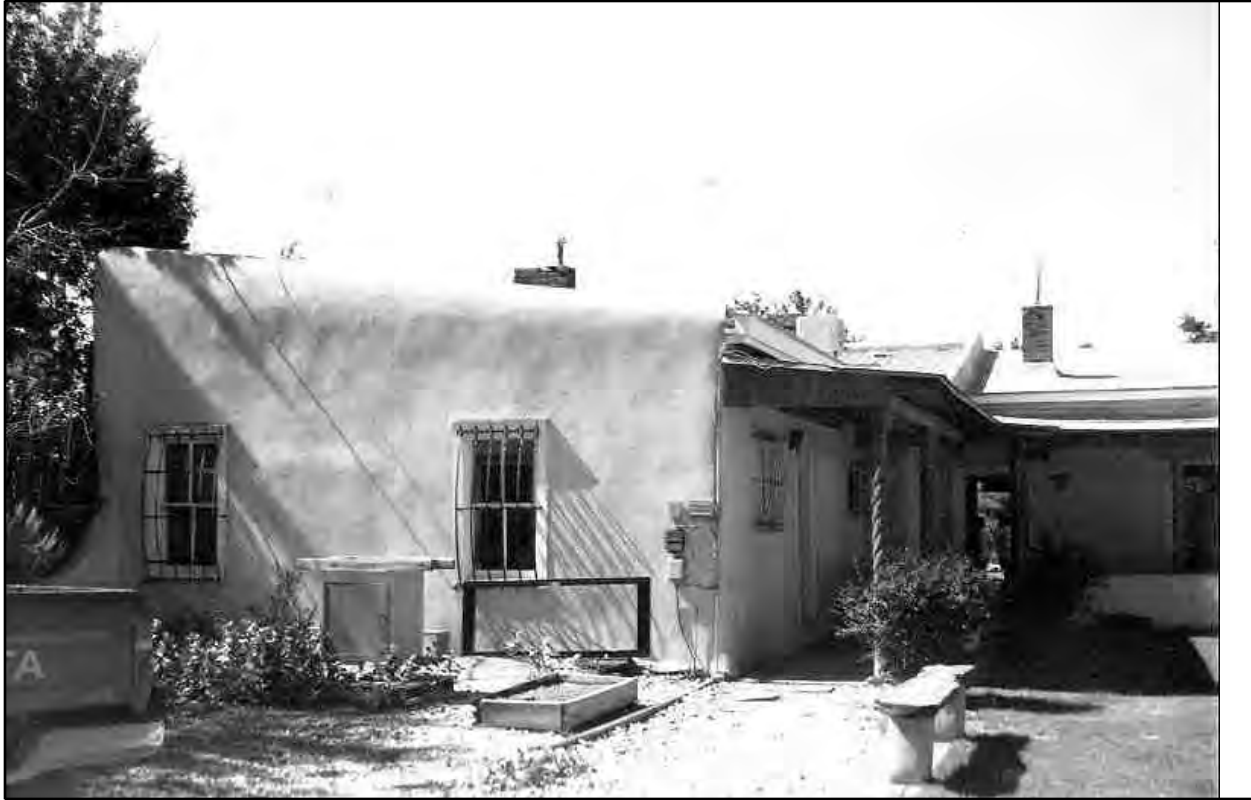
ADDITIONAL PERSPECTIVE: (Photo, drawing, footprint, etc.; indicate north arrow when possible)

NOTES ON ADDITIONAL PERSPECTIVE: **older**
(If photo, include photo info, as in #10)

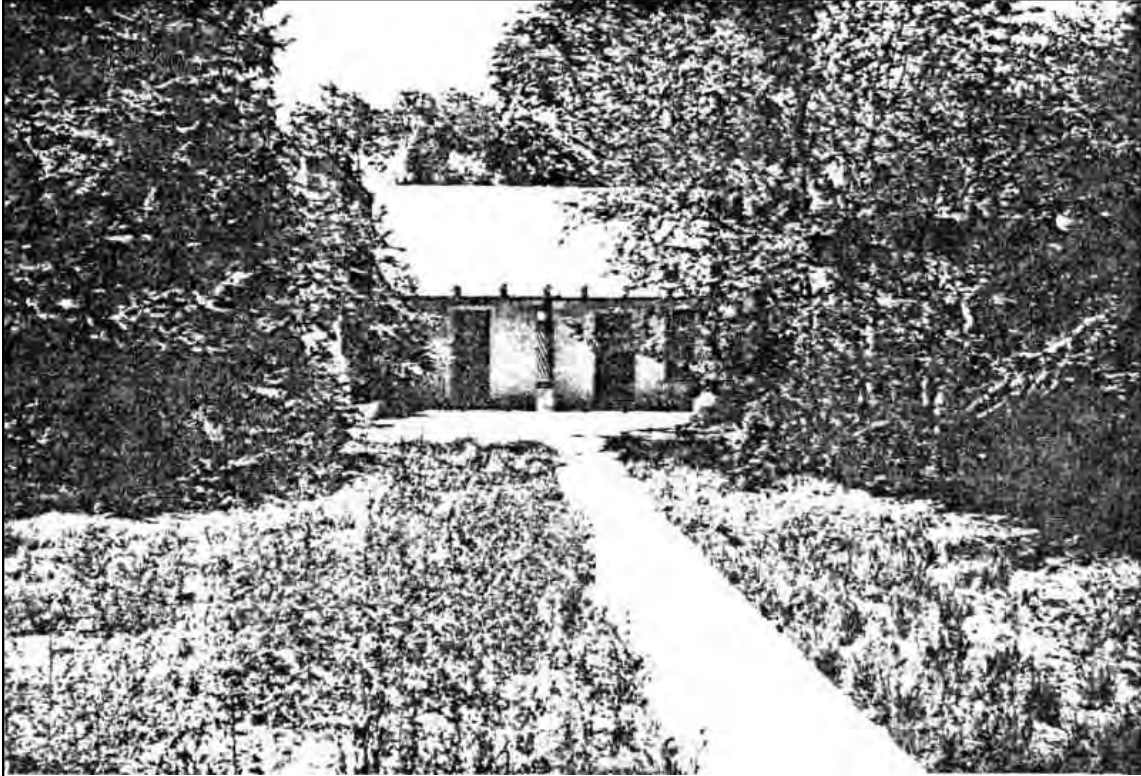
PHOTOGRAPH:

ARCHITECTURAL AND CONSTRUCTION DETAILSSTORIES ABOVE GRADE? **1.0****CONSTRUCTION MATERIAL:**PRIMARY VISIBLE CONSTRUCTION MATERIAL: **Adobe**NOTES ON VISIBLE CONSTRUCTION MATERIAL: **adobe with stucco****FOUNDATION:**

carved with columns, vigas, round viga used as beam, exposed viga ends

2/2 single hung
