Historic Cultural Properties Inventory (HCPI) Base Form (FORM 1)

NAME OF PROPERTY: **Civic Plaza Dr 112 - Society of Friends;
White Horse Studio**

LOCATION OF PROPERTY: **112 CIVIC PLAZA**

2005 CLG Survey

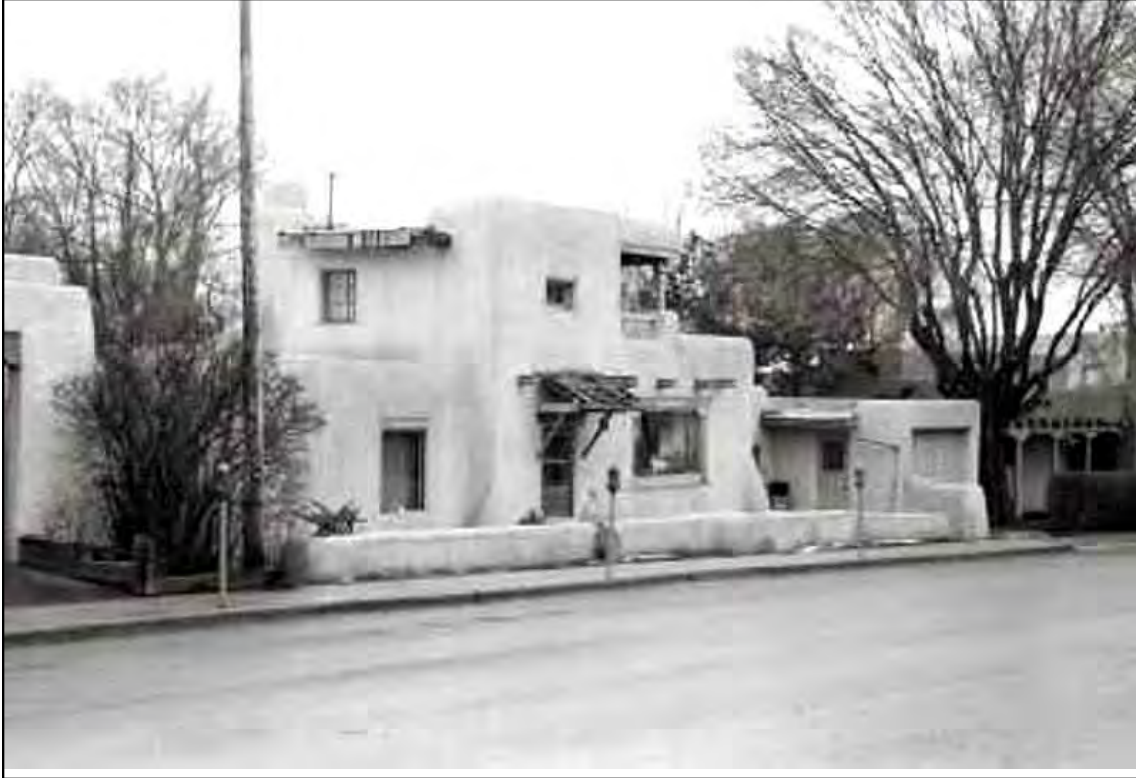
PHOTOGRAPH VIEW: **2005 Survey Photo 1**

112 Civic Plaza Place is a partial two-story Spanish Pueblo Revival style adobe/stucco with a flat parapet that partially conceals a shed roof that drains east as evidenced by the deep overhang on the upper story. There is a single story attached garage on the west elevation with a wooden pedestrian entrance on the west and a folding panel vehicular door on the north. Windows are a mix of deeply recessed wooden units that are fixed plate glass with exposed/carved lintels and engaged columns, 6-lite casement units on the upper level, and 2- and 3-lite awning units. There are exposed vigas on the north, and a recessed portal with round posts, corbels, wood railing, and parapet on upper level west elevation. Entry to the building is through a single-leaf wooden storm door that protects the vertical plank entry door. There is a tile-covered overhang at the main entry. A low yard wall runs across the front of the property at the sidewalk. A taller yard wall with a pedestrian gate stands to the east of the building enclosing the side and rear yard.

GENERAL: Notes*Details***Partial 2-story, painting and other minor cosmetic upgrades warranted.****EXTERIOR: Notes***Details***Exposed Vigas on north****ROOF: Notes***Details***Tile-covered entry overhang****Flat
Flat Parapet
Low****sloping east, deep overhang on****DOORS: Notes***Details***Wood****WINDOWS: Notes***Details***Mix of windows, deeply recessed.****Glazed
Fixed
Casement
Divided Light
Awning****PORCHES/PORTALES: Notes***Details*

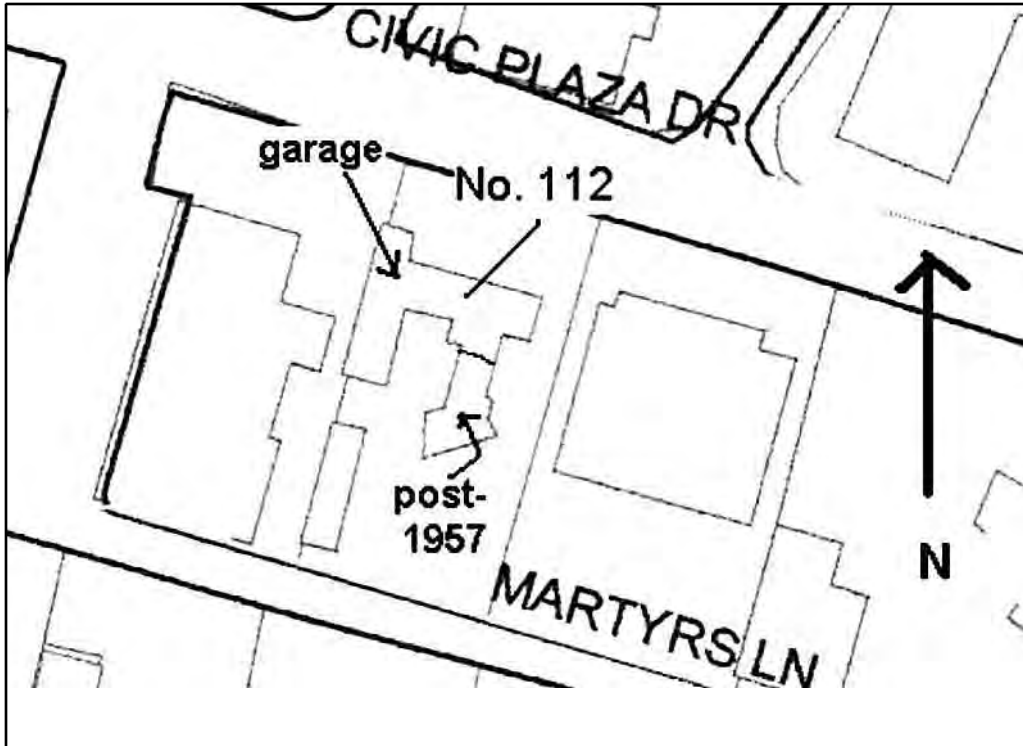
SITE PLAN:

Site. Base map provided by Taos GIS. NTS.

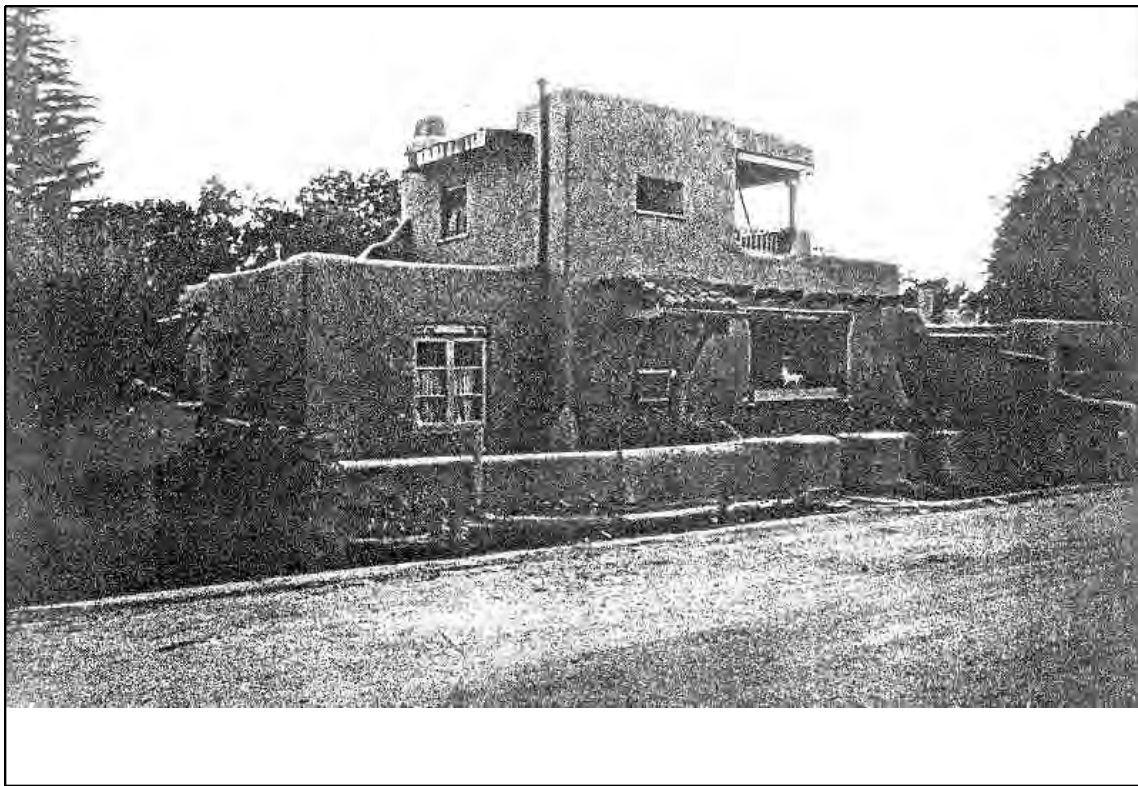
PHOTOGRAPH VIEW: **1981 Survey Photo 1**

112 Civic Plaza Place is a partial two-story Spanish Pueblo Revival style adobe/stucco with a flat parapet that partially conceals a shed roof that drains east as evidenced by the deep overhang on the upper story. There is a single story attached garage on the west elevation with a wooden pedestrian entrance on the west and a folding panel vehicular door on the north. Windows are a mix of deeply recessed wooden units that are fixed plate glass with exposed/carved lintels and engaged columns, 6-lite casement units on the upper level, and 2- and 3-lite awning units. There are exposed vigas on the north, and a recessed portal with round posts, corbels, wood railing, and parapet on upper level west elevation. Entry to the building is through a single-leaf wooden storm door that protects the vertical plank entry door. There is a tile-covered overhang at the main entry. A low yard wall runs across the front of the property at the sidewalk. A taller yard wall with a pedestrian gate stands to the east of the building enclosing the side and rear yard.

Society of Friends/White Horse Studio; exposed vigas, carving, painting, second story portal; solar addition

Large solar addition on SE.
