Historic Cultural Properties Inventory (HCPI) Base Form (FORM 1)

NAME OF PROPERTY: **Bent St 130 - Trujillo Carriage House**

LOCATION OF PROPERTY: **130 BENT**

2005 CLG Survey

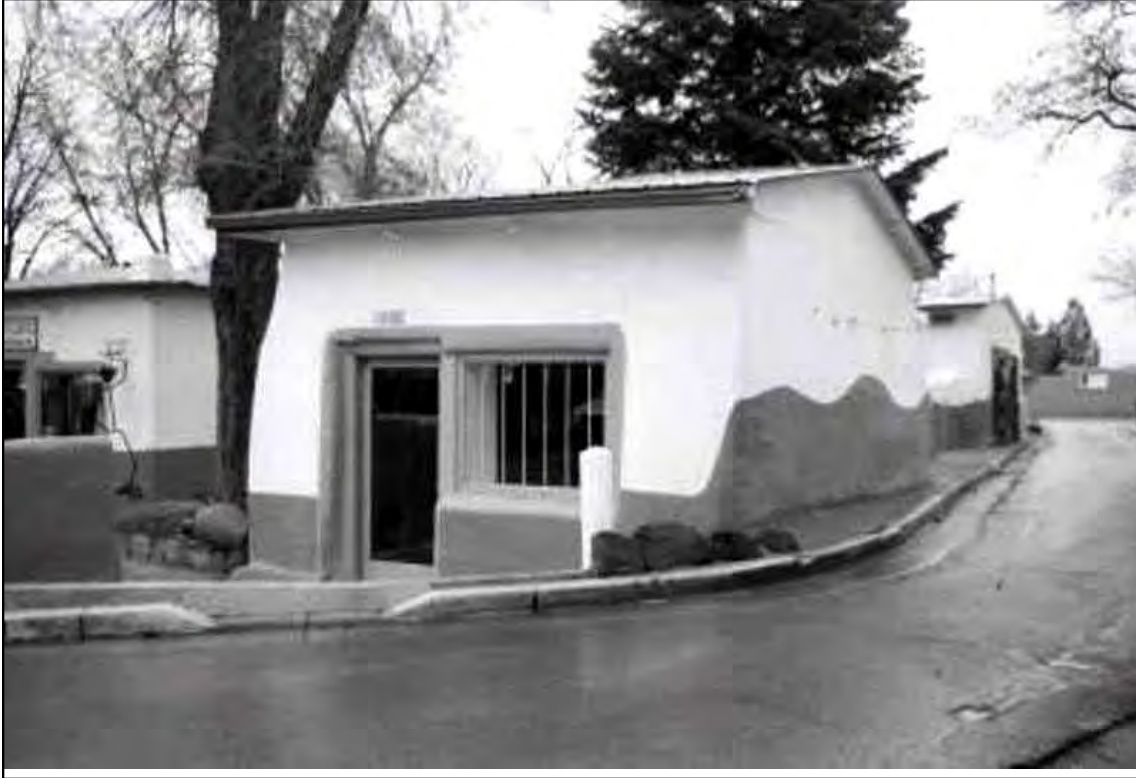
PHOTOGRAPH VIEW: **2005 Survey Photo 1**

130 Bent Street is a single story pitched roof painted stucco on adobe structure with a gable roof covered with blue propanel. The paint scheme matches that on the building to its west, the former main house on the site. There is vertical wood panel infill under the gable. Windows are fixed plate glass and there is a 4-lite window unit on the south elevation. Access to the interior is through a recessed single-leaf wood and glass door on the east. There is also a low vertical panel wood door on the west elevation. Exposed vigas project from the wall on the north and south elevations. The building sits on a concrete foundation and is at the street on the bend in Bent Street.

SIGNIFICANT MODIFICATIONS? **post-1957 height increased and gable roof added, infilled door on south, east elevation storefront**

NOTES ON CONDITION: **Good**

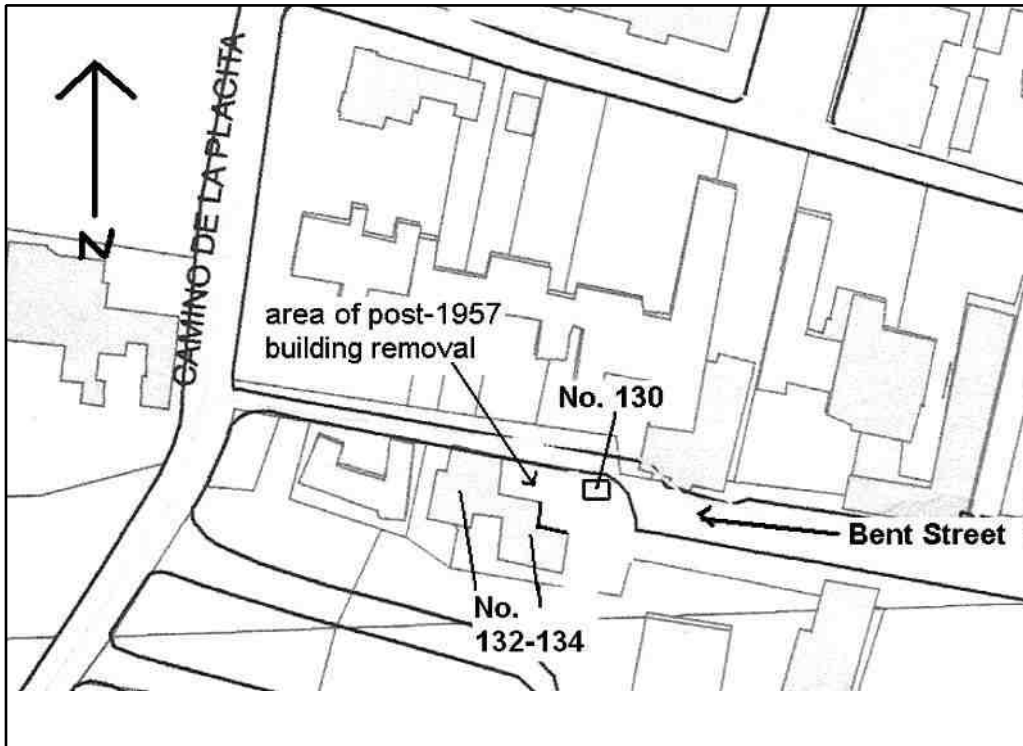
SITE PLAN:

Site. Base map provided by Taos GIS. NTS.
