# Historic Cultural Properties Inventory (HCPI) Base Form (FORM 1)

NAME OF PROPERTY: **Paseo del Pueblo Norte 219 - First Northern Savings and Loan**  
LOCATION OF PROPERTY: **219 PASEO DEL PUEBLO NORTE**  
CITY OR TOWN: **Taos**  
COUNTY: **Taos**

NAME OF PROJECT: **2005 CLG Survey**

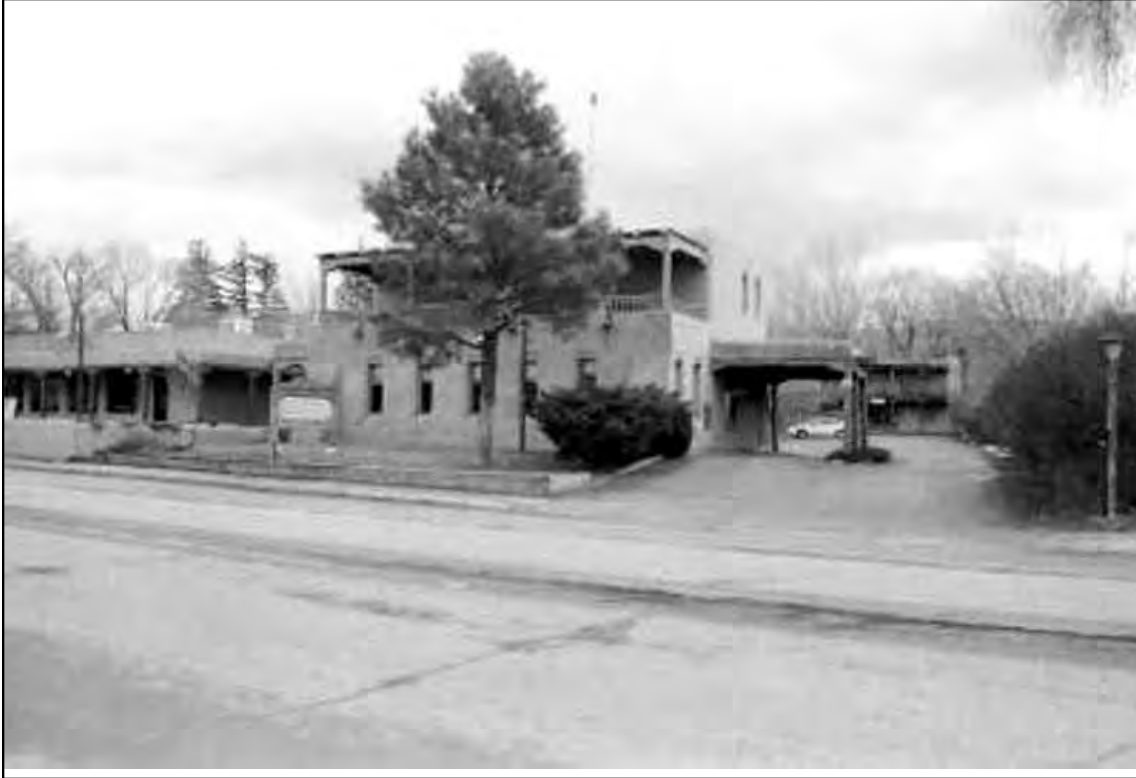
PHOTOGRAPH:  
ROLL NUMBER:  
FRAME NUMBER:  
NEGATIVE LOCATION:

PROPERTY TYPE: **Primary** PHOTOGRAPH VIEW: **west and south**

219 Paseo del Pueblo Norte is a two-story Spanish Pueblo Revival style commercial structure with a full basement. The stuccoed building has a flat parapet with large-lite fixed wooden window units with exposed lintels. There is a full-width portal on the north elevation first floor with a flat parapet, posts, corbels, and exposed vigas. The additional full-width portal on the west elevation second floor has a slight shed roof with vigas and latillas, posts and corbels, and a wooden railing. On the south elevation is a drive-up teller location covered with a porte cochere designed as a deep portal that matches that which is on the north elevation. The building has corner buttresses. A low railroad tie wall encloses the front yard at the sidewalk. The building sits slightly above the street grade with a parking area to its east.

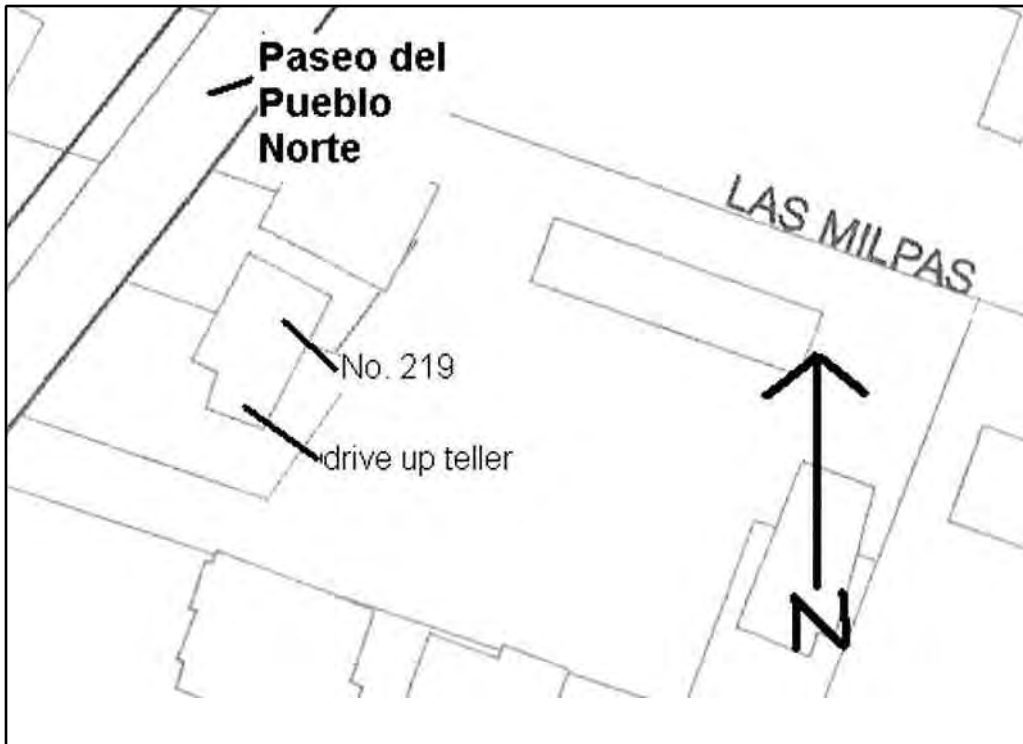
**SITE PLAN:**

Site. Base map provided by Taos GIS. NTS.
