# Historic Cultural Properties Inventory (HCPI) Base Form (FORM 1)

NAME OF PROPERTY: **Paseo del Pueblo Norte 228 - Rumaldo Garcia Building - Plaza Garcia** LOCAL REFERENCE NUMBER: **2005026**  
LOCATION OF PROPERTY: **228 PASEO DEL PUEBLO NORTE** UTM ZONE:  
CITY OR TOWN: **Taos** UTM EASTING:  
COUNTY: **Taos** UTM NORTHING:

NAME OF PROJECT:  
**2005 CLG Survey**

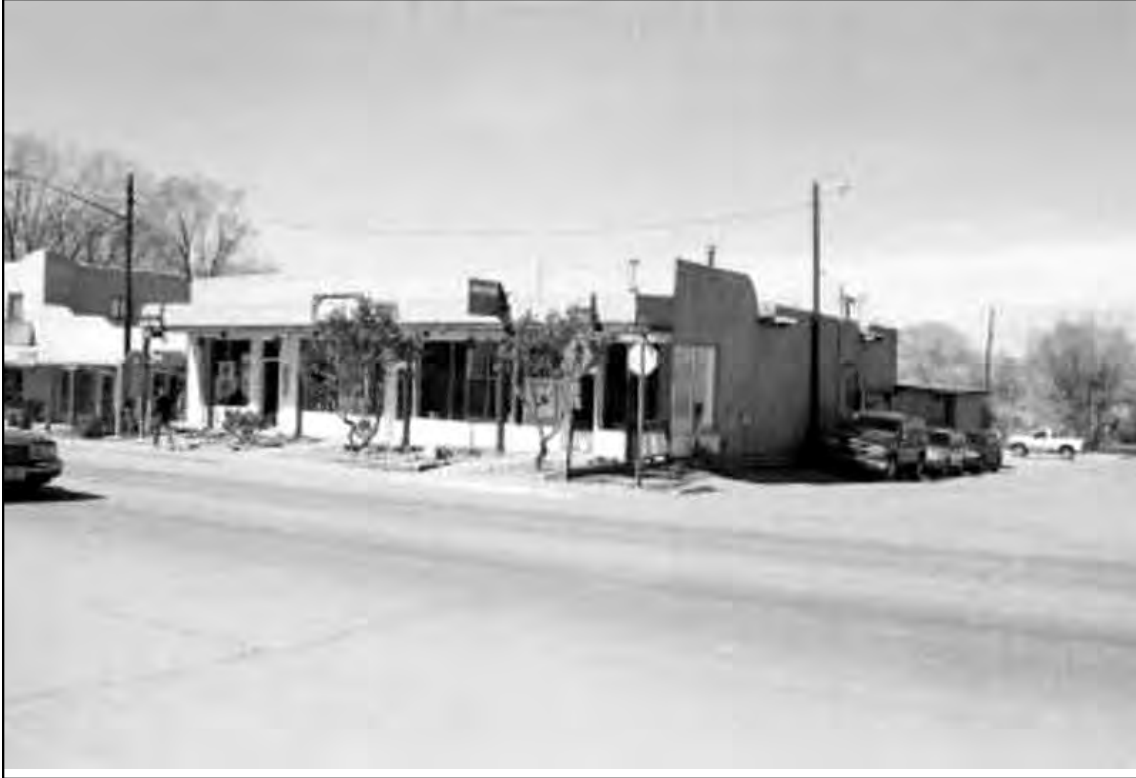
PROPERTY TYPE: **Primary** PHOTOGRAPH VIEW: **East and north**

228 Paseo del Pueblo Norte is a single story simplified Spanish Pueblo Revival style commercial structure. It is concrete block and stucco with a flat parapet that step along the north elevation. A full-width portal with posts, corbels, canales, and a flat parapet covers the east elevation storefronts. There are three storefronts which are accessed by way of individual single leaf large lite doors with transoms. Plate glass storefront windows rest on a knee wall; the northernmost storefront wraps the building's corner and extends along the north elevation. There are two wide canales on the north elevation. The building sits on a corner lot and is elevated about street grade.

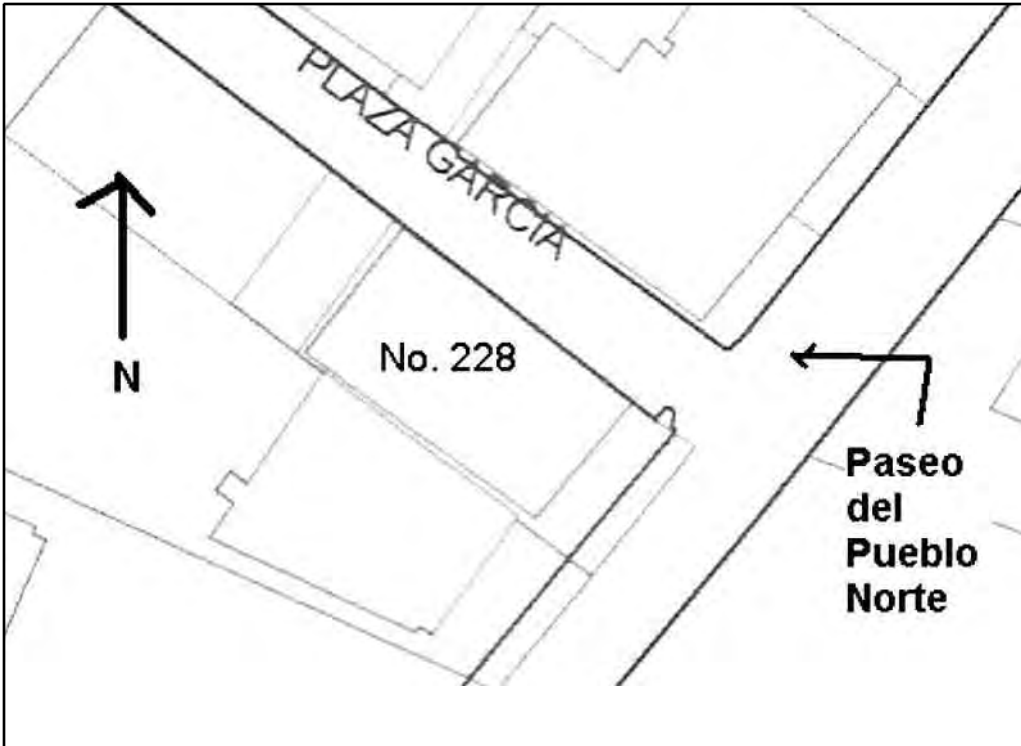
**SITE PLAN:**

**Site. Base map provided by Taos GIS. NTS.**
