Historic Cultural Properties Inventory (HCPI) Base Form (FORM 1)

NAME OF PROPERTY: **Paseo del Pueblo Norte 412 - Ilfeld Garage - El Pueblo Lodge # 1** LOCAL REFERENCE NUMBER: **2005035**
LOCATION OF PROPERTY: **412 PASEO DEL PUEBLO NORTE** UTM ZONE:
CITY OR TOWN: **Taos** UTM EASTING:
COUNTY: **Taos** UTM NORTHING:

NAME OF PROJECT:
2005 CLG Survey

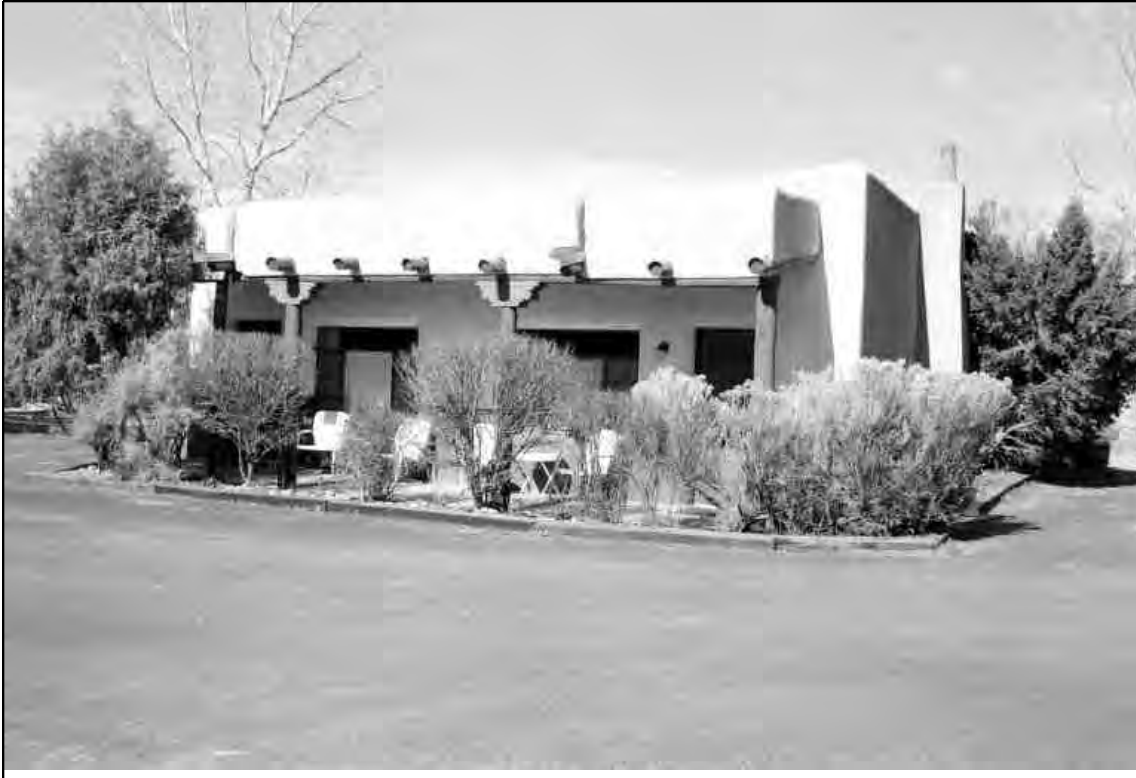
PROPERTY TYPE: **Primary** PHOTOGRAPH VIEW: **south**

Building #1 at 412 Paseo del Pueblo Norte is the former historic garage on the site. It is a single story stuccoed Spanish Pueblo Revival style commercial residential structure. It has a flat parapet which conceals the shed roofline. Windows on the south/front elevations are 3-lite steel casement units with divided-lite transoms and a central fixed plate glass unit. On the north elevation there is a single large lite plate glass window with an exposed wooden lintel. There is a partial width portal with wooden posts and corbels, exposed viga ends, canales, and a slanted ceiling. Three single leaf wooden panel pedestrian doors provide access to the interior. There are two exterior chimneys.

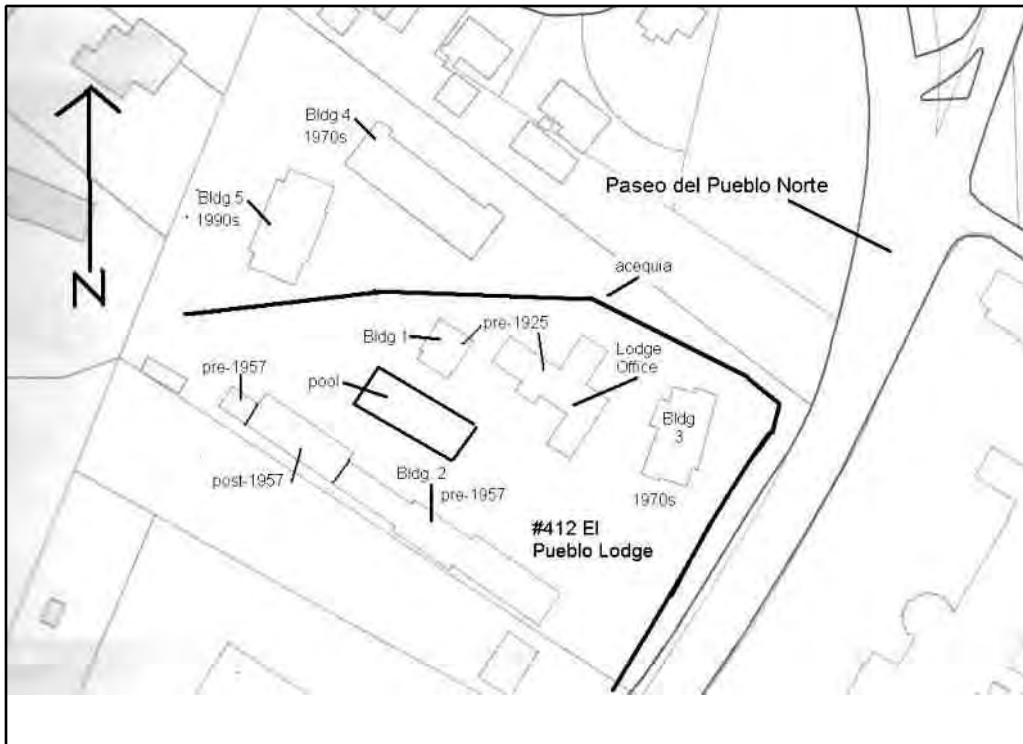
SITE PLAN:

Site. Base map provided by Taos GIS. NTS.
