Historic Cultural Properties Inventory (HCPI) Base Form (FORM 1)

NAME OF PROPERTY: Paseo del Pueblo Norte 514 - Ellis House/B&B

LOCATION OF PROPERTY: 514 PASEO DEL PUEBLO NORTE

2005 CLG Survey

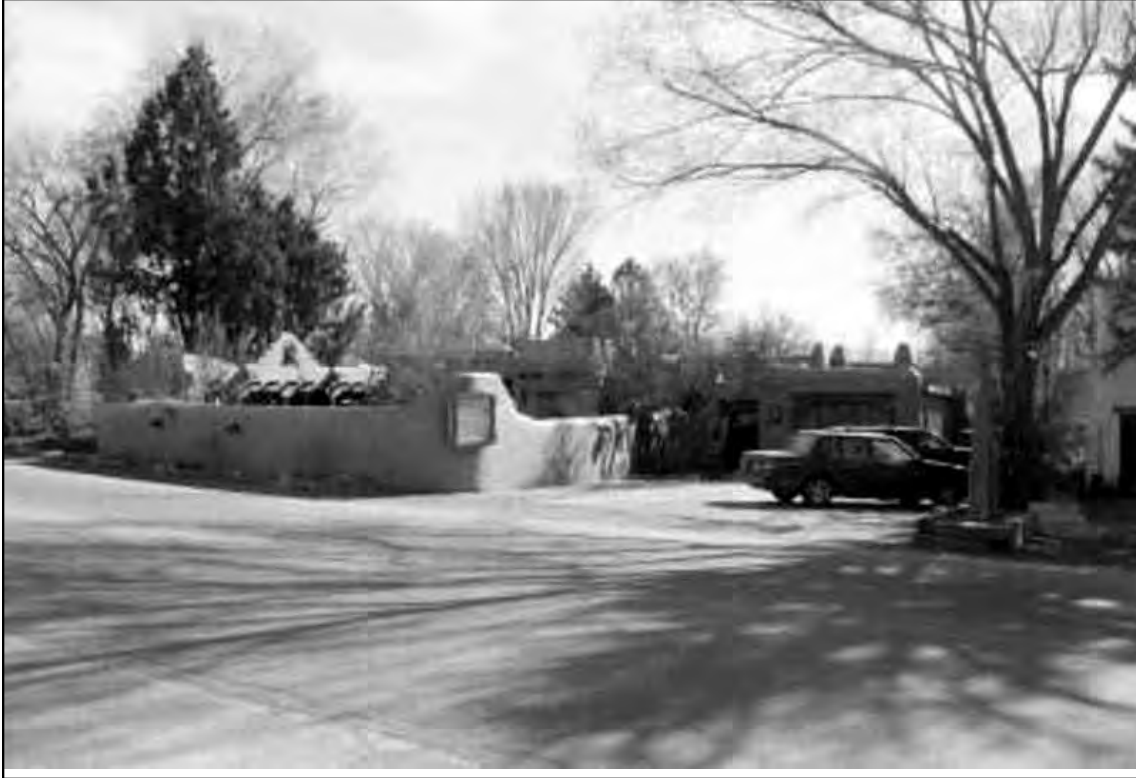
PHOTOGRAPH:

PHOTOGRAPH VIEW: north and west elevations

514 Paseo del Pueblo Norte is a single story Spanish Pueblo Revival style stuccoed residential building. It has a flat parapet with changes in its massing and height in various areas. A stepped bell tower dominates the north elevation of the south wing. Windows are 8-lite wooden casement units and fixed plate glass units. All have exposed wooden lintels. The south wing of the building is designed as a portal with an enclosed south elevation. It has turned wooden posts, corbels, canales, and a bell in the bell tower. A central projecting mass with exposed viga ends dominates the east elevation of the structure. The entrance to the building is concealed behind the high stucco yard wall across the east property line. There are multiple interior chimneys. An attached garage with a wooden paneled vehicular door stands on the north side of the building.

SIGNIFICANT MODIFICATIONS? new windows, areas of parapets raised

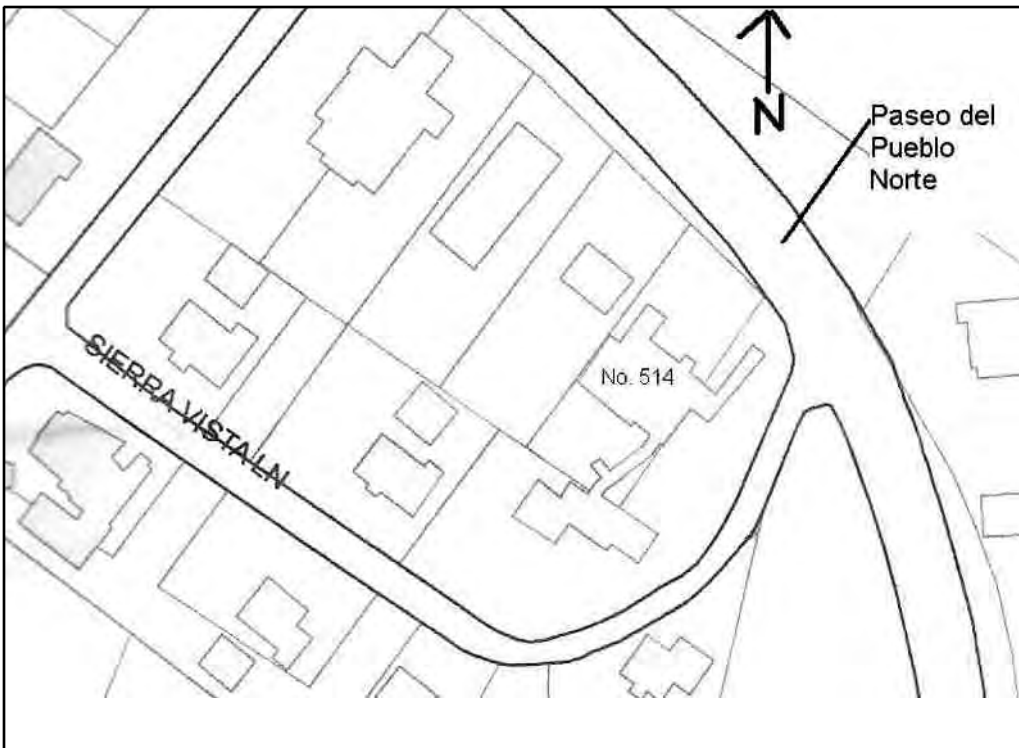
SITE PLAN:

Site. Base map provided by Taos GIS. NTS.
