# Historic Cultural Properties Inventory (HCPI) Base Form (FORM 1)

NAME OF PROPERTY: **Paseo del Pueblo Norte 303 - Pascual Martinez/Ouray Meyers Gallery** LOCAL REFERENCE NUMBER: **2005058**  
LOCATION OF PROPERTY: **303 PASEO DEL PUEBLO NORTE** UTM ZONE:  
CITY OR TOWN: **Taos** UTM EASTING:  
COUNTY: **Taos** UTM NORTHING:

NAME OF PROJECT:  
**2005 CLG Survey**

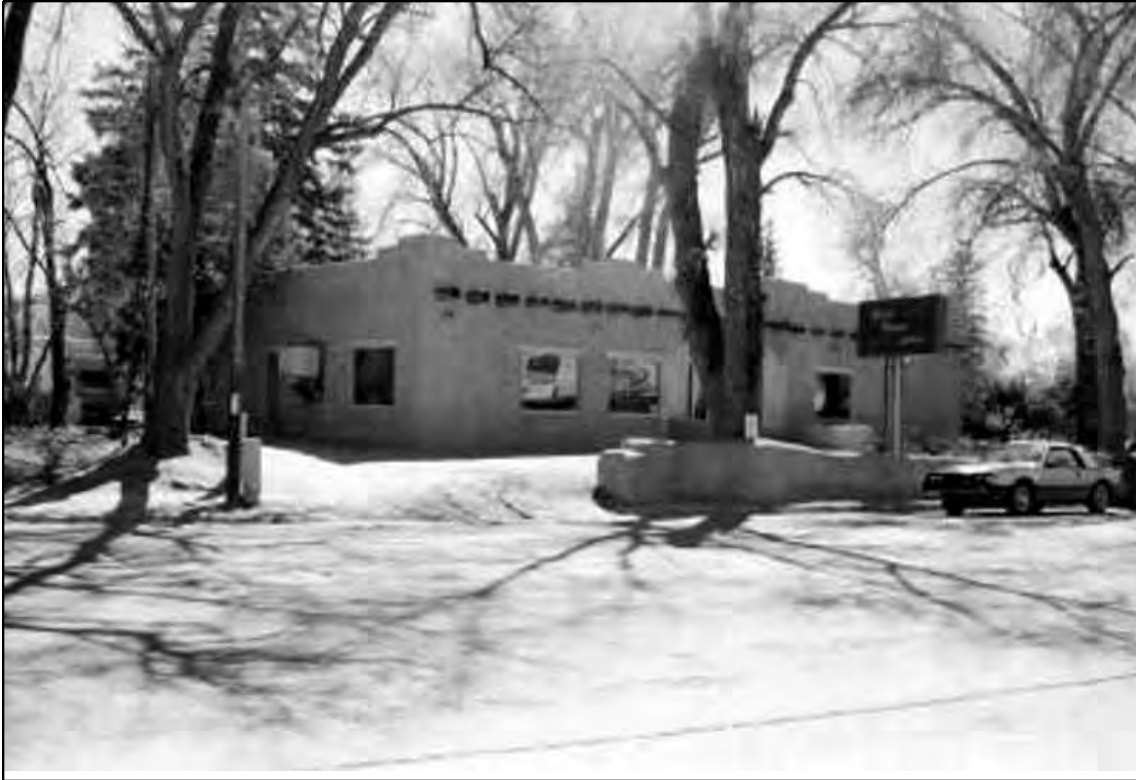
PROPERTY TYPE: **Primary** PHOTOGRAPH VIEW: **north and west elevations**

303 Paseo deo Pueblo Norte is a single story Spanish Pueblo Revival style stuccoed commercial structure with a stepped parapet which conceals a roofline that sheds to the south. Exposed vigas decorate the west façade. Windows are large fixed plate glass units with carved lintels. A central raised entrance is recessed on the west with double-leaf glass and wood doors. There is a low stucco wall along the front of the property at the sidewalk. Visibility of the historic portion of the structure is minimal on the south elevation. There are large evergreen and cottonwood trees on the site which further conceals the historic area of the building. Visible details on the historic portion include 6-over-6 double hung wooden windows, and a lean-to porch at the southeast corner.

NOTES ON CONDITION: **Good**

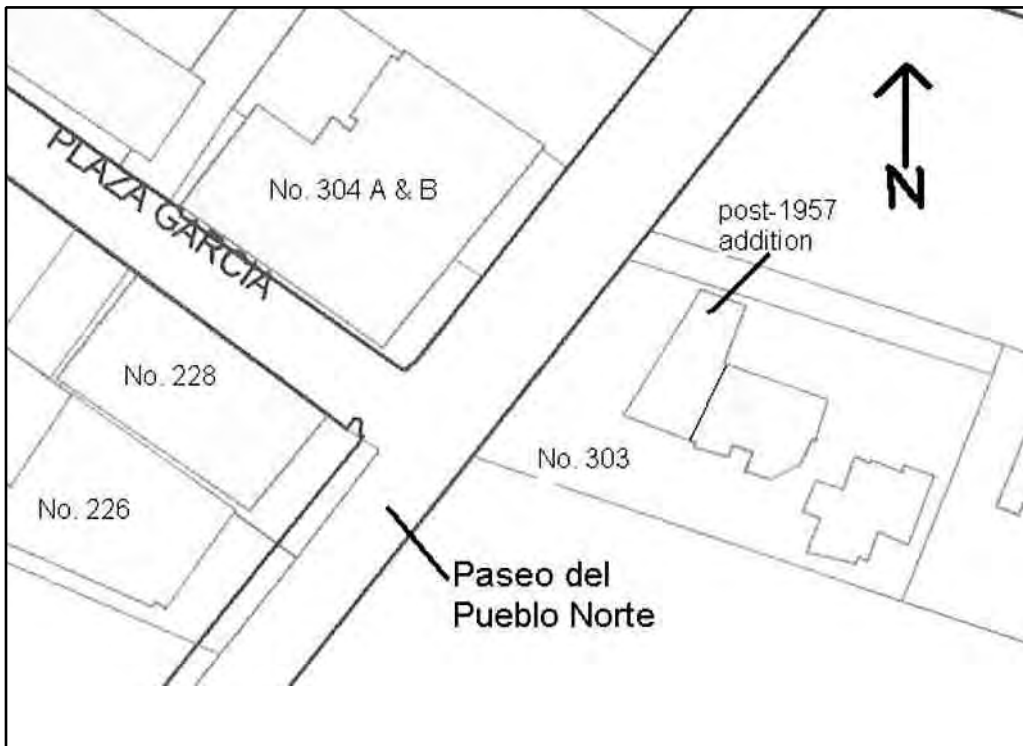
SITE PLAN:

Site. Base map provided by Taos GIS. NTS.
