Historic Cultural Properties Inventory (HCPI) Base Form (FORM 1)

NAME OF PROPERTY: **Plaza North 129 - H. Romero, Cabot Building**

LOCATION OF PROPERTY: **129 NORTH PLAZA**

1996 CLG Survey

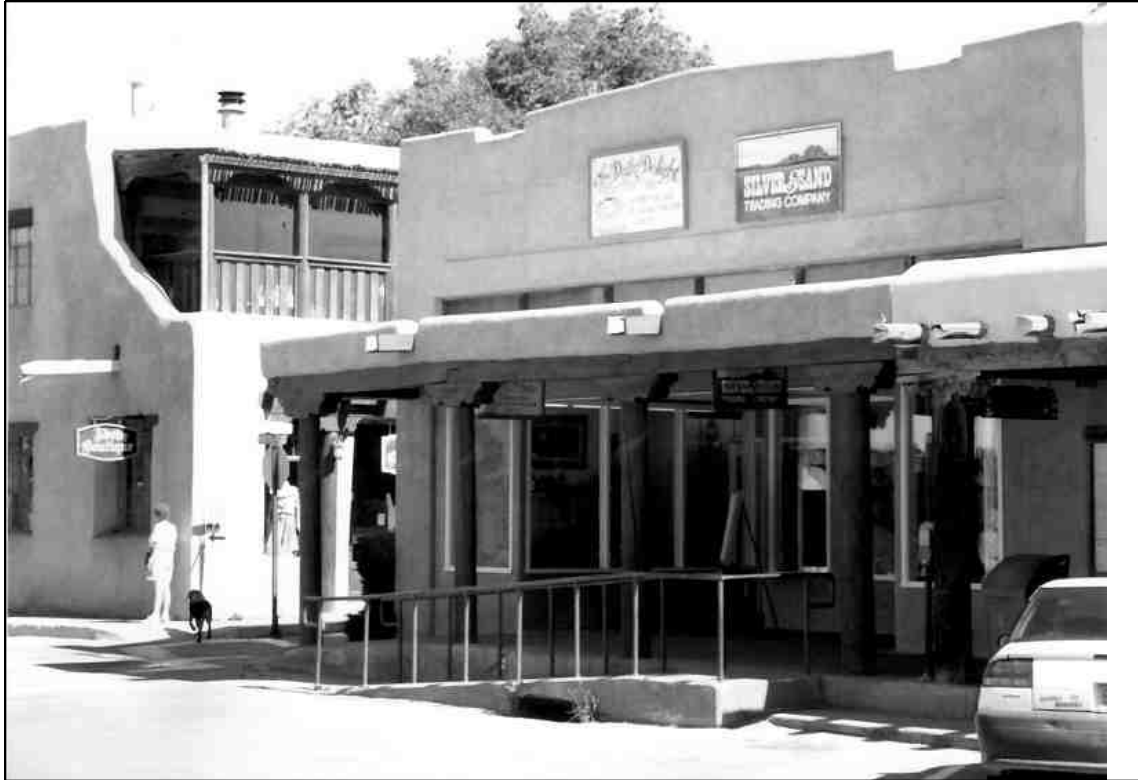
PHOTOGRAPH:

PHOTOGRAPH VIEW: **older**

ARCHITECTURAL AND CONSTRUCTION DETAILSSTORIES ABOVE GRADE? **1.0****CONSTRUCTION MATERIAL:**PRIMARY VISIBLE CONSTRUCTION MATERIAL: **Adobe**

top front parapet is pedimented (1981 Survey); clerestory recessed on wall above portal - continuous

stepped in front; canales to west side

2 at entrance lg. leaf lite with wood surround & vertical side lites

12 lg. lite; west side - 2/2 metal - upper level

6" round posts with zapata bracket corbels supporting 6" x 6" beams; two canales to south (front); pine ceilings

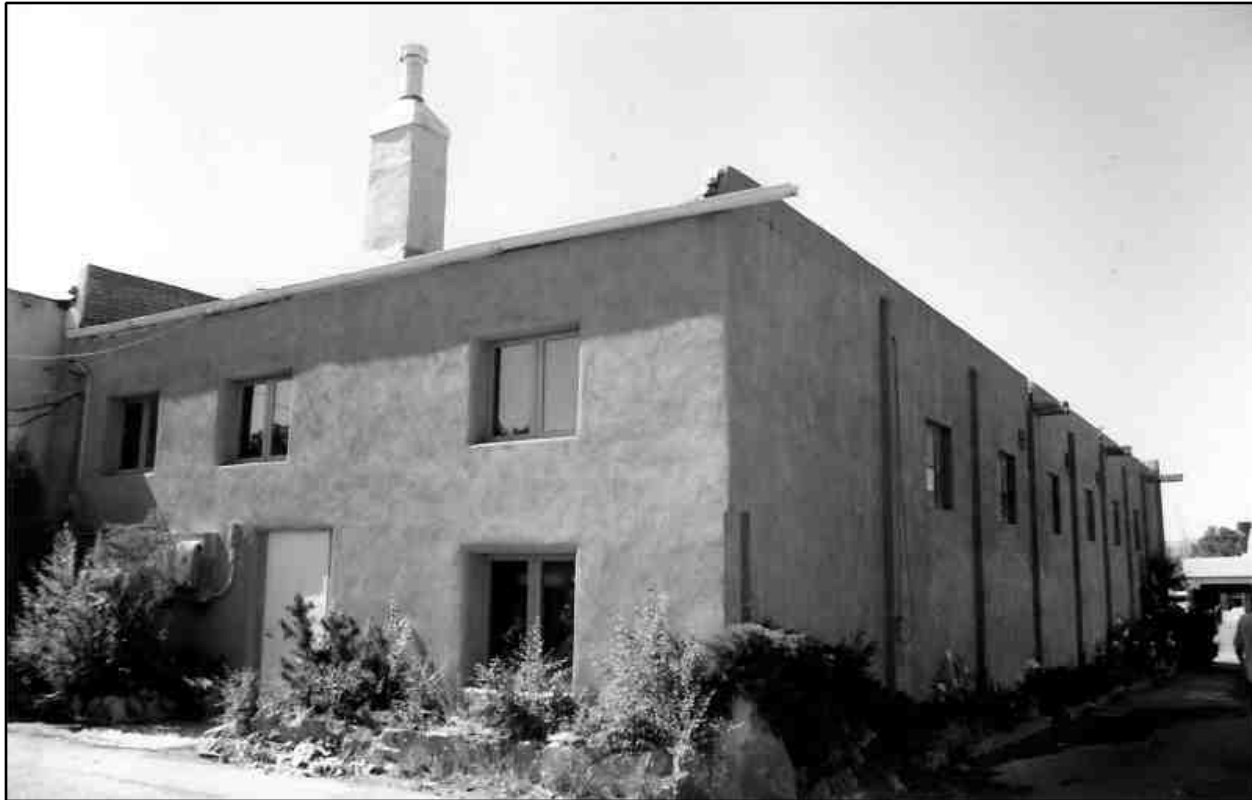
ADDITIONAL PERSPECTIVE: (Photo, drawing, footprint, etc.; indicate north arrow when possible)

NOTES ON ADDITIONAL PERSPECTIVE: **older**
(If photo, include photo info, as in #10)
