Historic Cultural Properties Inventory (HCPI) Base Form (FORM 1)

NAME OF PROPERTY: **Kit Carson Rd 109 - Liebert/Dell Fine Art/House Feathers**

LOCATION OF PROPERTY: **109 KIT CARSON**

1996 CLG Survey

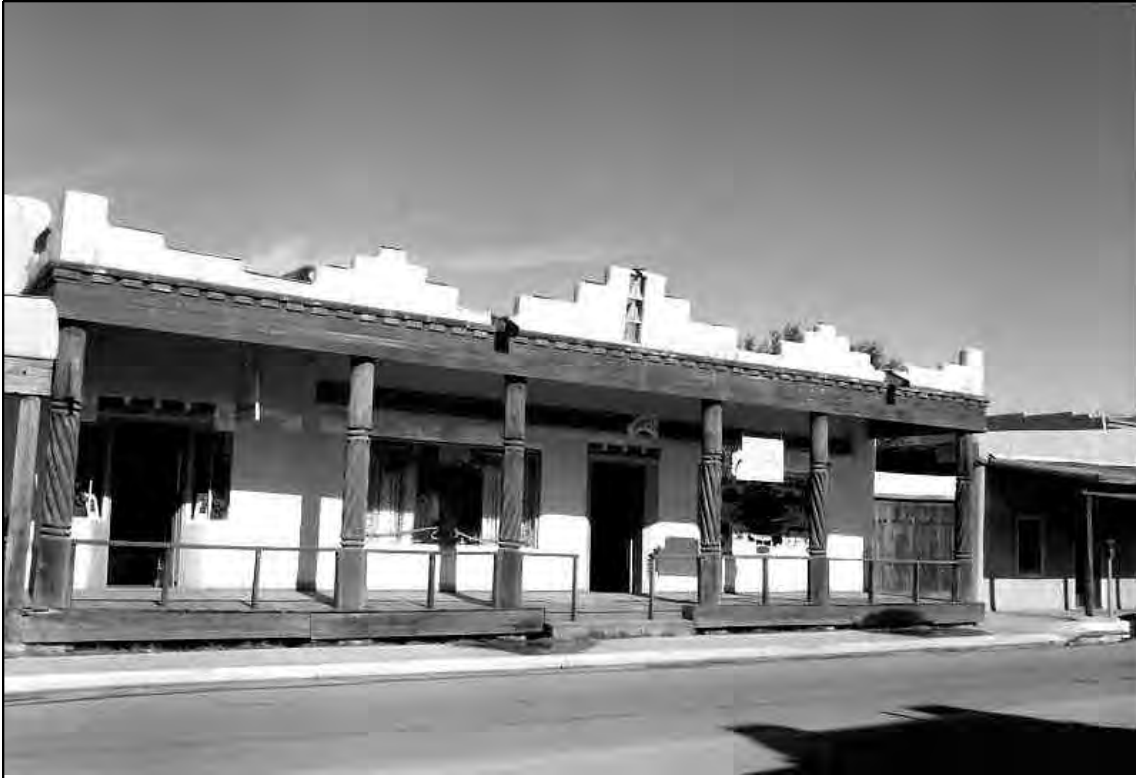
PHOTOGRAPH:

decorative portal with boardwalk, carved posts & wood decorative facia; gate attached to southwest corner of 4005, sidewalk & curbing on south side of portal; wood steps on east, south & west access to portal

adobe with stucco

stepped on portal in front - double bell opening in front

west end - 1 single leaf lite & 1 wood panel with side lites with vertical panes - door is recessed Territorial style; east center - 1 single leaf lite panel with sign manufactured on wrought iron frame

front - 2 long display lites

raised porch with vertical 1 x 14" pine boardwalk; 12" round rope carved posts with 2" x 4" rail connecting posts; beams supported 12" x 12" square posts with 2" x 12" horizontal rafters with pine board ceiling, wood facia & stepped stucco parapet above

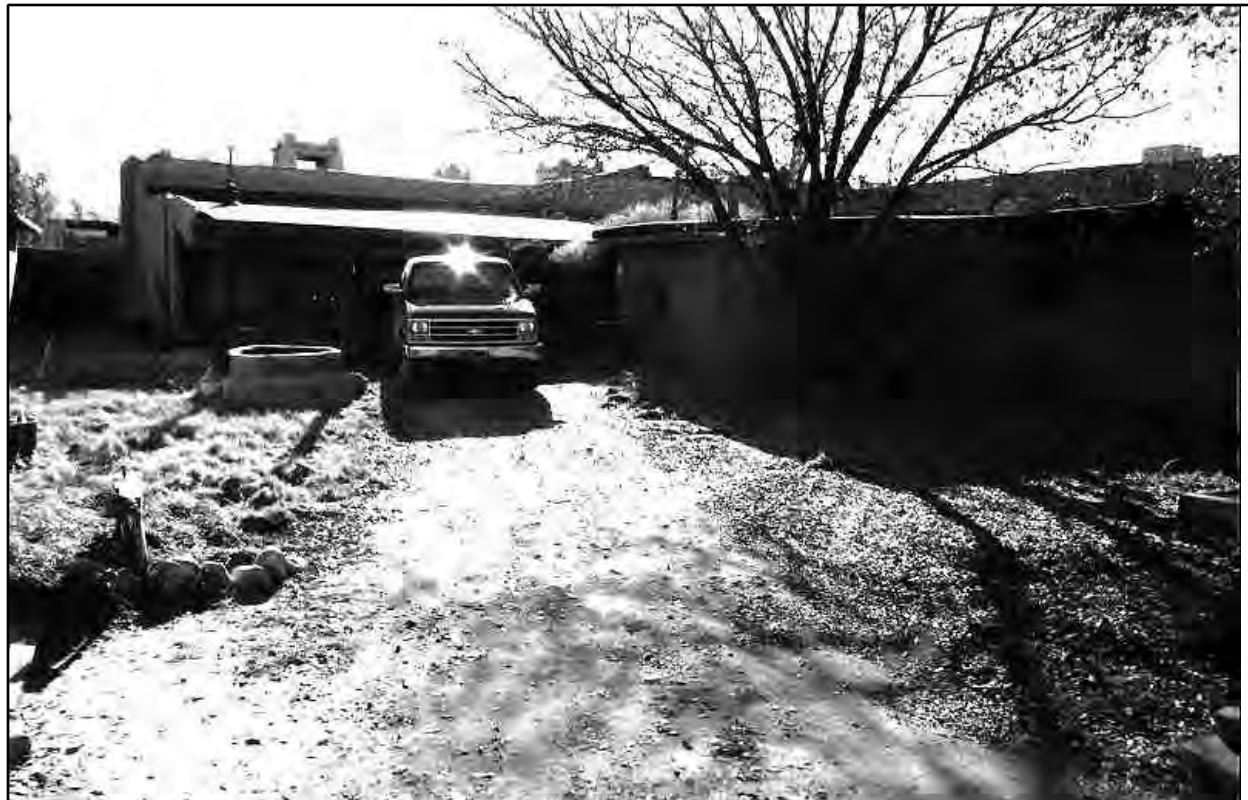
ADDITIONAL PERSPECTIVE: (Photo, drawing, footprint, etc.: indicate north arrow when possible)

NOTES ON ADDITIONAL PERSPECTIVE: **older**
(If photo, include photo info, as in #10)

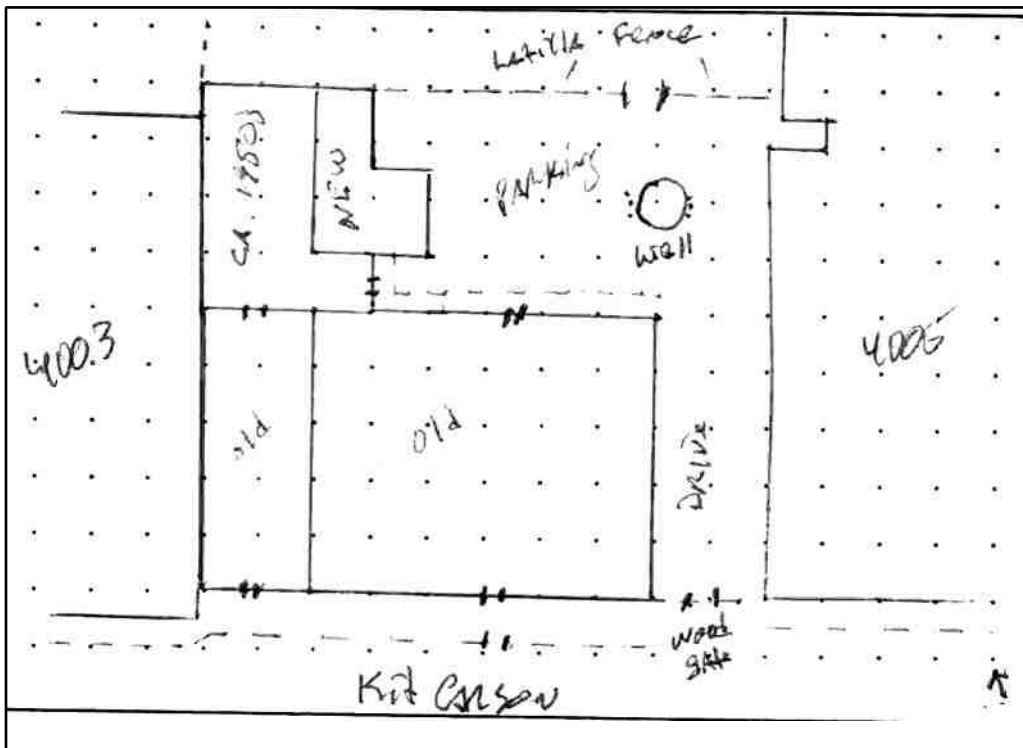
SITE PLAN:

courtyards: rear yard has round wall of recent construction; fire brick & masonry with latilla posts on east & west side; yard used for parking

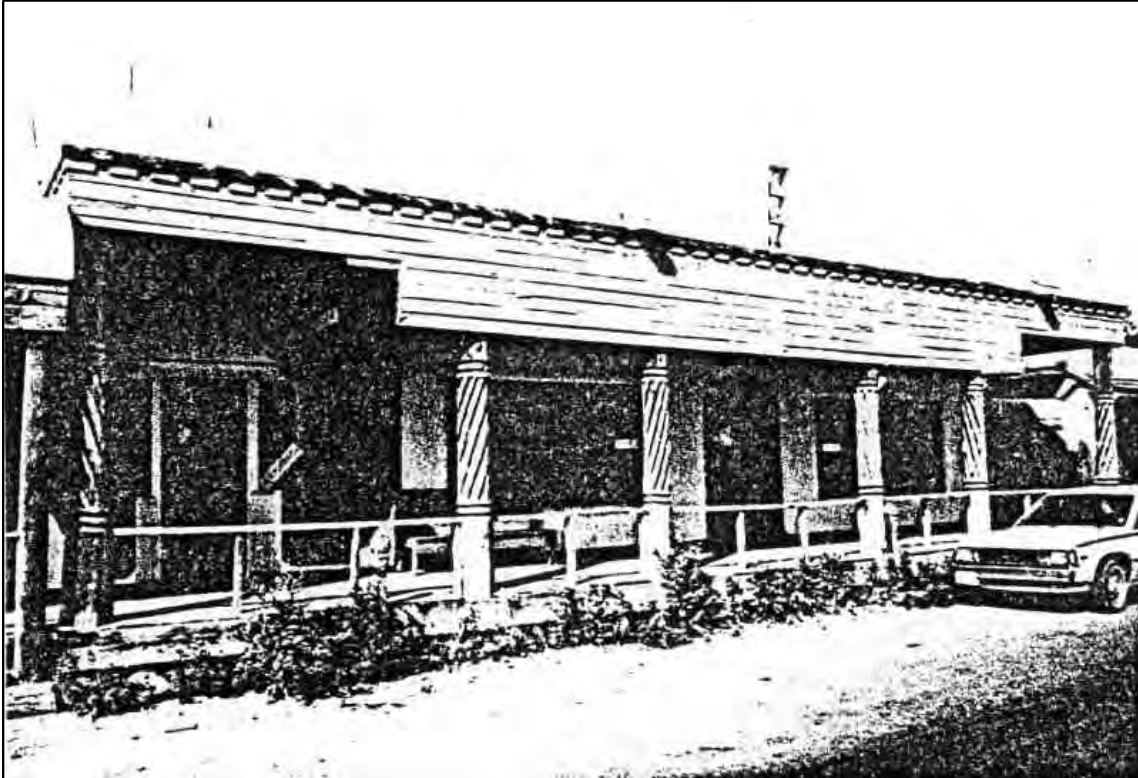
PHOTOGRAPH:

stucco on adobe

portal with wood facia, rope columns, boardwalk
